# Appendix A: Site Inventory Sheets

## Introduction

## RICHMOND BRIDGE

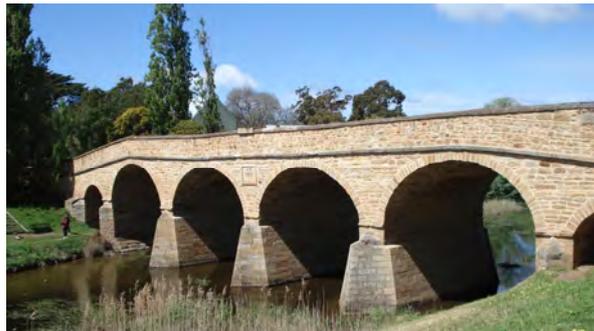
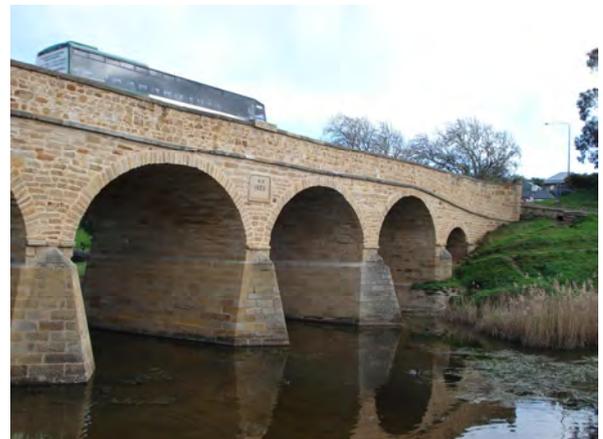
**2****NORTHERN FACE OF BRIDGE**

The northern face of the Bridge is generally in a good condition.

- ▶ Considerable progress has been made on the replacement of the old cement-rich mortar, with more appropriate lime based mortars. The replacement of the mortar has improved the aesthetic appeal of the Bridge and will assist in long term conservation.
- ▶ Hard, cement-rich mortar still exists on the fins of the piers and the eastern abutment. Cracks are also located on the northern face, located on the north east abutment, eastern and western piers. Separate Inventory Sheets address these issues.
- ▶ The north face of the Bridge receives a greater amount of sun and is largely free of organic growth. The fins of the piers have some staining.

- ▶ Appointment of an appropriately skilled stonemason to undertake conservation work to Bridge stonework (see policy 7.2.1) (7.5.7);
- ▶ Appointment of appropriately skilled stonemason; and stones to be replaced when subject to a 50mm surface loss and new stones to use 100mm thick inserts of a better quality stone (7.5.8);

- ▶ Appointment of appropriately skilled stonemason; and replacement of lost bedding with quicklime grout (7.5.10);
- ▶ Appointment of appropriately skilled stonemason to undertake condition assessment of the mortar, remove inappropriate mortar and replace with quick lime based mortar with a weather struck finish (7.5.22, 7.5.11, 7.5.13);

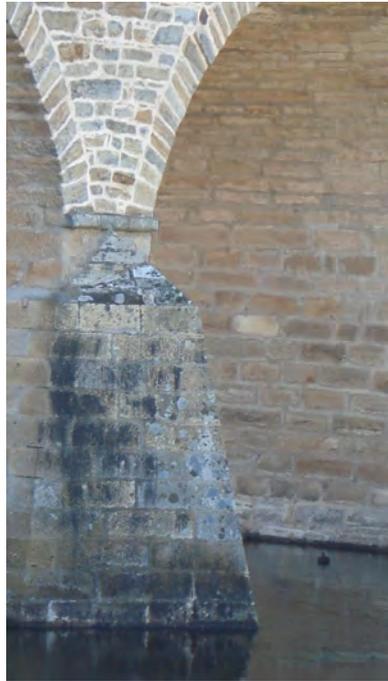
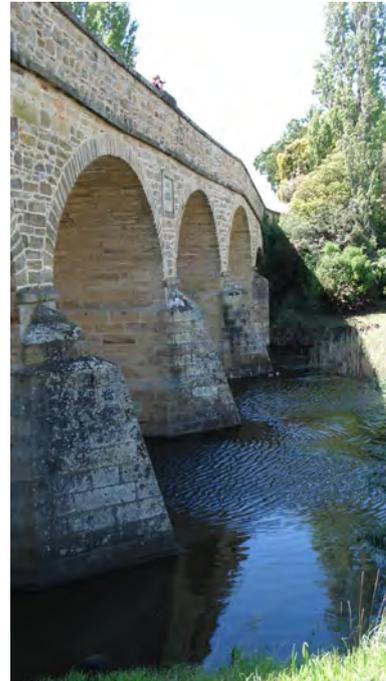
**3****SOUTHERN FACE OF BRIDGE**

The southern face of the Bridge is generally in a good condition.

- ▶ Considerable progress has been made on the replacement of the old cement-rich mortar, with more appropriate lime based mortars. The replacement of the mortar has improved the aesthetic appeal of the Bridge and will assist in long term conservation.
- ▶ Hard, cement-rich mortar still exists on the fins of the piers.
- ▶ The south face of the Bridge receives less sun and the fins of the piers have some staining.
- ▶ Damp problems exist on the south west wing wall following the stone steps.
- ▶ Ivy is growing on the south east abutment and face of the Bridge.

- ▶ The remaining hard, cement-rich mortar could cause further structural problems at the mortar joints by being impermeable to water; and
- ▶ Organic growth on the Bridge could have an adverse affect on the aesthetic significance of the place.

- ▶ Appointment of an appropriately skilled stonemason to undertake conservation work to Bridge stonework (see policy 7.2.1) (7.5.7);
- ▶ Appointment of appropriately skilled stonemason; and stones to be replaced when subject to a 50mm surface loss and new stones to use 100mm thick inserts of a better quality stone (7.5.8);

- ▶ Appointment of appropriately skilled stonemason; and replacement of lost bedding with quicklime grout (7.5.10);
- ▶ Appointment of appropriately skilled stonemason to undertake condition assessment of the mortar, remove inappropriate mortar and replace with quick lime based mortar with a weather struck finish (7.5.22, 7.5.11, 7.5.13);

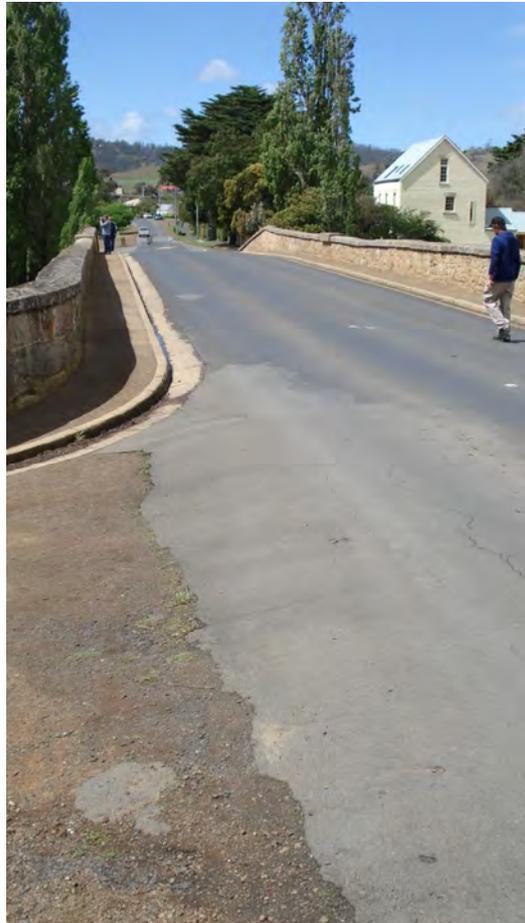
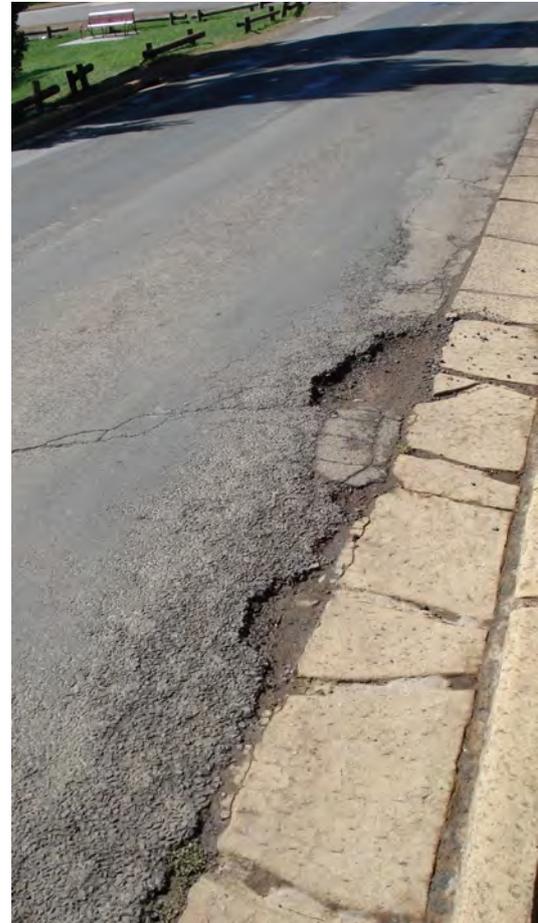
**RICHMOND BRIDGE ROAD SURFACE**

The road surface of the Bridge of the Bridge is in a fair condition. The bitumen surface has degraded adjacent to the right hand gutter, forming potholes. There is a diagonal crack in the road surface.

- ▶ Lack of maintenance; and
- ▶ The potholes and crack will continue to cause further degradation to the road surface.

- ▶ That the road surface should be subject to ongoing maintenance (7.5.25);
- ▶ That the potholes on the right hand side of the road surface adjacent to the gutters and the diagonal crack be repaired (see also policy 7.5.25) (7.5.16).

- ▶ Ongoing inspection and maintenance (7.5.25)
- ▶ The immediate repair of the potholes in excess of 20mm depth is required to prevent excessive vibrations and the entry of water. (7.5.16).

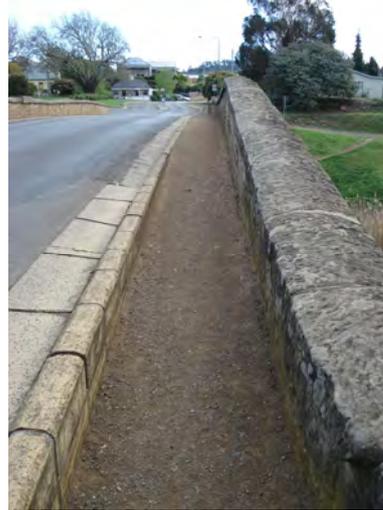
**BRIDGE FOOTPATHS**

The gravel footpaths are in a good condition. It is unclear whether the subsurface of the footpaths were waterproofed as part of the general waterproofing works.

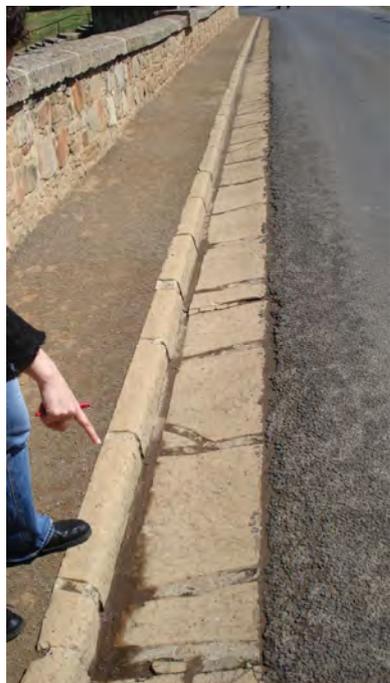
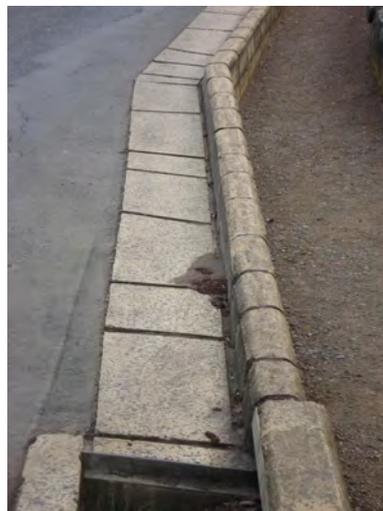
## BRIDGE GUTTERS &amp; KERBS

The Bridge gutters and kerbs vary from good to fair condition. The gutters and kerbs are concrete, coloured to match sandstone kerbing.

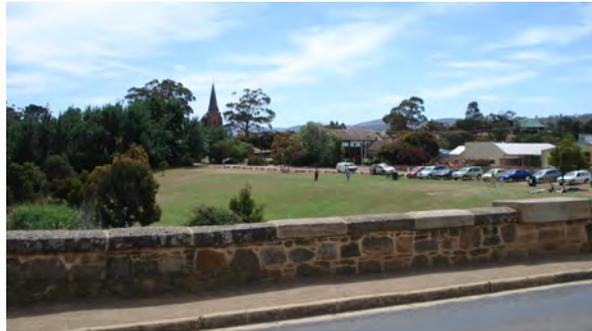
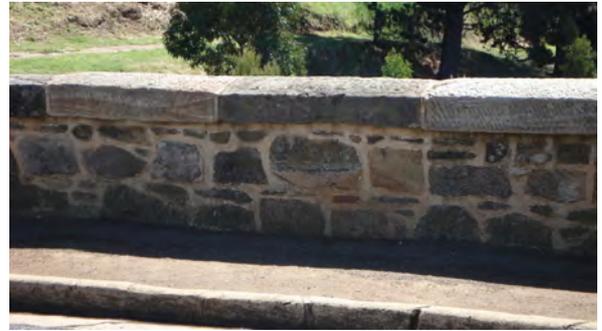
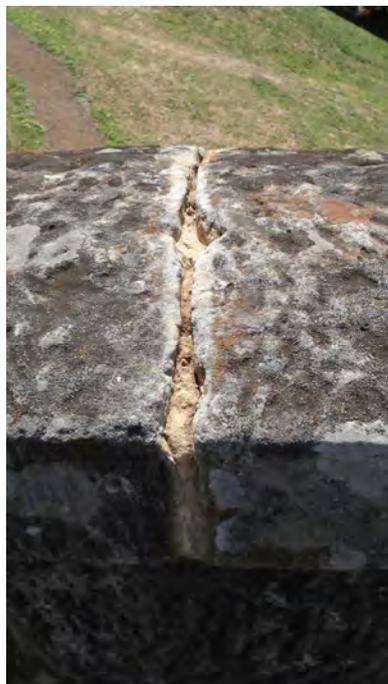
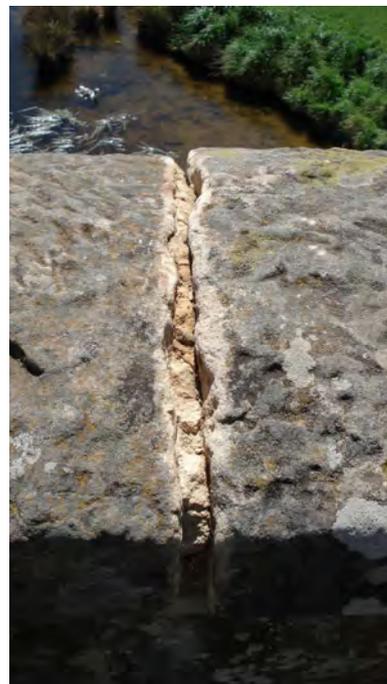
## INNER FACE, NORTHERN PARAPET

The inner face of the northern parapet wall is generally in a good condition. The western end of the parapet was raised in 1835. The replacement of most of the inappropriate cement-rich mortar on the inner faces of the parapet with lime based mortars occurred prior to 1990.

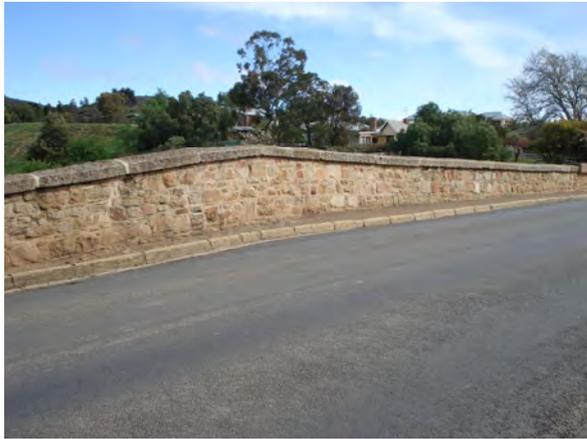
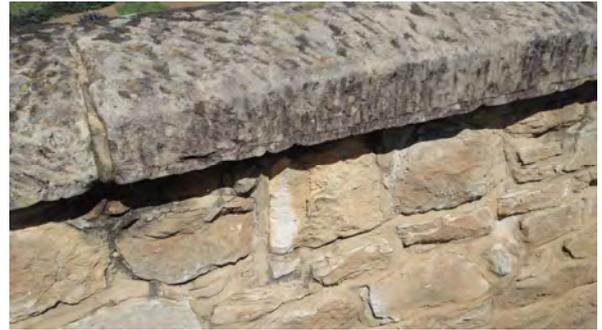
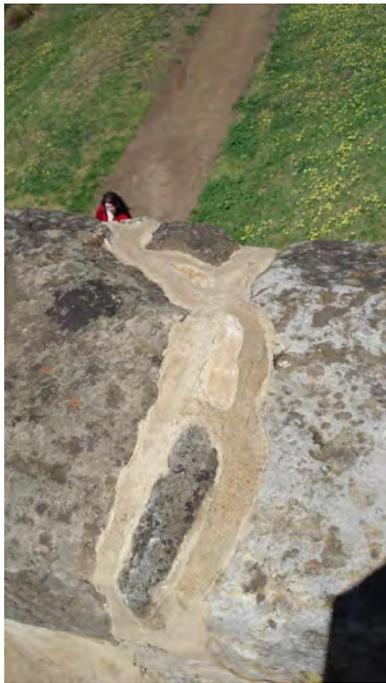
**INNER FACE, SOUTHERN PARAPET**

The inner face of the southern parapet wall is generally in a good condition. The western end of the parapet was raised in 1835. The replacement of most of the inappropriate cement-rich mortar on the inner faces of the parapet with lime based mortars occurred prior to 1990.

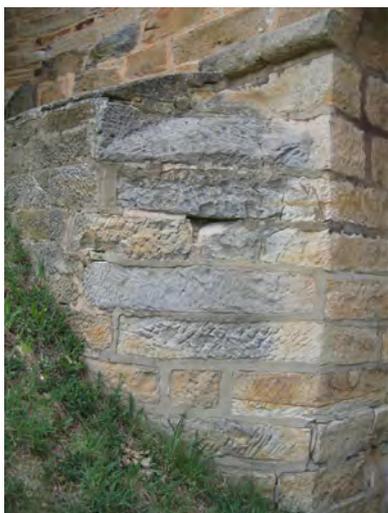
*Cracks in north east abutment*

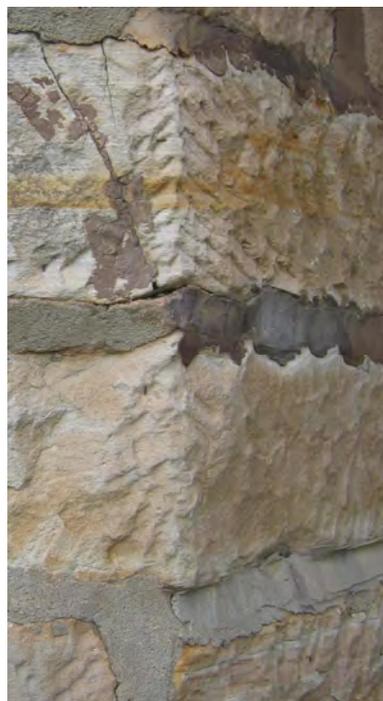
*Detail, cracks in north east abutment*

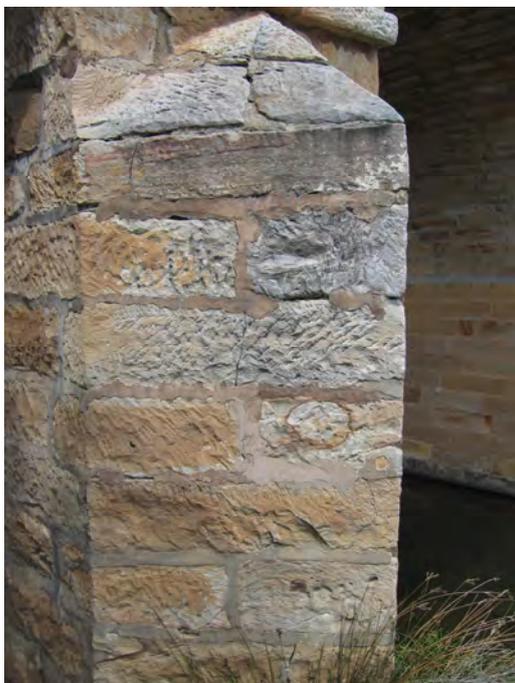
*Cracks eastern pier*

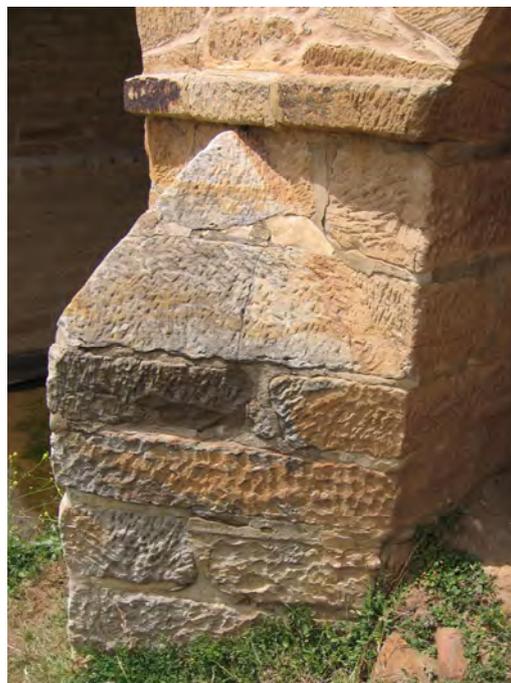
*Cracks western pier*

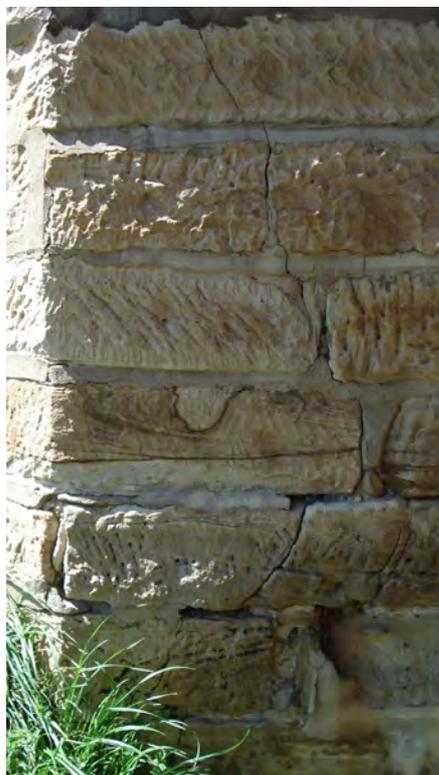
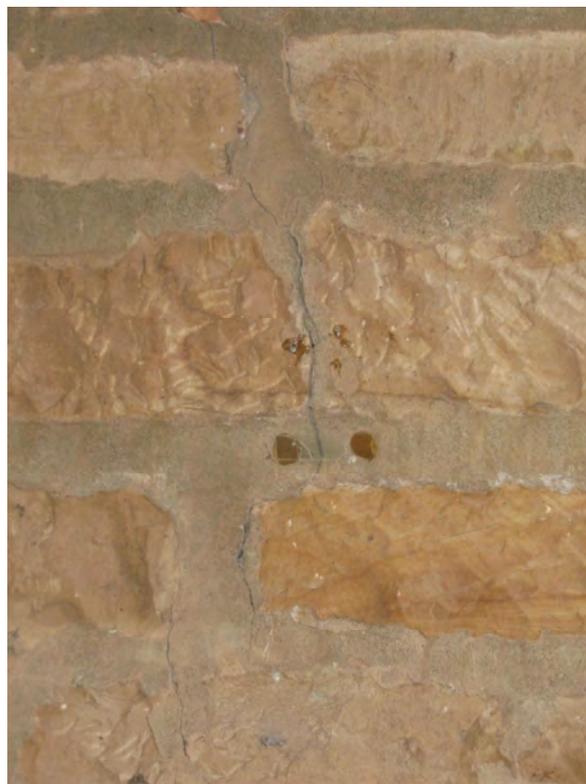
Spry previously assessed the structural integrity of the Bridge. He identified both transverse and longitudinal cracks. Longitudinal cracks are located under the arches, most prominently in the eastern arch. Spry identified that the cracks generally commence at the spring line and ceased before the mid span of the arch.

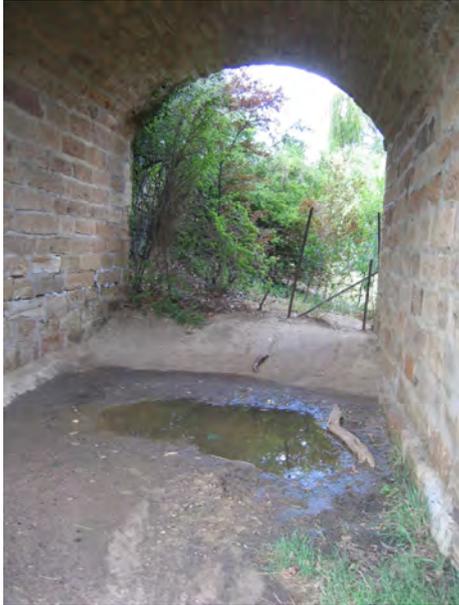
*Ponding and small tree*

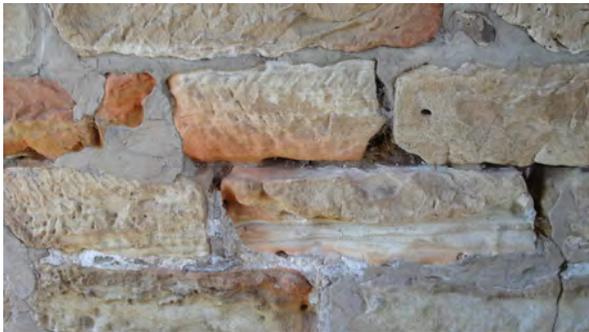
*Degree of stone decay and loss of mortar*

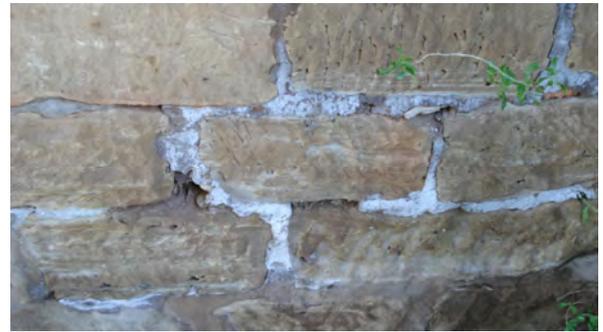
*Salt efflorescence on mortar joints and stonework*

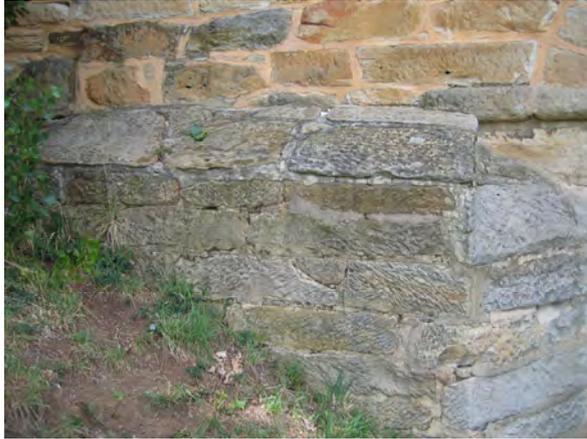
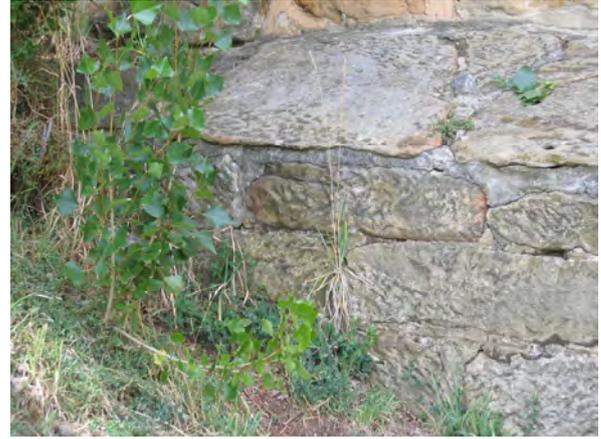
## NORTH EAST ABUTMENT POINTING

Spry previously assessed the stonework and pointing condition of the Bridge. He identified the cement-rich mortars used for pointing. This hard, grey mortar continues to exist on the north east abutment of the Bridge.

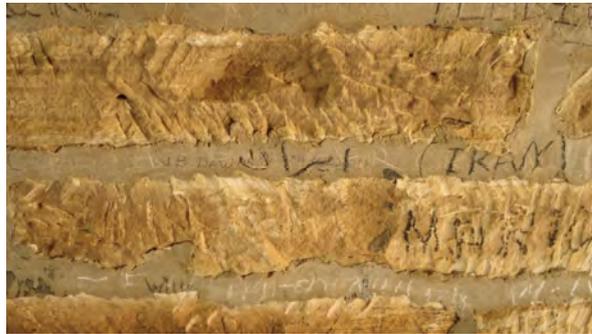
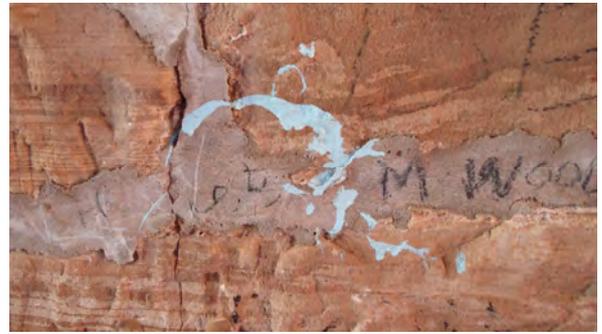
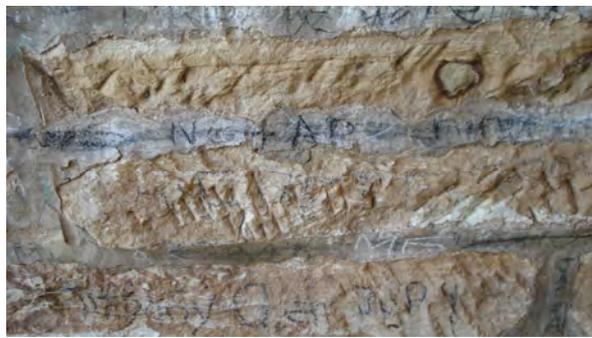
The western arch is generally in a fair condition. This arch has historically been subject to vandalism, dating back several decades. The vandalism occurs particularly on the mortar joints.

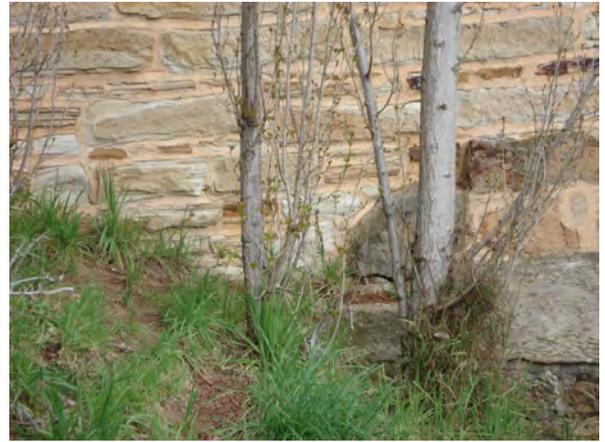
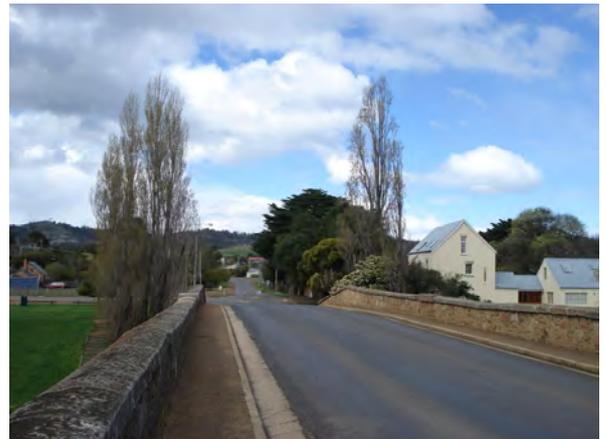
Coppices of mature poplars exist at the eastern end of the Bridge. A 1940s photograph shows large Lombardy poplars near the south east abutment of the Bridge. Lombardy poplars were also established on the north east abutment by the 1950s. The trees appear to be in a healthy condition. However, should the trees be causing structural damage to the Bridge, their removal will be necessary.

28	LOMBARDY POPLARS EASTERN END OF BRIDGE
Structural damage from roots.	
<b>RECOMMENDATIONS:</b>	
Engage appropriate arborist and structural engineer to assess the impact of the Lombardy poplars on the structural integrity of the Bridge (7.7.11).	
<b>PREVIOUS INVENTORY:</b>	
The 1997 CMP assessed the original poplars on Eldershaw's mill site as having some cultural significance.

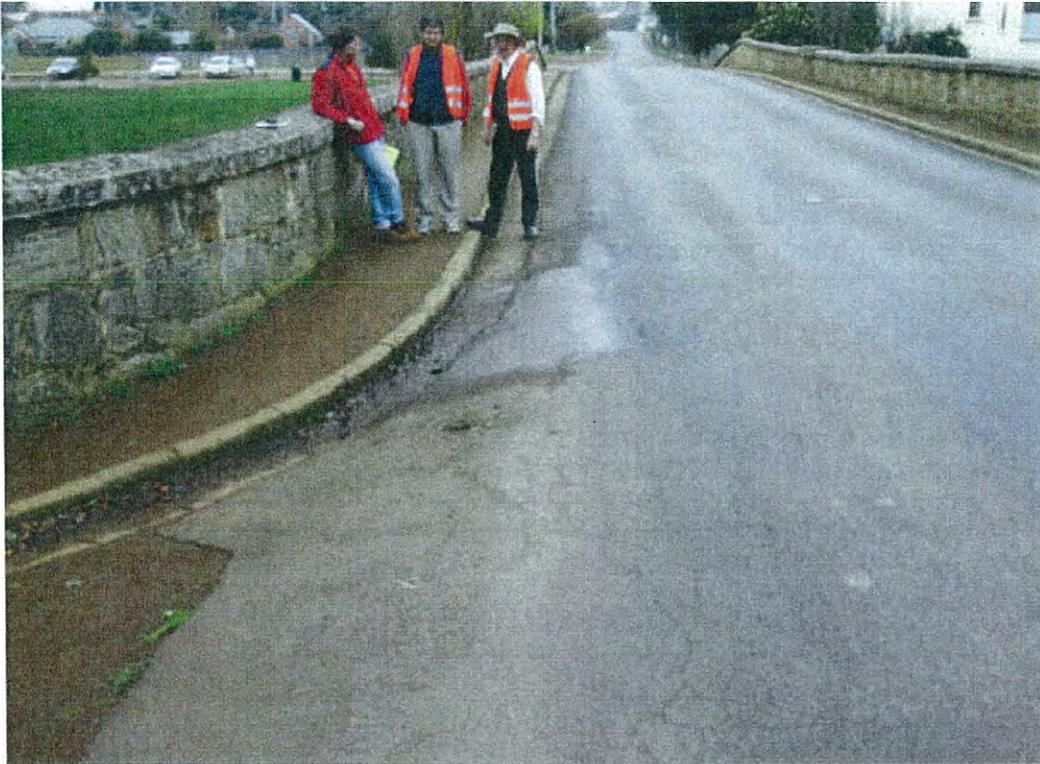
Photo 1  
Note water ingress causing pavement failure adjacent to sensor location 1.
