Northern Suburbs Transit Corridor

Final Condition Assessment Report

Department of State Growth (TAS)

19 October 2021

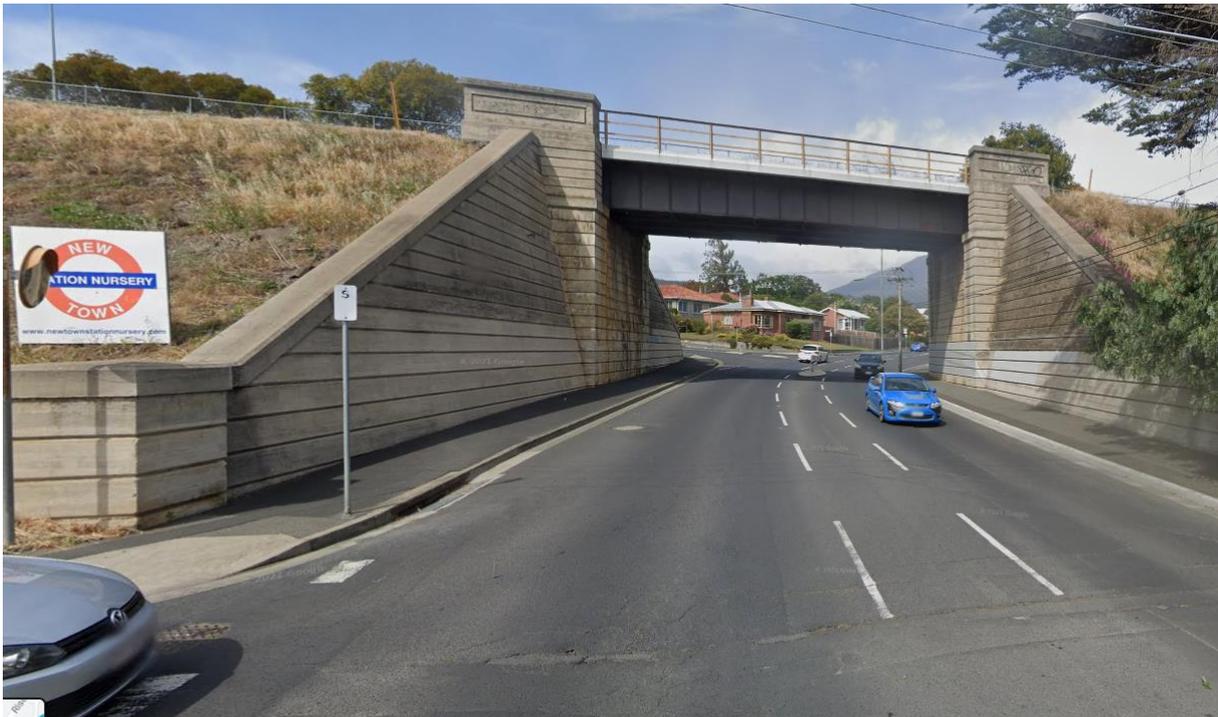
Figure 3 Elevation photograph of Risdon Road Rail Bridge (Google maps 2021)

- Rails were in good condition and the sleepers fair
- Ballast is reasonable, however heavy fines present
- Steel trough and deck in good condition apart from the edges of the wrought iron trough which were considerably rusted. If the concrete is unreinforced, then spalling may be expected
- Wrought iron girders and bracing in excellent condition
- Bearings appear to be functioning satisfactorily

- The masonry piers and abutments appeared to be in good condition except for some cracking around access manholes indicating slight abutment movement. This is not considered serious.
- The massiveness of the foundation tends to suggest no foundation problems are likely.

- The eventual replacement of the wrought iron trough along the edges of the bridge due to corrosion, however not critical at the time of the assessment
- Confirmation of any shear connectors between wrought iron girder and deck
- The presence of heavy fines within the ballast is not deemed critical at this stage

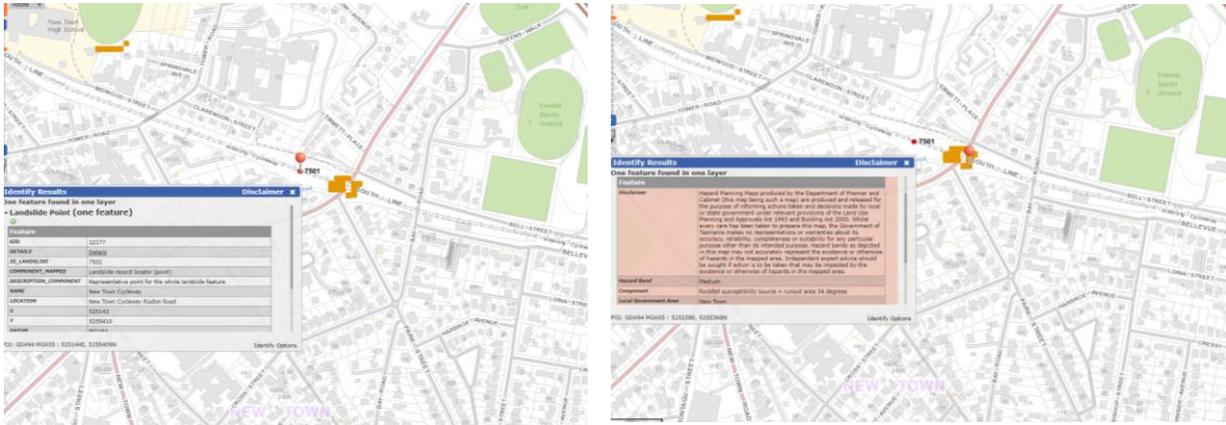
Figure 11 Areas susceptible to landslide/rockfall (located at Risdon Road overpass)

Landslide/rockfall susceptible areas were found to be at the Risdon Road Overpass area, the Domain Highway area and the Tasman Highway areas. These locations would require detailed investigations prior to any proposed works to widen or remediate the associated embankments in these areas.

Geotechnical recommendations include the undertaking of intrusive investigations for identified soft substrate locations, a formal landslide risk assessment for each identified risk area, geological mapping of each occurrence of rock cutting face, and an embankment stability risk assessment.
