**General Arrangement Plan Drawings –  
Culvert Location**

Size <b>A3</b>	Row <b>A</b>	
Client <b>DEPARTMENT OF STATE GROWTH</b>		Drawing Title <b>GENERAL ARRANGEMENT PLAN</b>	
Project <b>NSTC CONDITION ASSESSMENT</b>		Status <b>S2</b>	
Project No. <b>12548571</b>		Drawing No. <b>12548571-SK003</b>

Department of State Growth  
Northern Suburbs Transit Corridor -  
Condition Assessment

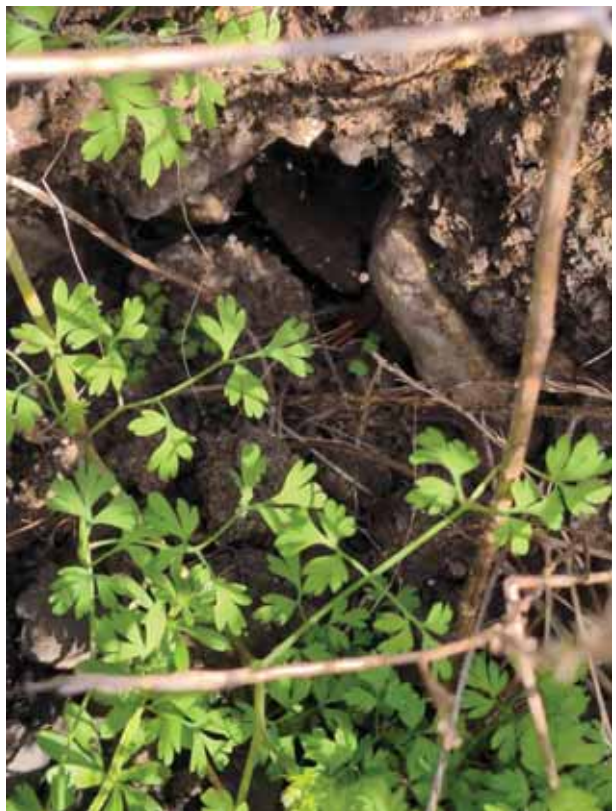
Photo Outlet

During this inspection is there water in the culvert?			No
Barrel flow	clear	Inlet flow	
Outlet flow	100% blocked		Clear
Outlet condition	vegetation, outlet covered with rocks. no wingwall or headwall, pipe end appears to be damaged		
Inlet condition	grated pit along shared path appears to be in good condition		
Structure condition	pipe_box_damage, joint_damage, no headwall or wingwall at outlet. difficult to assess pipe condition		
Road surface condition	Refer to rail track condition assessment provided separately		
Batter condition	batters are not steep, vegetated		
What routine maintenance is required?	check pipe condition, clear outlet, missing headwall/wingwall

- further inspection may be required if pipe is being used.
- existing building on the eastern side
- concrete pipe appears to be connected to steel pipe
- condition at joints will need to be assessed for erosion, seepage, etc.
- blockage will need to be cleared to ensure smooth flows and avoid flooding

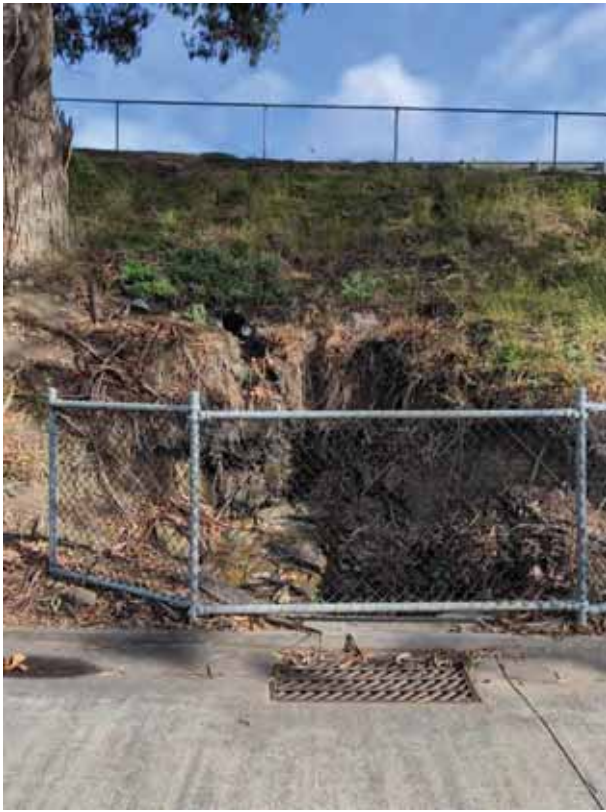
Photo Inlet

During this inspection is there water in the culvert?			No
Barrel flow	25% blocked	Inlet flow	
Outlet flow	75% blocked		25% blocked
Outlet condition	vegetation. Grated pit appears to be the low point within the area. Possible ponding during heavy rains		
Inlet condition	dirt and dry leaves partially covering pit invert. Scouring		
Structure condition	Dirt and leaves from embankment can easily get into the outlet. Grated pit cover rusty.		
Road surface condition	Refer to rail track condition assessment provided separately		
Batter condition	steeper on outlet side, flat on the northern and southern side		
What routine maintenance is required?	clear outlet of dirt and vegetation. Outlet flow direction unclear. Provide treatment for embankment scouring on inlet side

- condition at joints will need to be assessed for erosion, seepage, etc.
- blockage will need to be cleared to ensure smooth flows and avoid flooding

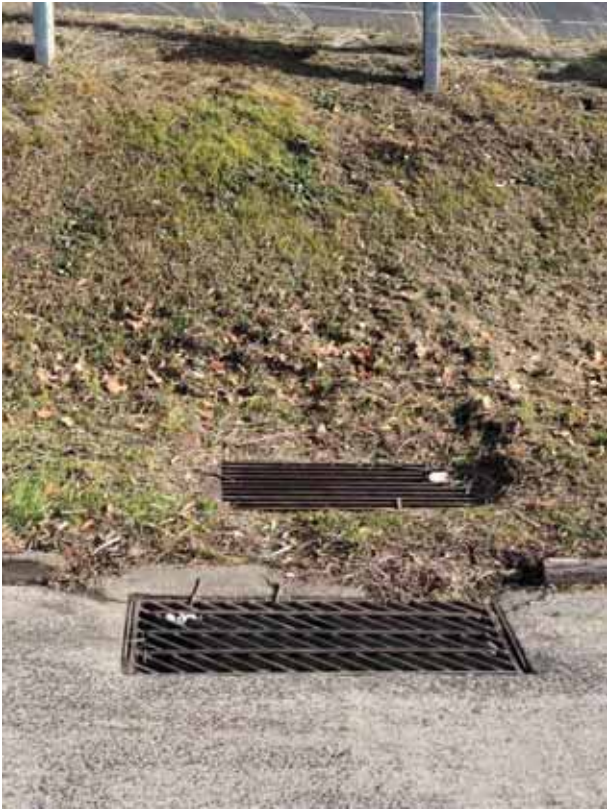
Photo Condition

During this inspection is there water in the culvert?			Yes
Barrel flow	Clear	Inlet flow	
Outlet flow	75% blocked		Clear
Outlet condition	vegetation, cannot determine location of outlet. batters are steep and vegetated		
Inlet condition	looks clear of blockages. inlet pit is on other side of fenced cycleway, stagnant water. possible dirt at inlet		
Structure condition	outlet location cannot be determined. inlet pit cover appears to be in good condition		
Road surface condition	Refer to rail track condition assessment provided separately		
Batter condition	Batters are flat for about 2 m approx. then steepens on the eastern side. batter on west side that is adjacent to the cycleway is flat		
What routine maintenance is required?	mark outlet location. possibility of clearing outlet may be required, clear outlet of vegetation and debris

- further inspection may be required as outlet was not found during site inspection
- separation of pipe at joints evident

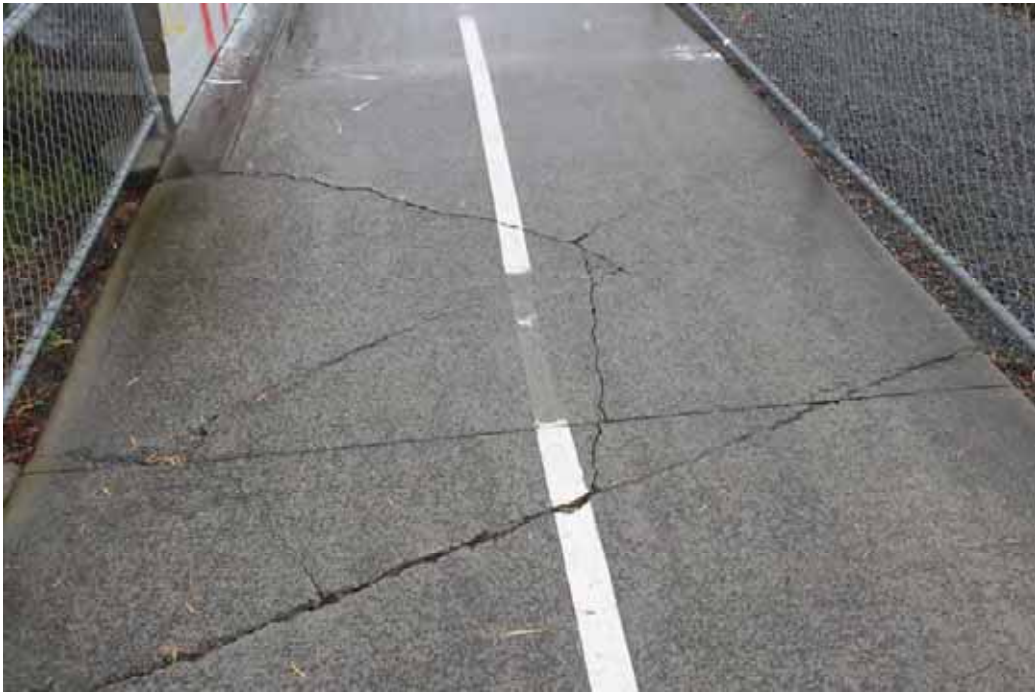
Figure 5 Failure of footpath concrete at Approach 1 (typical)

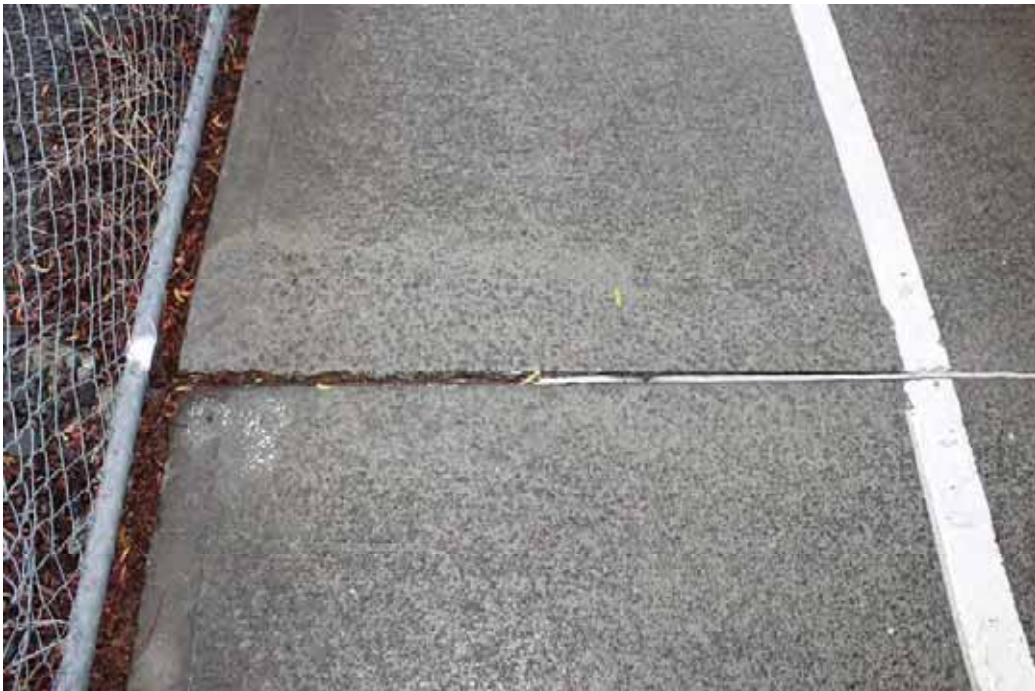
Figure 6 Joint Failure at Abutment 2

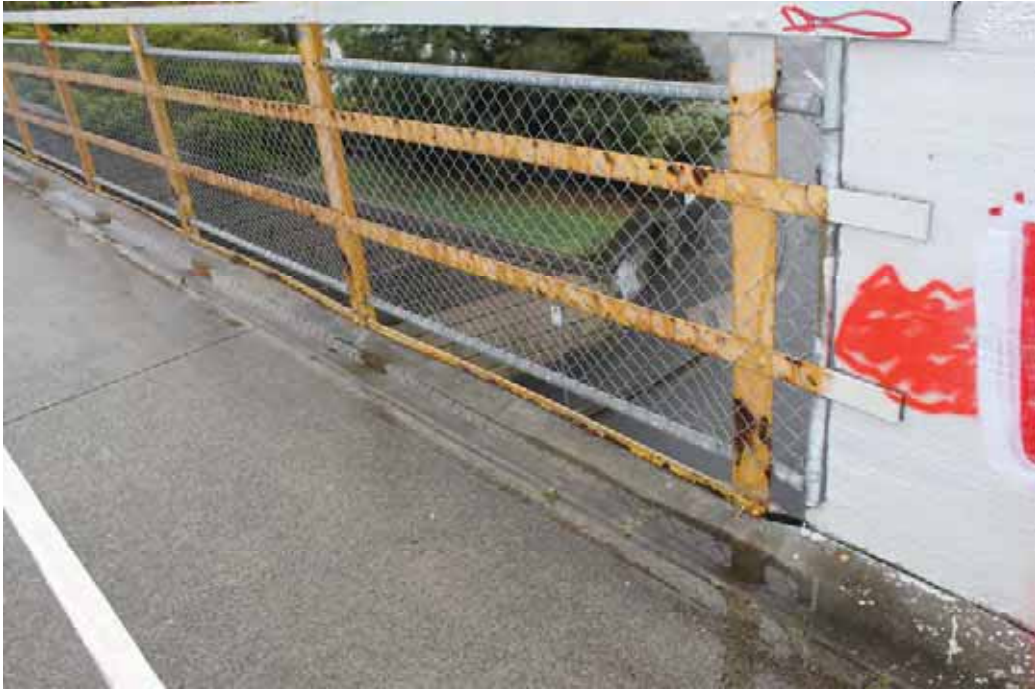
Figure 7 *Guardrail 1 with corrosion and deflected kick plate (typical)*

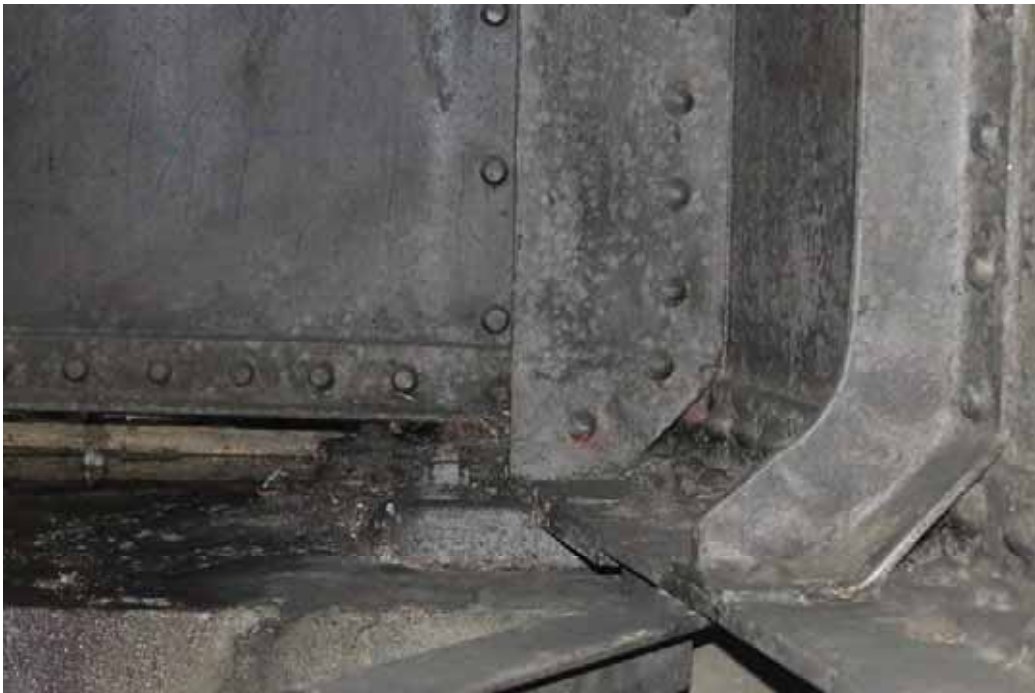
Figure 8 *Build-up and moisture at bearing (typical)*

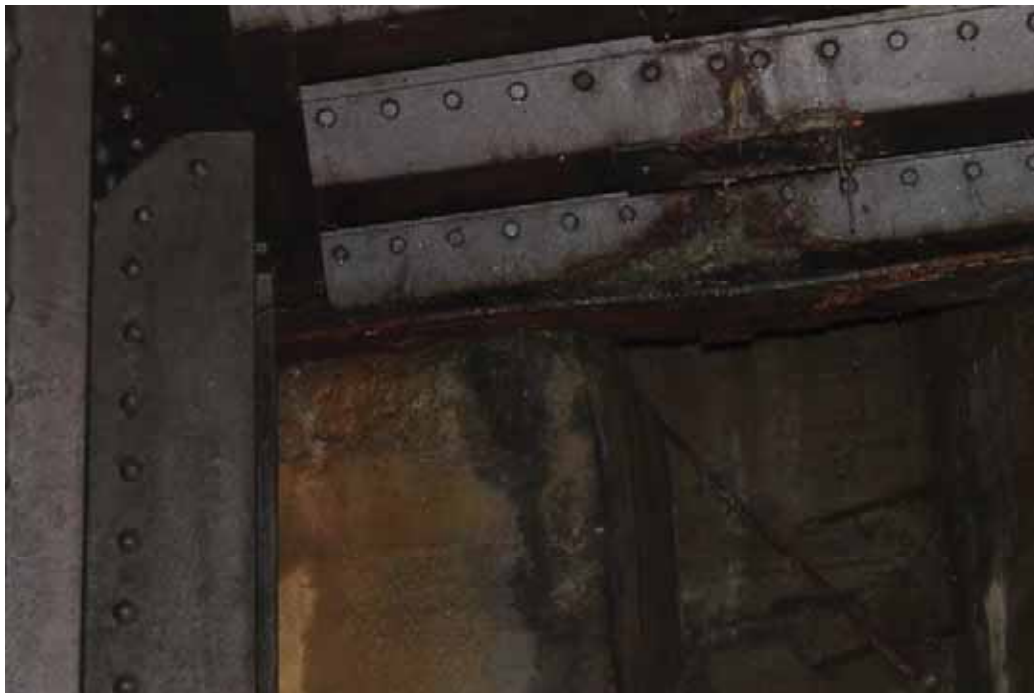
Figure 10 Deflection in Deck 2 end member with corrosion (typical)

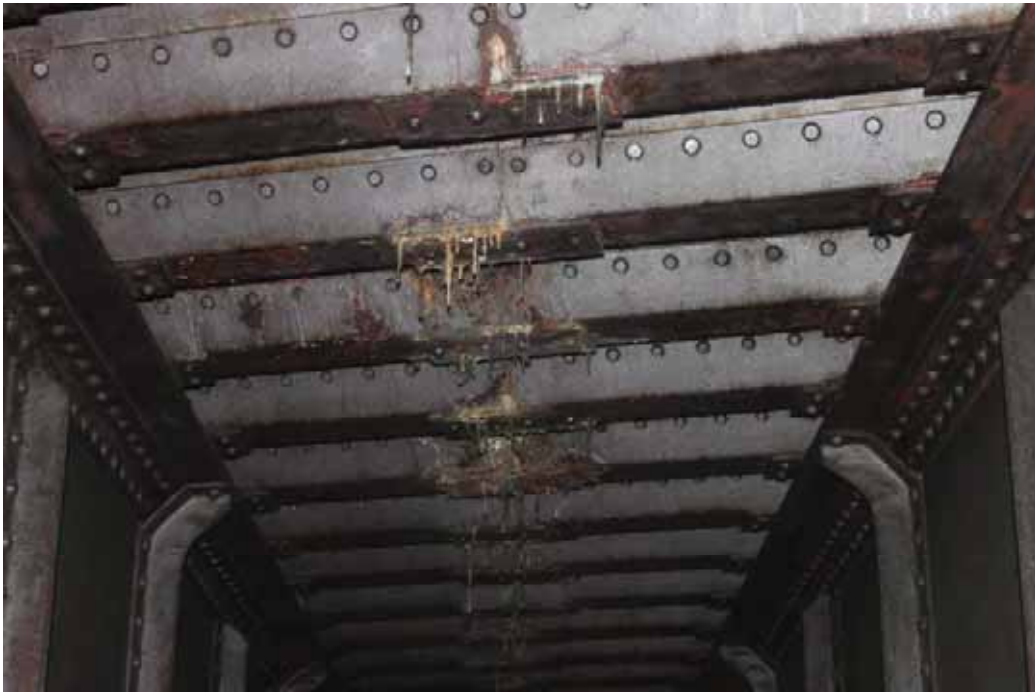
Figure 11 *Stalactites on deck soffit (typical)*

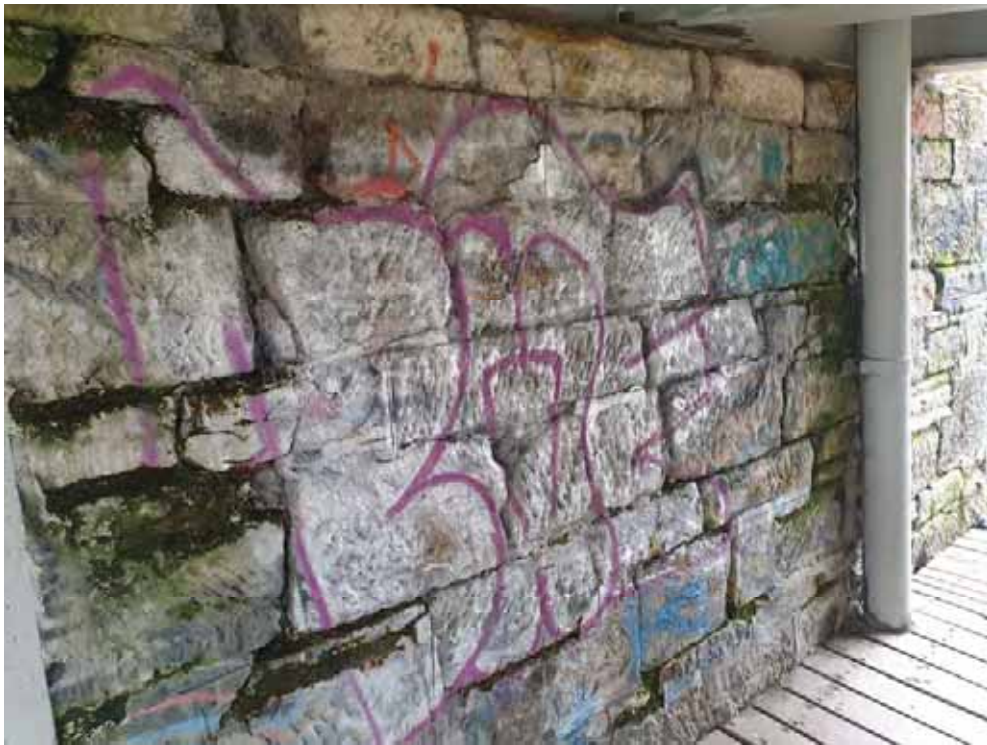
*Deteriorated sandstone wall at Abutment 1*

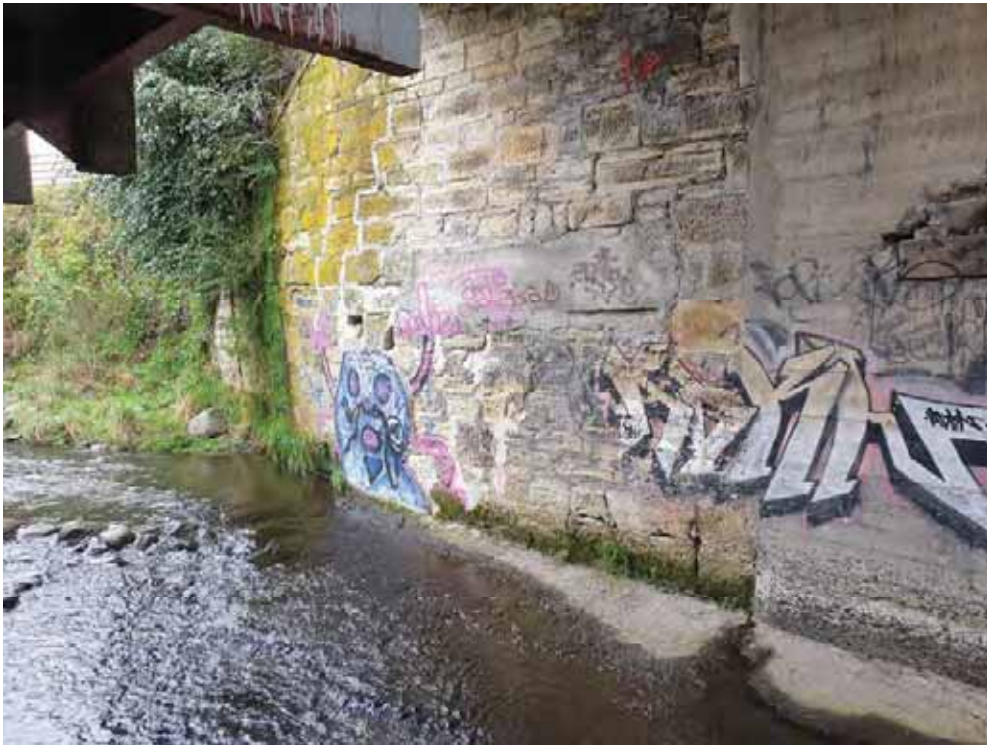
Figure 5 *Deteriorated sandstone wall and wingwall movement at Abutment 2*

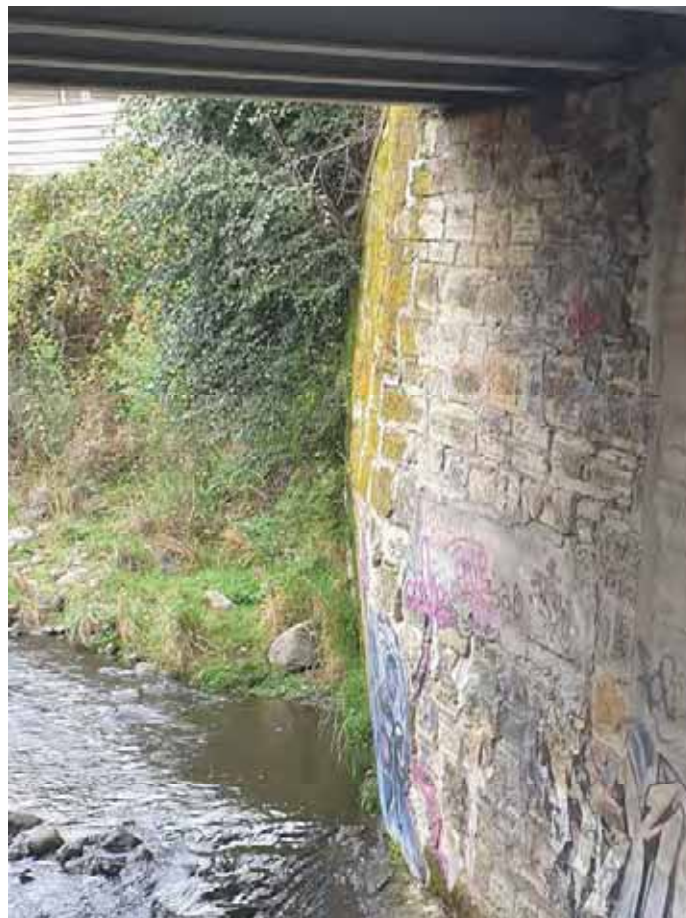
Figure 6 *Bulging in the sandstone wall at Abutment 2*

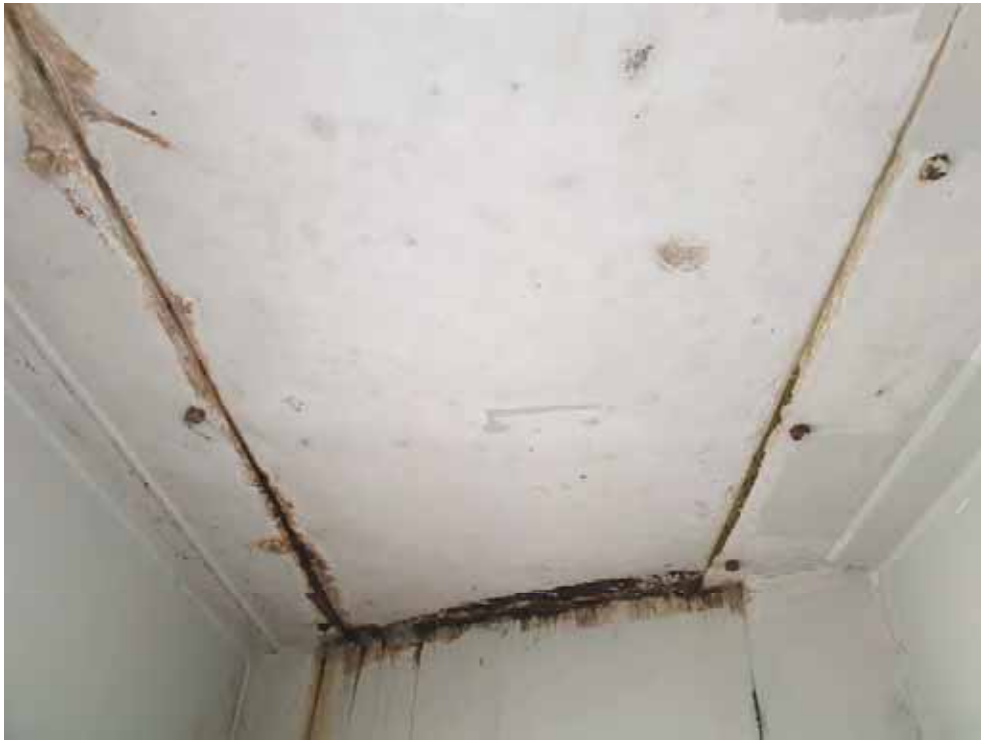
Figure 7 *Deteriorated bolts connecting the girders to the deck*

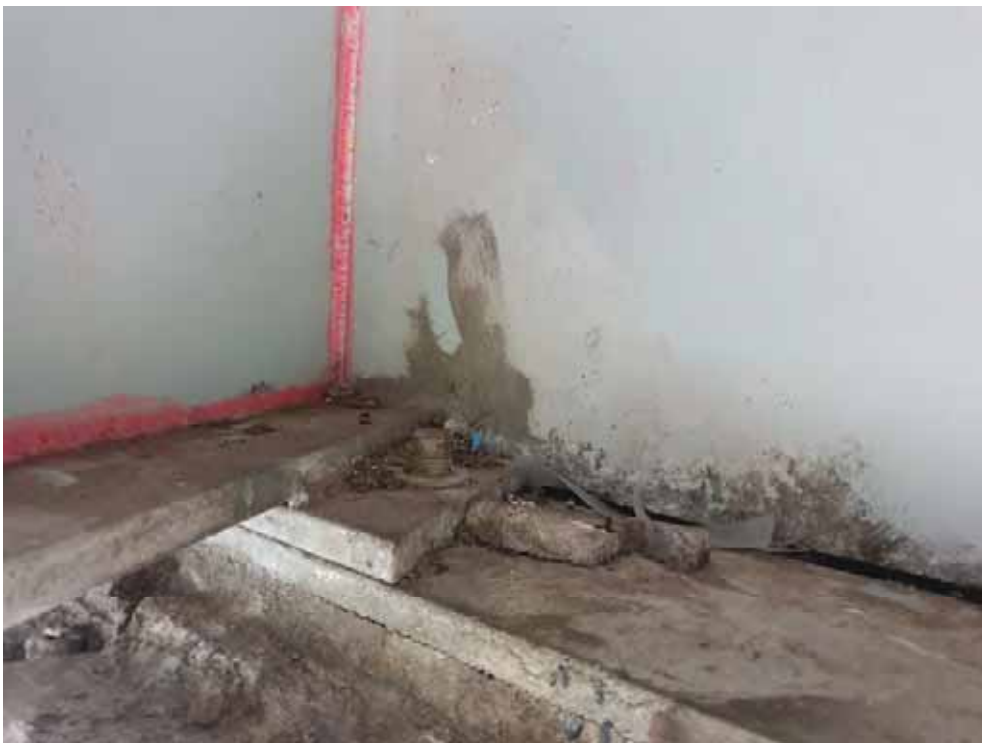
Figure 8 *Inadequate bolts at the bearings (typical)*
