Roadkill Monitoring Report 1 July to 30 September 2023 Tarkine Drive Upgrade

Tarkine Drive – Roadkill Monitoring Report – July to September 2023

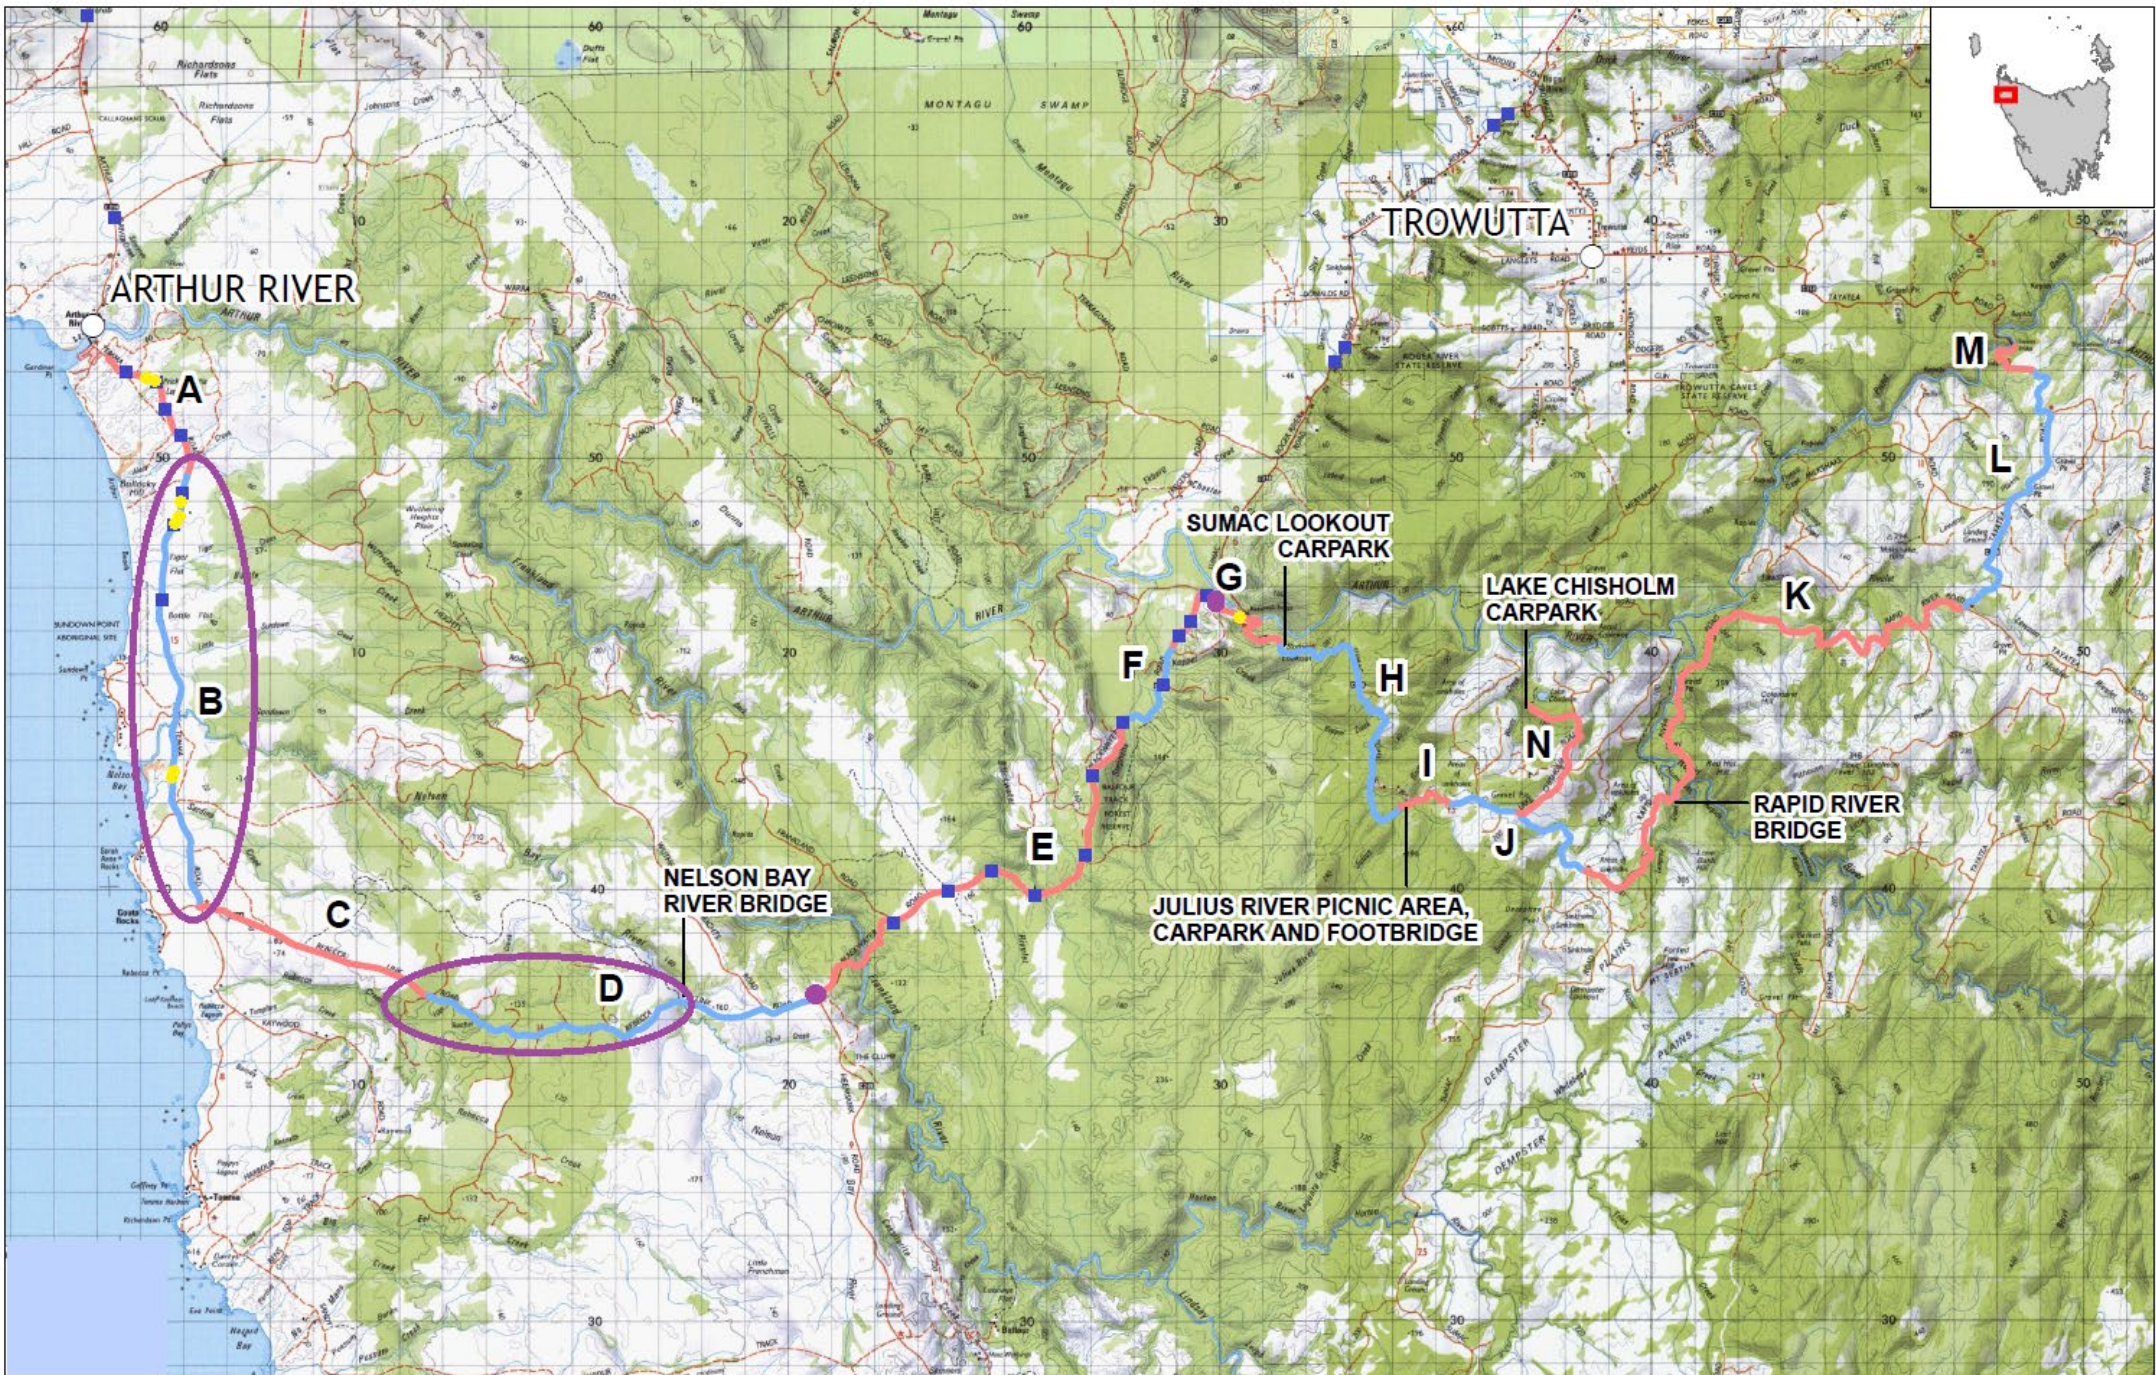
Appendix B: Map of Installed Mitigation Measures

Roadkill mitigation measures were implemented as part of the construction project to minimise roadkill numbers (see Appendix B). These measures include:

- Reduced speed limits;
- Installation of audible 'rumble' strips at 26 separate locations;
- Installation of virtual fencing to prevent animals entering the road (undertaken by Tasmanian Parks and Wildlife Service)
- Use of light-coloured pavement in the road surface to improve visibility;
- Removal of roadside vegetation to reduce proximity of habitat to road;
- Installation of new table drains to reduce ponding of water at the roadside;
- Improved sight distance;
- Wildlife warning signs; and
- Regular monitoring and removal of roadkill to prevent other scavenger animals being attracted to the road.
