A Review of Serious Casualty Pedestrian Crashes

A Review of
Serious Casualty Pedestrian Crashes
in Tasmania

Traffic & Infrastructure Branch
Department of Infrastructure, Energy and Resources
February 2012

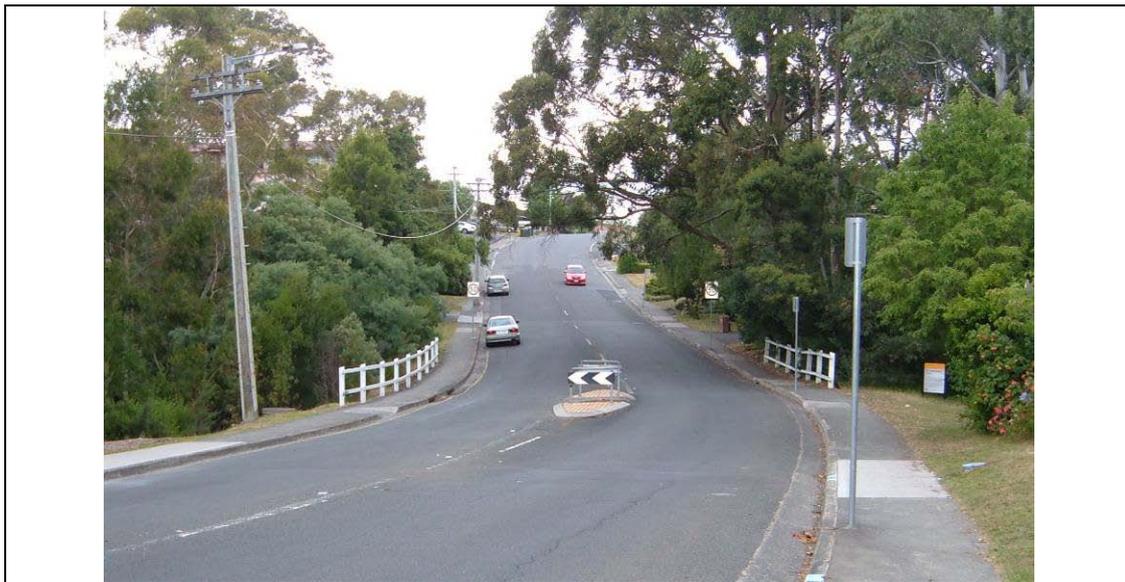
Photo 3.1 – A pedestrian refuge

A pedestrian refuge is a traffic island in the middle of the road that allows pedestrian to cross the road in two stages. This is particularly useful on busy roads where there are not many gaps in the traffic. Kerb extensions can be provided in association with the pedestrian refuge to reduce the crossing distance and to improve visibility between the pedestrian and the motorist.

Traffic islands can also be installed in the mouth of side street junctions.

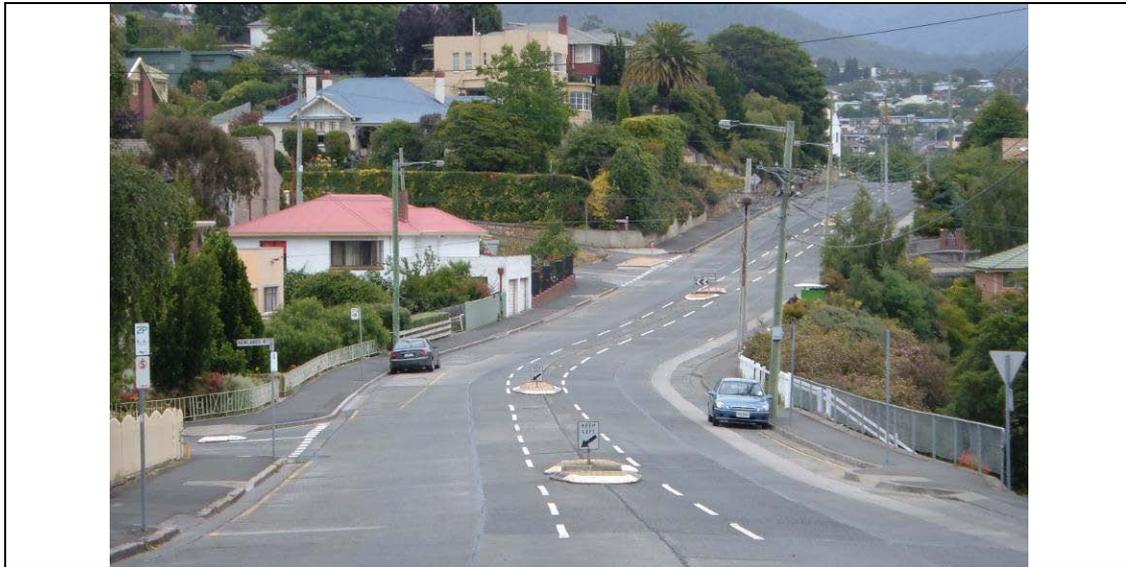
Photo 3.2 – A median treatment

A median treatment comprises a series of traffic islands along the middle of the road. Median treatments are appropriate where pedestrian crossing movements are dispersed along a length of road.

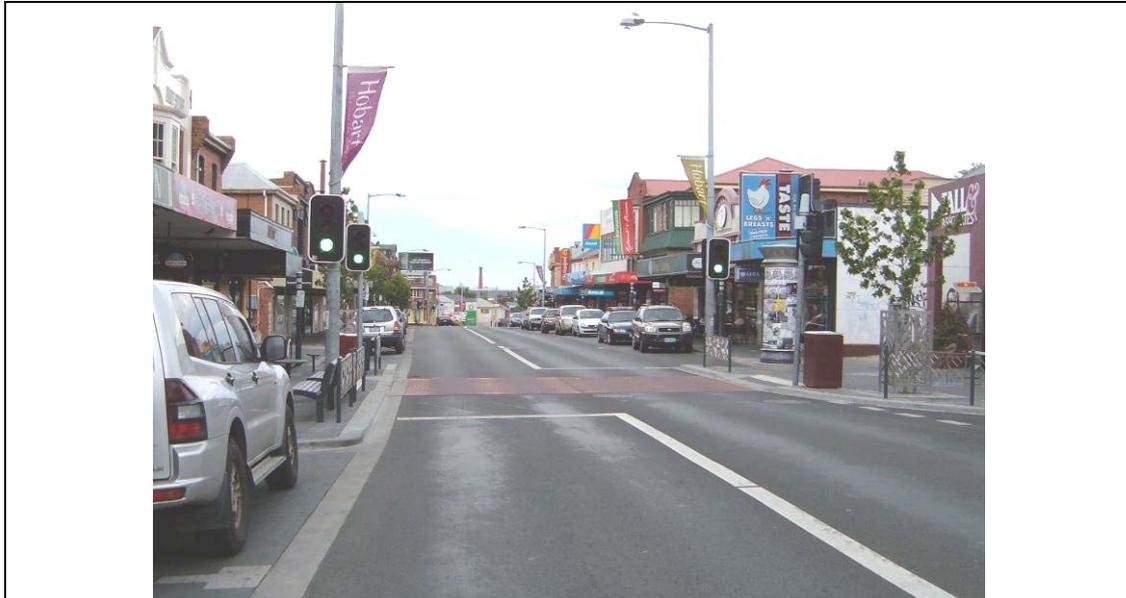
Photo 3.3 – Pedestrian operated signals

Pedestrian operated signals can be installed at locations where traffic volumes along the road and the number of pedestrians crossing are both high. Pedestrian signals are not effective when pedestrian crossing movements are dispersed along a length of road – experience has shown that pedestrians will not deviate far from the shortest route to their destination.

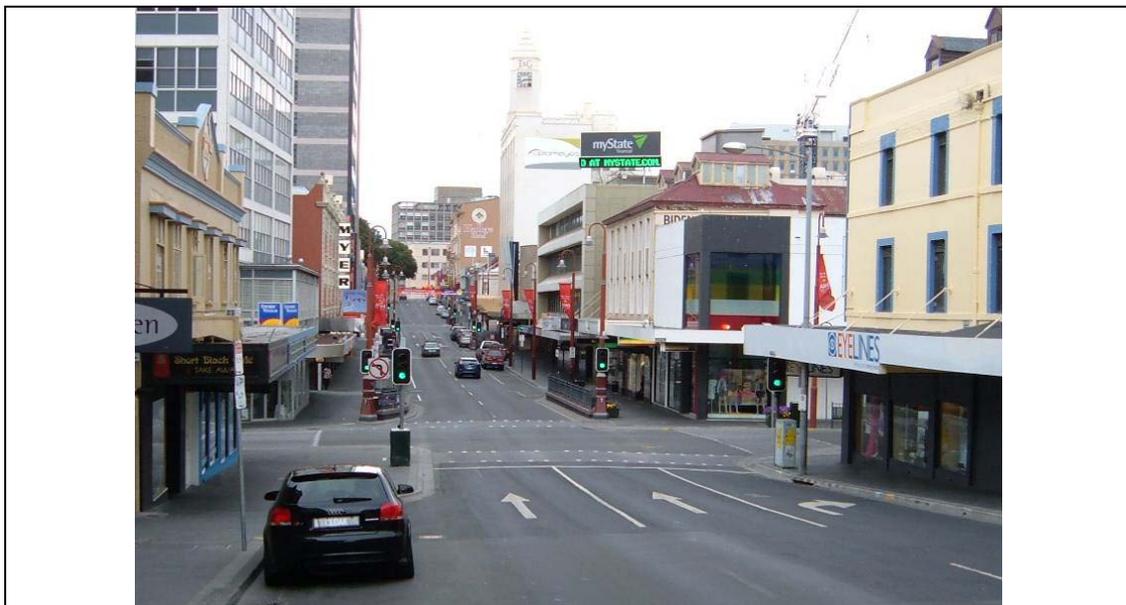
Photo 3.4 – Signal controlled intersection with provision for pedestrians

Intersections controlled by traffic signals normally include facilities for pedestrians. Traffic turning left or right at the intersection is required to give way to pedestrians. Kerb extensions can be provided to reduce the crossing distance for pedestrians and, where there is more than one lane of turning traffic, pedestrians can be given an 'early start' that allows them to start crossing before any traffic starts to move.

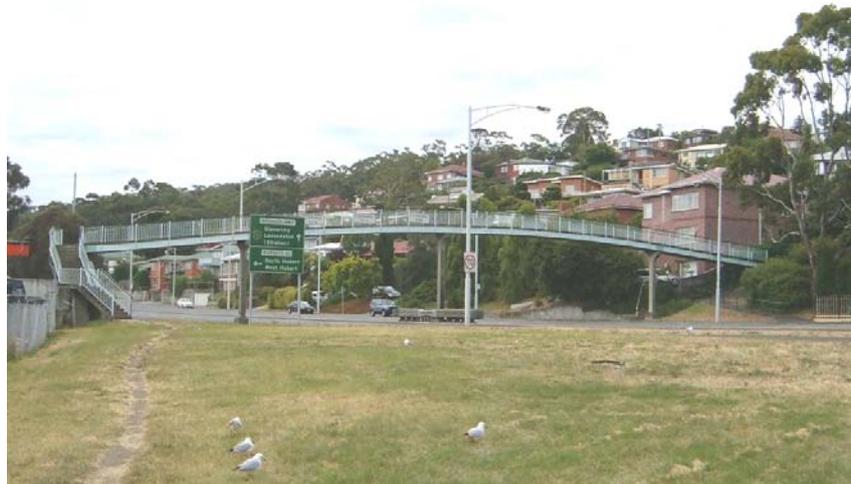
Photo 3.5 – An overpass

Underpasses and overpasses theoretically provide the highest degree of pedestrian safety by separating pedestrians and vehicles. However, they are extremely expensive to install and maintain, and their long ramps or stairs discourage some people from using them.

Furthermore, experience has shown that pedestrians will not deviate far from the shortest route to their destination. Underpasses and overpasses are generally only provided to help people cross highways.

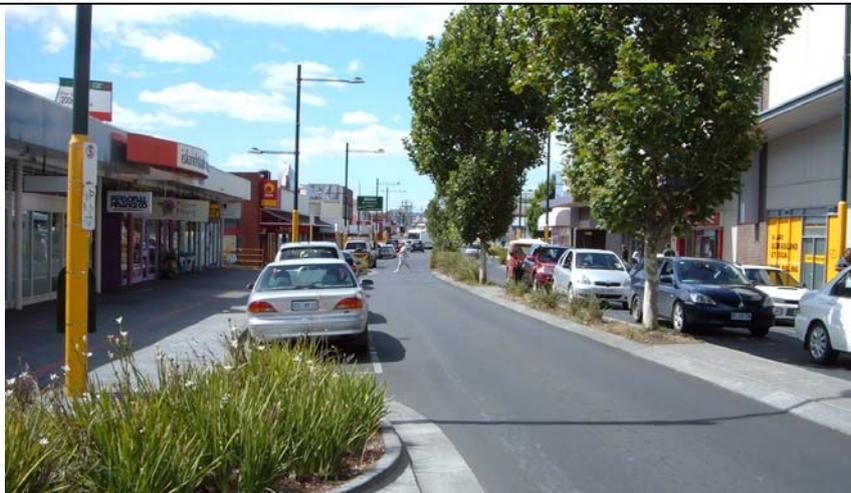
Photo 3.6 – Traffic management to reduce operating speeds

Lower vehicle speeds improve pedestrian safety – they make it easier for pedestrians to identify gaps in the traffic to safely cross the road, and they reduce the likely severity of any collisions that do occur.

However, simply reducing the posted speed limit is not guaranteed to have a substantial effect on operating speeds. In order to attract compliance, the speed limit needs to reflect the road environment. Operating speeds can be reduced by narrowing the traffic lanes or installing traffic calming.

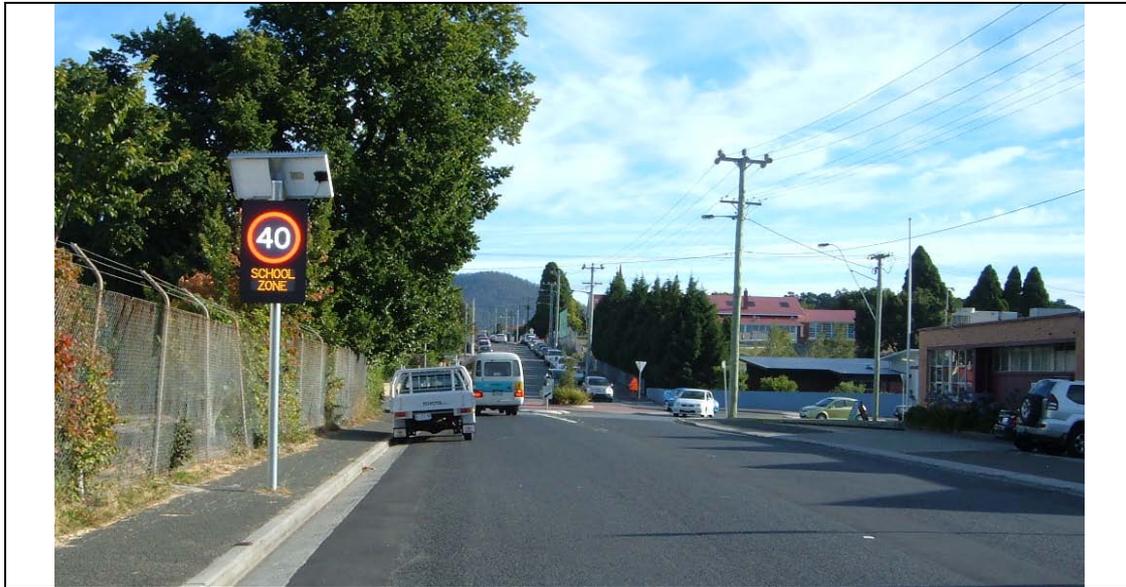
Photo 3.7 – An electronic 40 km/h school zone sign

Part-time 40 km/h school zones operate in the vicinity of schools and cover the periods of high pedestrian activity at the beginning and end of the school day. The Tasmanian Road Safety Strategy – Infrastructure Program is funding the replacement of the old conventional style school zone signs with new electronic signs. The new signs have more impact because they only come on when the lower limit applies. They are expected to improve awareness and compliance with the lower limit.

The application of lower speed limits in city centres and busy shopping zones during the periods of high pedestrian activity would also improve pedestrian safety, and could be achieved with the new type of electronic signs that are being used in school zones.
