# Appendix A: Site Inventory Sheets

## Introduction

## RICHMOND BRIDGE

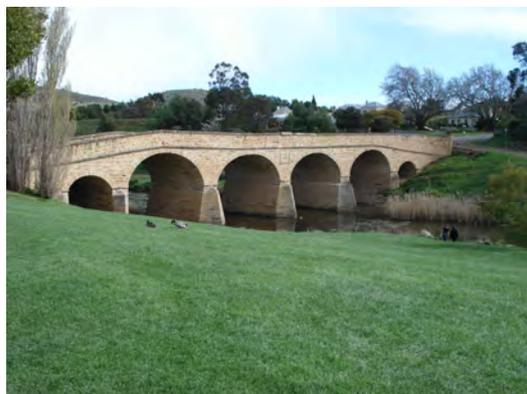
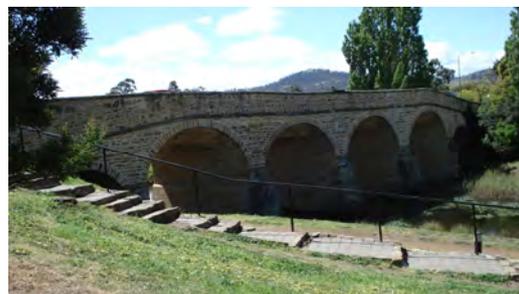
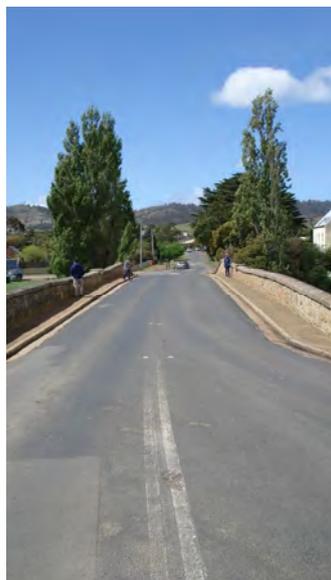
The Richmond Bridge crosses the Coal River at a low point between the east and west escarpments. The Bridge was constructed from 1823 to 1825 and is an arched road bridge constructed from locally sourced brown sandstone. The Bridge has six spans of 4.3, 8.1, 8.3, 8.5 and 4.1 metres respectively with four main semi-circular arches founded in the river bed, with two smaller arches founded on the east and west banks. It has been suggested that a cross section through the Bridge would show longitudinal walls built 600mm apart providing the structure with robust stiffness. The fill of the Bridge is basalt and sandstone gravel of loose to medium density with sandy clay fines. The depth of the foundations are unknown and they have been subject to settlement, providing the Bridge with its asymmetrical and undulating outline.

The Bridge is generally in good condition and continues to be used for both pedestrian and vehicular transport.

Implement the Action/Recommendation works as provided in the Conservation Policies (Section 7).

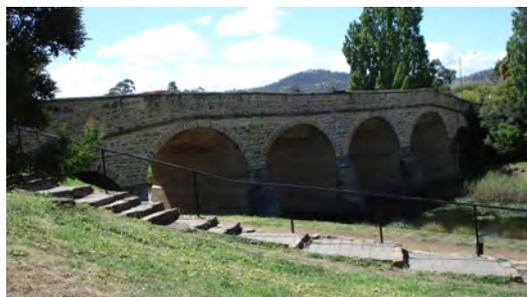
**3****SOUTHERN FACE OF BRIDGE**

The southern face of the Bridge is generally in a good condition.

- ▶ Considerable progress has been made on the replacement of the old cement-rich mortar, with more appropriate lime based mortars. The replacement of the mortar has improved the aesthetic appeal of the Bridge and will assist in long term conservation.
- ▶ Hard, cement-rich mortar still exists on the fins of the piers.
- ▶ The south face of the Bridge receives less sun and the fins of the piers have some staining.
- ▶ Damp problems exist on the south west wing wall following the stone steps.
- ▶ Ivy is growing on the south east abutment and face of the Bridge.

- ▶ Appointment of an appropriately skilled stonemason to undertake conservation work to Bridge stonework (see policy 7.2.1) (7.5.7);
- ▶ Appointment of appropriately skilled stonemason; and stones to be replaced when subject to a 50mm surface loss and new stones to use 100mm thick inserts of a better quality stone (7.5.8);

- ▶ Appointment of appropriately skilled stonemason; and replacement of lost bedding with quicklime grout (7.5.10);
- ▶ Appointment of appropriately skilled stonemason to undertake condition assessment of the mortar, remove inappropriate mortar and replace with quick lime based mortar with a weather struck finish (7.5.22, 7.5.11, 7.5.13);

- ▶ Annual inspection and recording of Bridge for pointing and stormwater defects, flood damage, cracking movements and general condition of stonework (7.5.22);

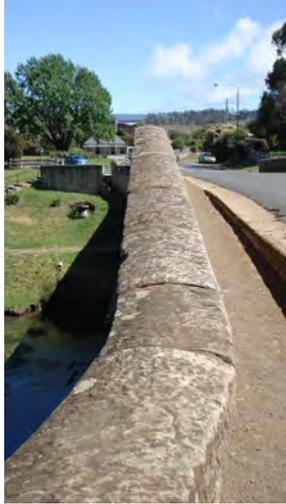
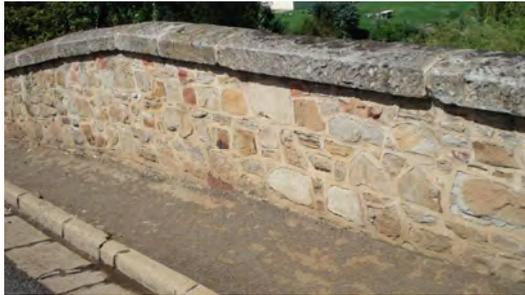
**BRIDGE FOOTPATHS**

The gravel footpaths are in a good condition. It is unclear whether the subsurface of the footpaths were waterproofed as part of the general waterproofing works.

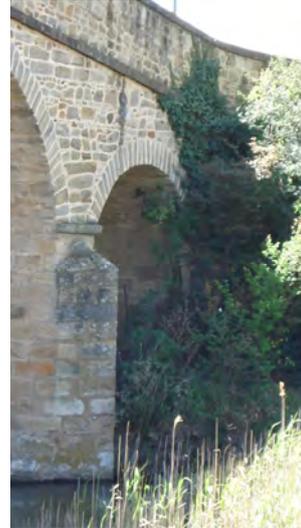
*Ivy growing on south east abutment*

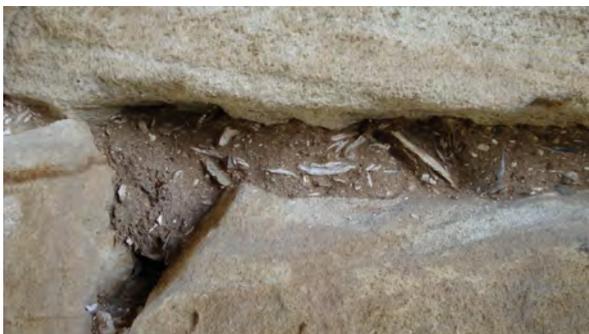
*Salt efflorescence on mortar joints and stonework*

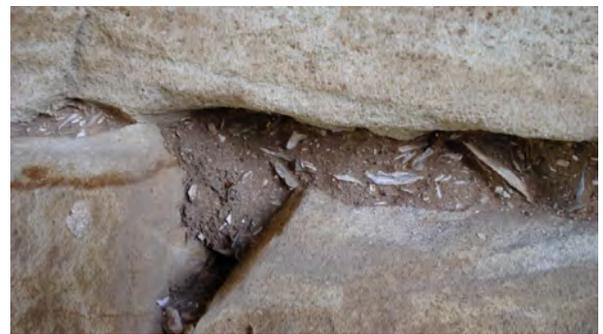
*Coarse shell mortar*

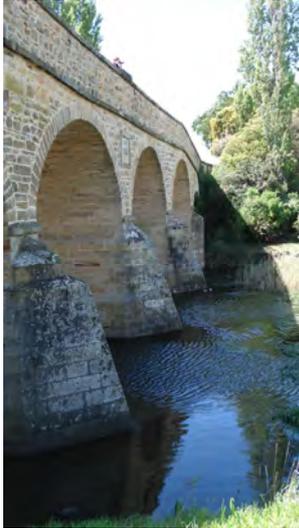
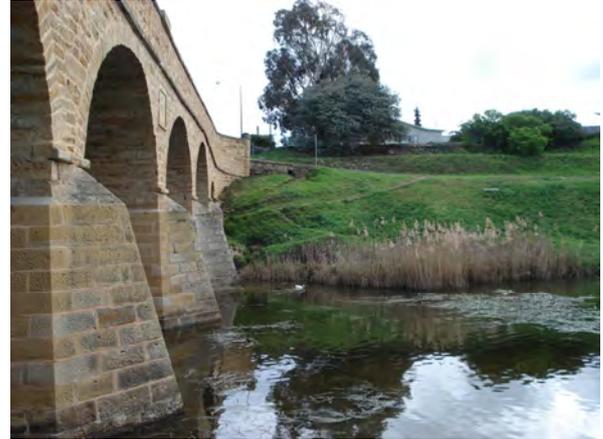
In 1884, the Bridge piers were encased and the riverbed paved in sandstone to improve water flow. The piers have sloping fins with angular leading edges to direct the water flow and are constructed from smooth faced ashlar sandstone. The sandstone is tied to the piers with painted iron cramps. In 1973 it was recommended that the iron cramps were rusting and should be replaced. The southern faces of the piers demonstrate greater staining than the northern piers. The piers are in good condition.

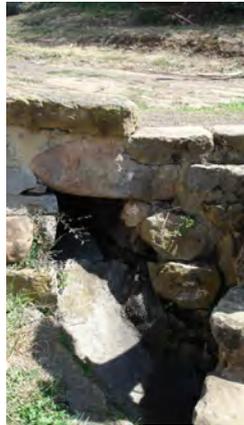
*Drainage infrastructure northwest bank*

Drainage infrastructure on the north east, north west and south east and south west banks is in a state of poor repair. It is unknown whether or not this infrastructure is in use. Damp problems exist, particularly in the eastern arch and on the south west wing wall. The effectiveness and maintenance of the drains is questionable. Drainage infrastructure, particularly on the north east, north west and south west is also visually intrusive.

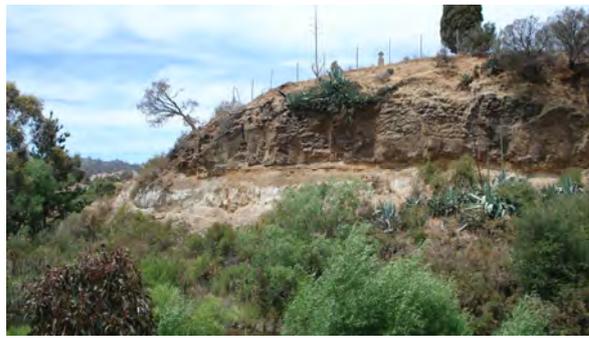
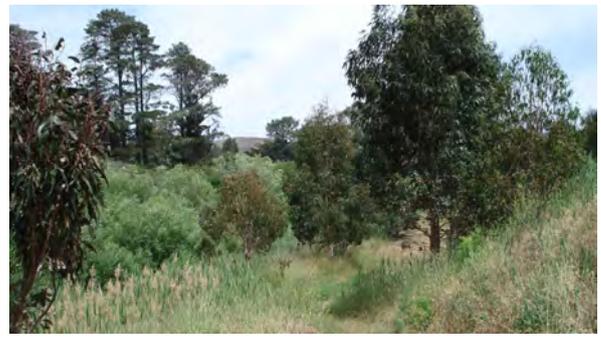
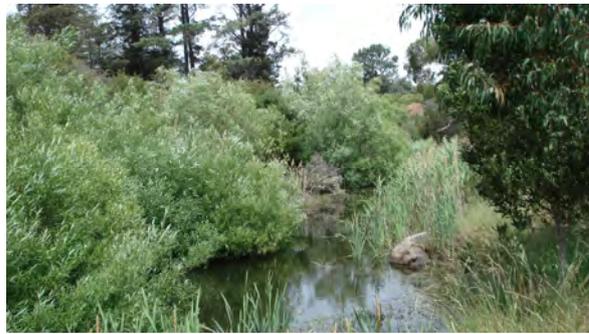
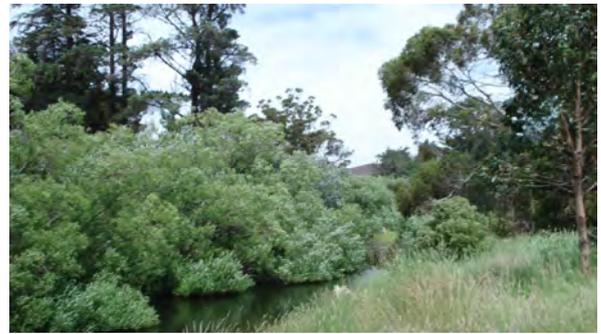
**NORTHERN BOUNDARY: ST JOHNS CEMETERY ESCARPMENT**

This area is not formally vegetated and although overall the vegetation contributes to the setting of the escarpment, weed infestation is apparent, particularly, on the eastern bank which has thick growths of crack willows. On the western bank, considerable work has been undertaken in removing the willows and planting native species. No public access exists connecting the public north west bank area above the Bridge to this location. No views of the Bridge are available from this location.

- ▶ Ongoing crack willow and weed infestation causing problems for the river health and posing risks during times of flood;
- ▶ Erosion of cemetery cliff; and
- ▶ Water pollution from excessive water fowl population.

- ▶ As part of a coordinated approach to flood risk (see also policies 7.8.3 to 7.8.6) remove debris from upstream of the bridge and support and encourage the work of Landcare for the removal of crack willows and debris. Ongoing maintenance will be required to prevent reinfestation (7.7.7, 7.8.4);

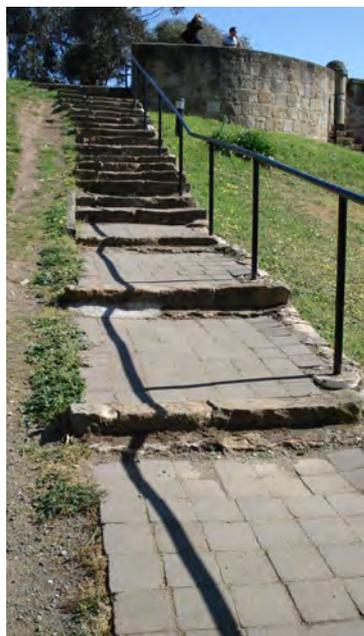
The cement block stair was constructed in 1989 by the then Richmond Council. It leads off the southern end of the sandstone viewing platform also constructed at that time. The stairs are in a fair condition.

The current cement block stair is visually intrusive on the cultural significance of the place in terms of location, materials and the handrail. The replacement of this stair with new infrastructure requires careful consideration.

Remove the existing cement block stair. Any replacement stair should not visually intrude on the cultural significance of the place (7.6.5).

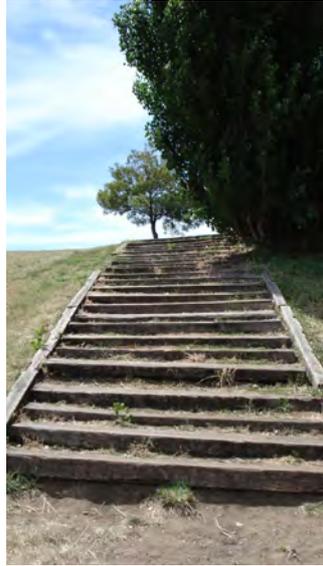
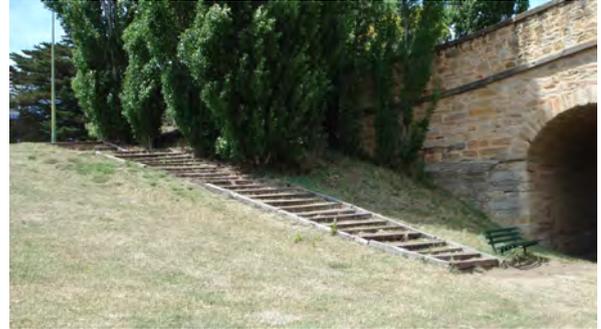
## TIMBER STAIRS

The timber stair is located on the north eastern bank of the Coal River. It is located adjacent to the north east abutment. The stairs are in a fair condition.

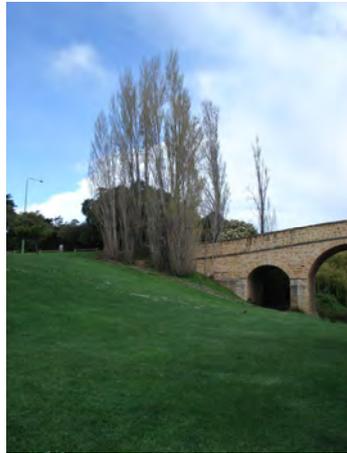
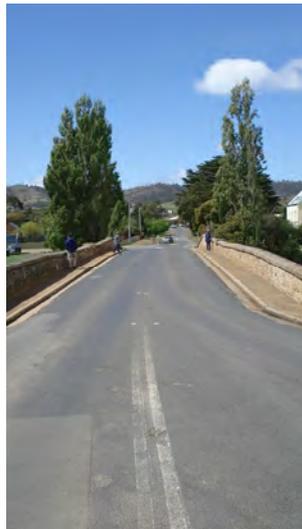
Coppices of mature poplars exist at the eastern end of the Bridge. A 1940s photograph shows large Lombardy poplars near the south east abutment of the Bridge. Lombardy poplars were also established on the north east abutment by the 1950s. The trees appear to be in a healthy condition. However, should the trees be causing structural damage to the Bridge, their removal will be necessary.

28	LOMBARDY POPLARS EASTERN END OF BRIDGE
Structural damage from roots.	
<b>RECOMMENDATIONS:</b>	
Engage appropriate arborist and structural engineer to assess the impact of the Lombardy poplars on the structural integrity of the Bridge (7.7.11).	
<b>PREVIOUS INVENTORY:</b>	
The 1997 CMP assessed the original poplars on Eldershaw's mill site as having some cultural significance.

An arborist and structural engineer should be engaged to assess the potential structural damage to the Bridge being caused by the Lombardy Poplars at the south east and south west Bridge abutments (7.7.11).

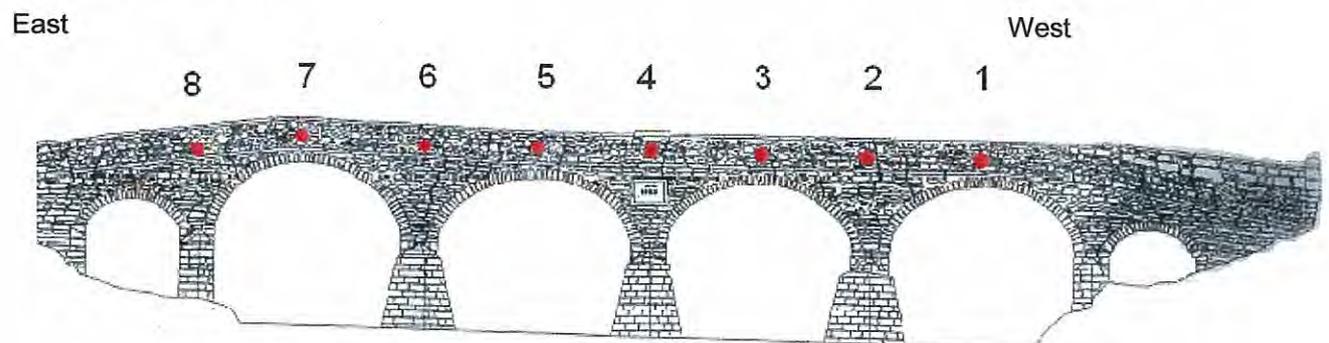
- All of the arch centres gave high vibrations for the tip truck.  
Loaded trucks to this configuration are shown to be vehicles requiring attention.
- Centre of arch location 1 on the west gave high readings for the utility at 50km/hr., the tanker, bus and tip truck.  
There is a longitudinal pavement failure due to water ingress close to this location. The pavement failure is considered to be the cause of the high vibrations.

Photo 1  
Note water ingress causing pavement failure adjacent to sensor location 1.
