Northern Suburbs Transit Corridor

Final Condition Assessment Report

Department of State Growth (TAS)

19 October 2021

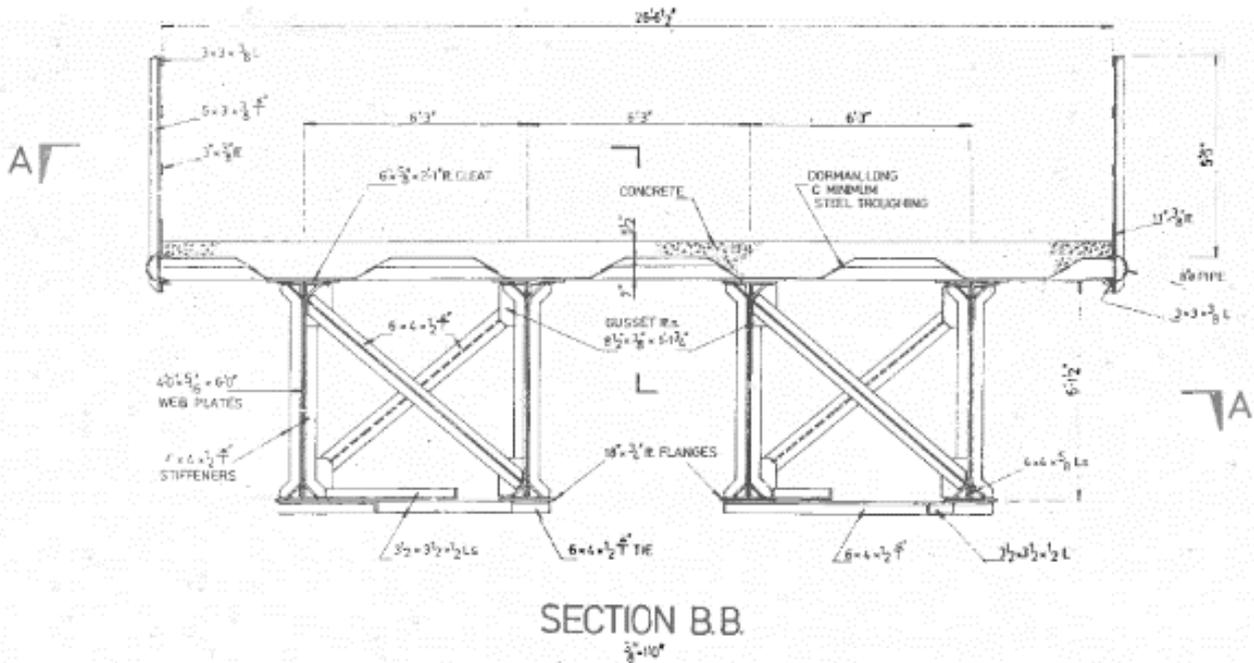
Figure 4 Typical bridge cross section

- Four (4) 1867 mm deep stiffened riveted wrought iron girders braced in pairs at 1.91 m centres. Bracing positioned both in plan and laterally
- Simply supported girders seating on bearings
- Wrought iron girder span of 18.67 m (taken at centreline of bearing plate)
- Trough steel decking with 140 mm concrete overlay
- Assumed that each pair of rails are supported by a braced pair of wrought iron girders
- Bridge span between two ‘massive’ concrete abutments and wingwalls
- Bridge width of 8.1 m between barriers

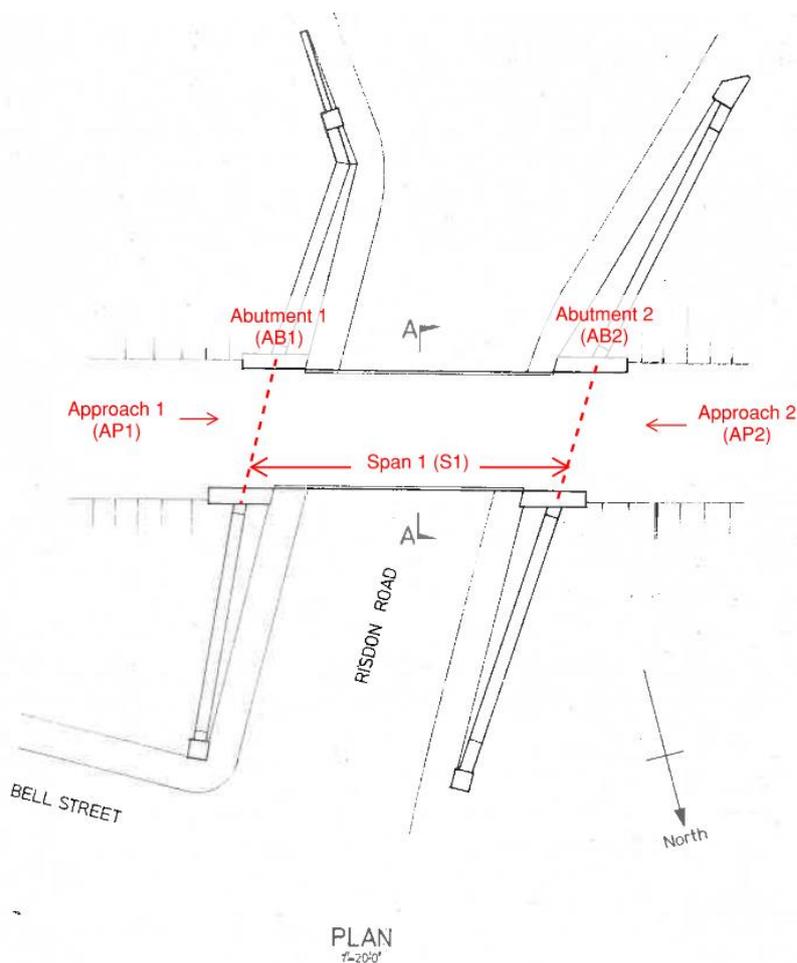
Figure 14 Risdon Road Bridge nomenclature plan

The Risdon Road bridge was constructed in approximately 1914 and supported two rail tracks. The bridge comprises a single 19.5 m span, consisting of four riveted, wrought iron, open girders in two braced pairs. The deck consists of a wrought iron trough with 140 mm thick (approximate) concrete deck, and thin plated, riveted, wrought iron, open channel members on the underside. The girders are simply supported by steel bearing plates, sitting on in-situ concrete abutments with adjoining concrete wingwalls. The bridge deck now consists of a concrete pedestrian/cyclist thoroughfare on the south-western side, and the rail on the north-eastern side, separated by a steel chain link fence.

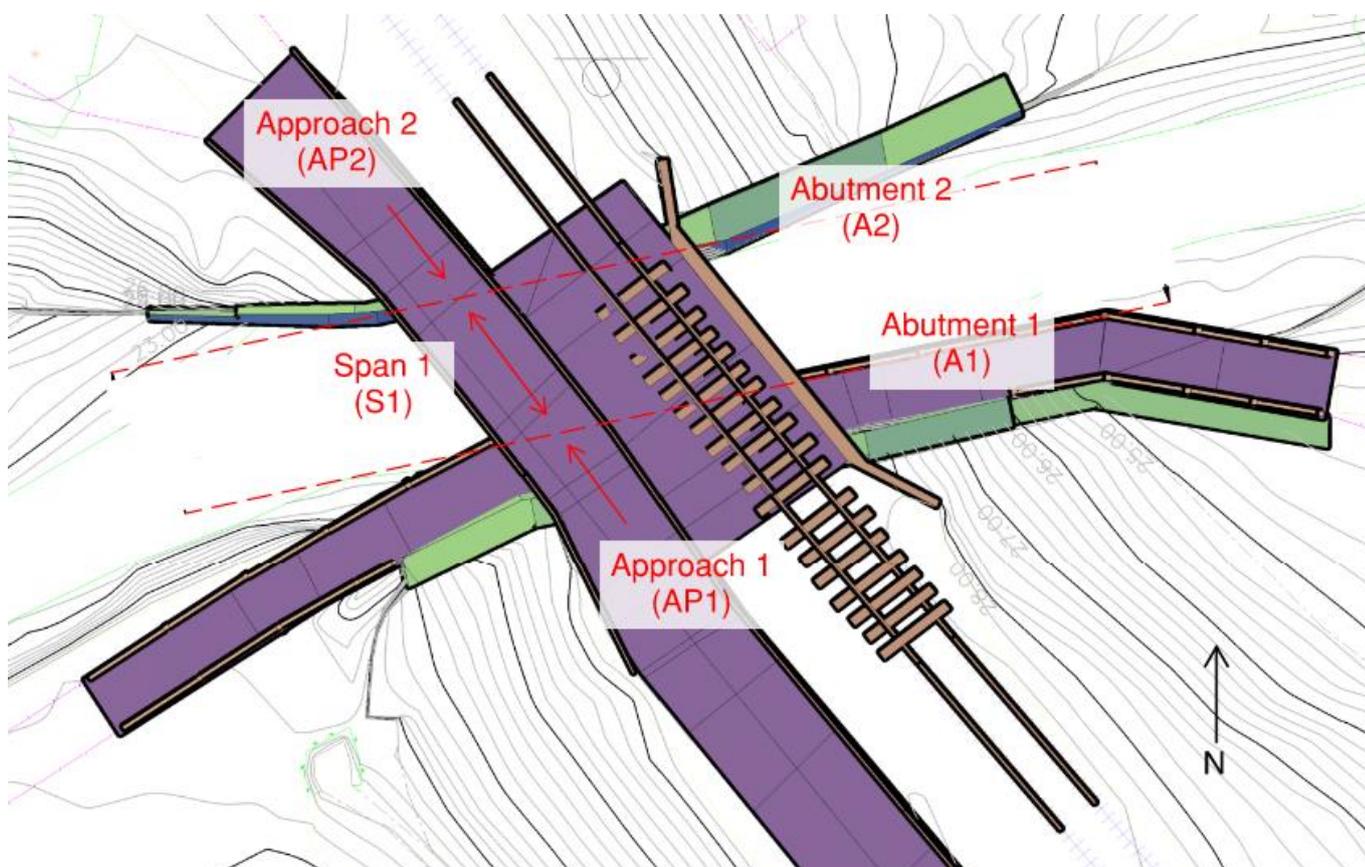
Figure 15 New Town Rivulet Bridge nomenclature plan

The New Town Rivulet bridge comprises a single span approximately 4.3 m long, consisting of six steel girders, restrained by four steel cross girders. The bridge utilises a concrete deck supported on simply supported girders. The abutments of the bridge have been modified since its construction, with half of the abutments being constructed of the original sandstone and the other half being constructed of concrete. Originally designed as a rail bridge, the bridge deck now consists of a concrete pedestrian/cyclist thoroughfare on the western side, and the rail on the eastern side, separated by a steel chain link fence.

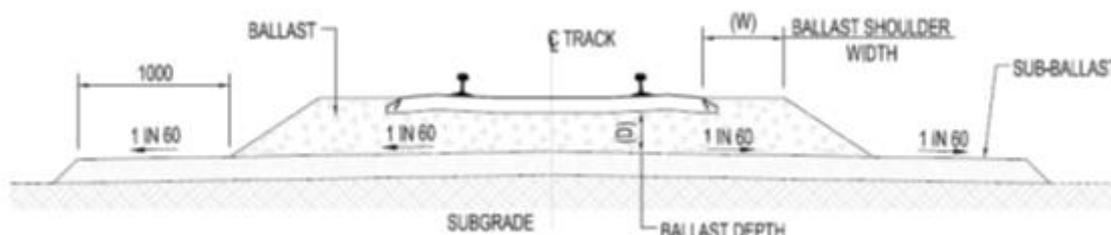
Figure 24 Track Formation (Extract From TR-INF-STD-027)

Following analysis of the survey data, aerial imagery and 360° drone video footage, there are multiple locations where steep embankments of generally 1(H):2(V) grade are located within proximity to the existing track, with various densities of vegetation observed along the alignment. These steep embankments generally occur between Macquarie Point Station and New Town Station where the bay is located adjacent to the rail corridor; however, there are other various locations where steep embankments have been identified, including on the approach to and departure from rail and road bridges.

Various degrees of clearing, grubbing and general topsoil removal will be required below the corridor footprint, with major earthworks including bulk cutting and fill as required to widen the rail corridor and achieve the finished sub-ballast and subgrade levels in accordance with Tasmanian Railway Standard Document TR-INF-STD-027 as noted in Figure 24.

Due to the proximity of the steep embankments, retaining walls may be required along the alignment to accommodate the widening of the rail corridor, additionally it is recommended a slope stability and geotechnical assessment be undertaken to determine whether the existing ground conditions can support an active light rail system.

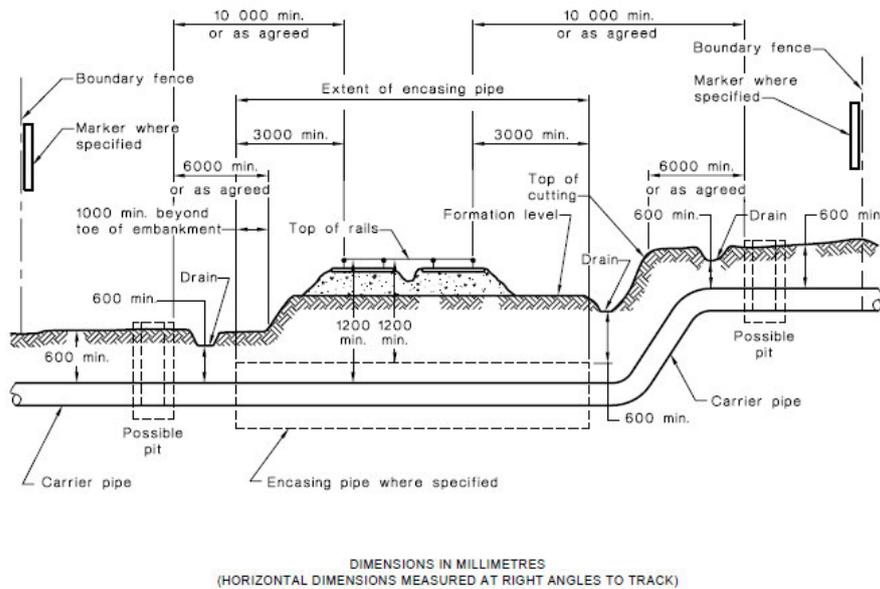
Figure 25 Minimum Cover Requirements for Non-flammable Infrastructure (extract for AS 4799-2000)

Limited existing drainage pipe crossings located under the rail identified within the provided survey data, have been assessed to ensure they comply with the minimum cover requirements outlined within Australian Standards AS 4799-2000. All identified under-track drainage infrastructure currently complies with the minimum 1.2 m cover from existing track level as shown in Figure 25.
