**General Arrangement Plan Drawings –  
Culvert Location**

Size <b>A3</b>	Row <b>A</b>	
Client <b>DEPARTMENT OF STATE GROWTH</b>		Drawing Title <b>GENERAL ARRANGEMENT PLAN</b>	
Project <b>NSTC CONDITION ASSESSMENT</b>		Status <b>S2</b>	
Project No. <b>12548571</b>		Drawing No. <b>12548571-SK003</b>

Department of State Growth  
Northern Suburbs Transit Corridor -  
Condition Assessment

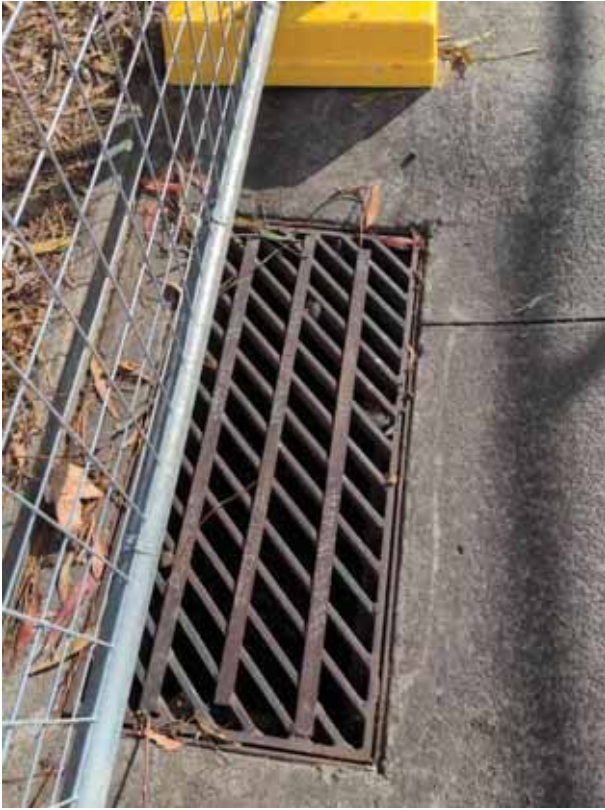
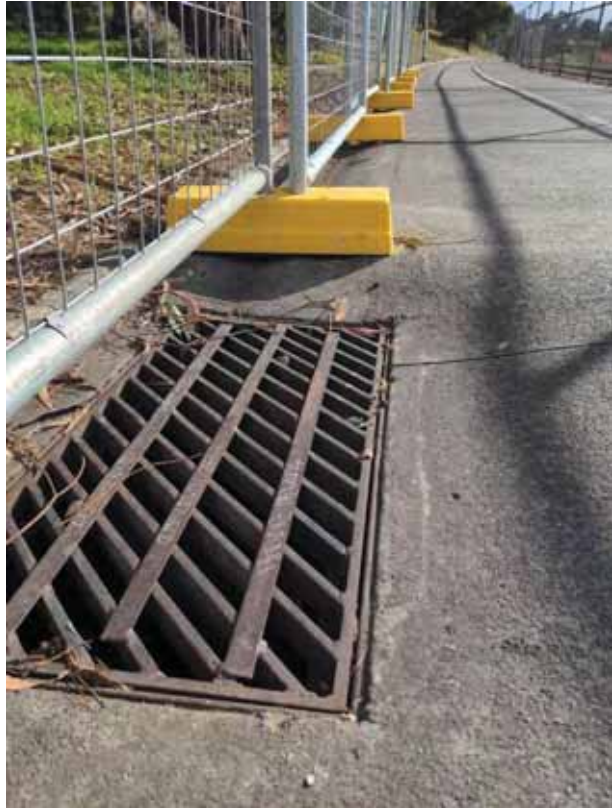
During this inspection is there water in the culvert?			No
Barrel flow	clear	Inlet flow	
Outlet flow	100% blocked		Clear
Outlet condition	vegetation, outlet covered with rocks. no wingwall or headwall, pipe end appears to be damaged		
Inlet condition	grated pit along shared path appears to be in good condition		
Structure condition	pipe_box_damage, joint_damage, no headwall or wingwall at outlet. difficult to assess pipe condition		
Road surface condition	Refer to rail track condition assessment provided separately		
Batter condition	batters are not steep, vegetated		
What routine maintenance is required?	check pipe condition, clear outlet, missing headwall/wingwall

Photo Inlet

- further inspection may be required if pipe is being used.
- existing building on the eastern side
- concrete pipe appears to be connected to steel pipe
- condition at joints will need to be assessed for erosion, seepage, etc.
- blockage will need to be cleared to ensure smooth flows and avoid flooding

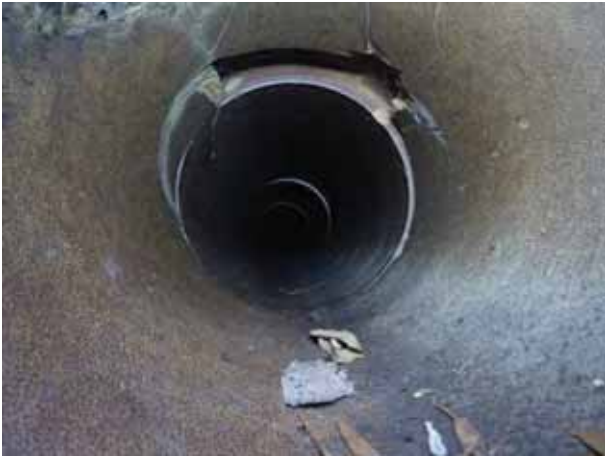
Photo Inlet – view towards outlet

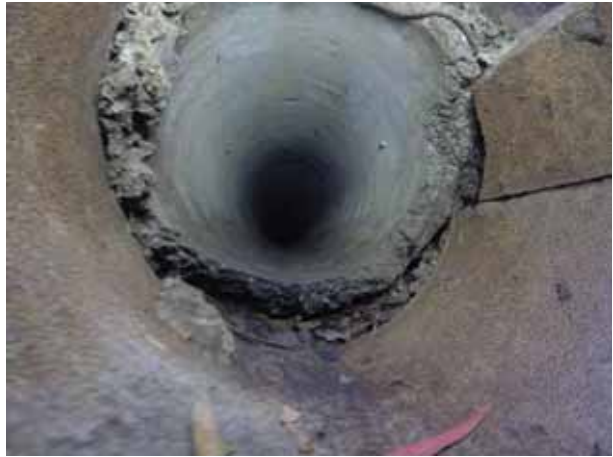
Photo Inlet – upstream side

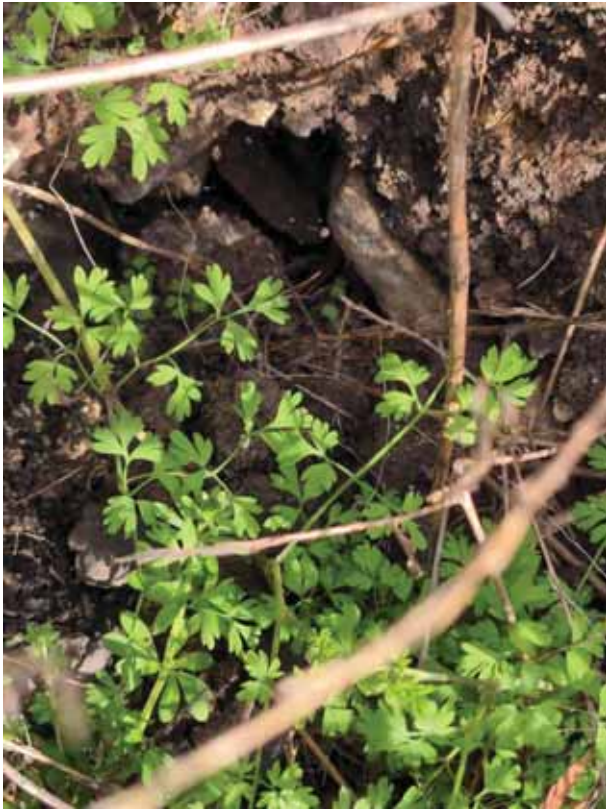
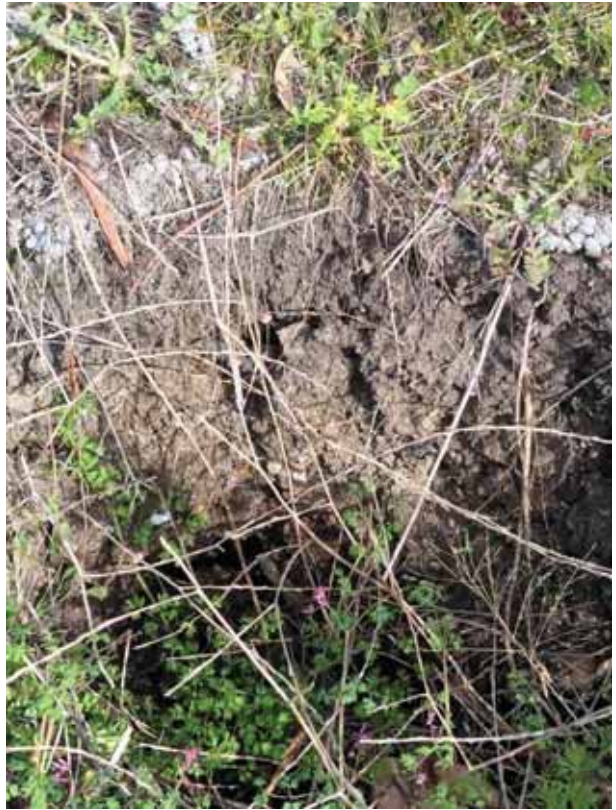
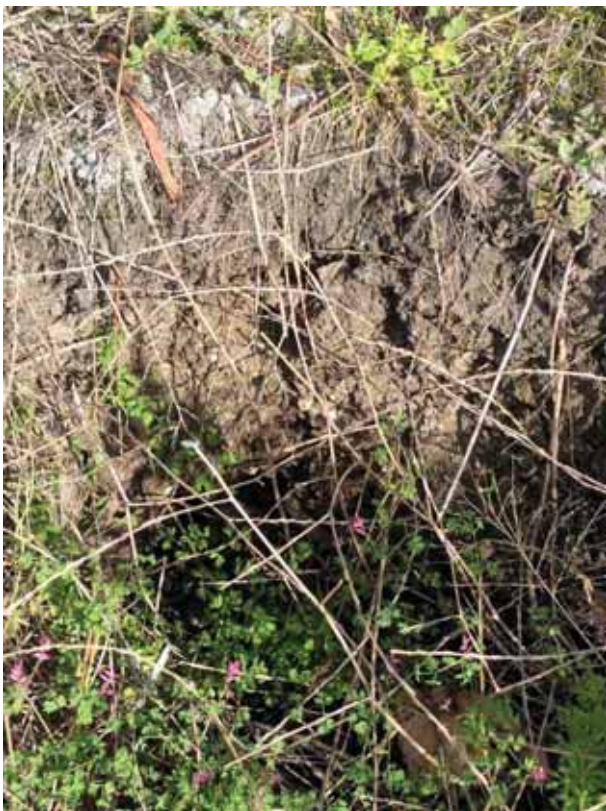
Photo Outlet

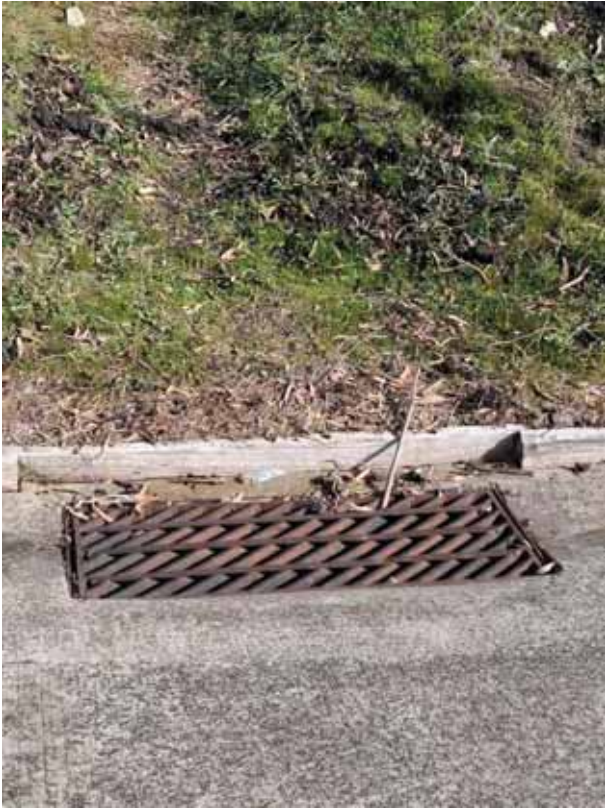
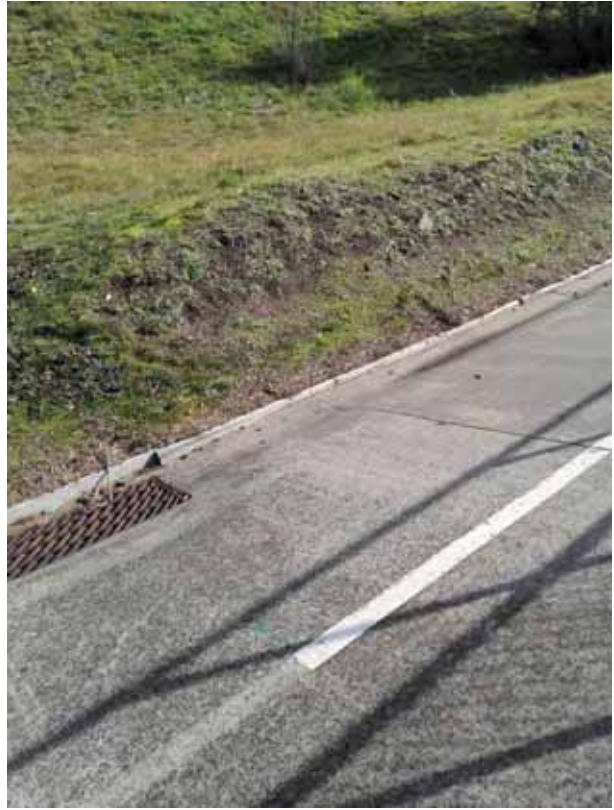
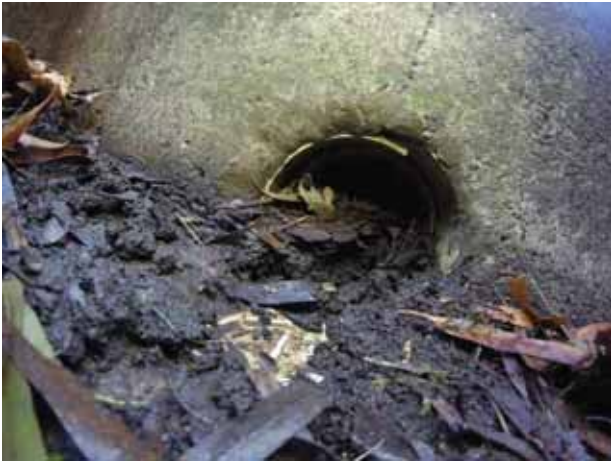
During this inspection is there water in the culvert?			No
Barrel flow	75% blocked	Inlet flow	
Outlet flow	100% blocked		50% blocked
Outlet condition	veg,hard to tells at outlet pipe 100% covered by vegetation and dirt, flow path evident		
Inlet condition	grated pit along shared path appears to be in good condition.		
Structure condition	headwall has no wingwall		
Road surface condition	Refer to rail track condition assessment provided separately		
Batter condition	flat batters on either side		
What routine maintenance is required?	clear outlet of vegetation and dirt. Consider providing wingwalls to avoid dirt from batters moving towards outlet.

Photo Inlet

- further inspection may be required if pipe is being used.
- condition at joints will need to be assessed for erosion, seepage, etc.
- blockage will need to be cleared to ensure smooth flows and avoid flooding

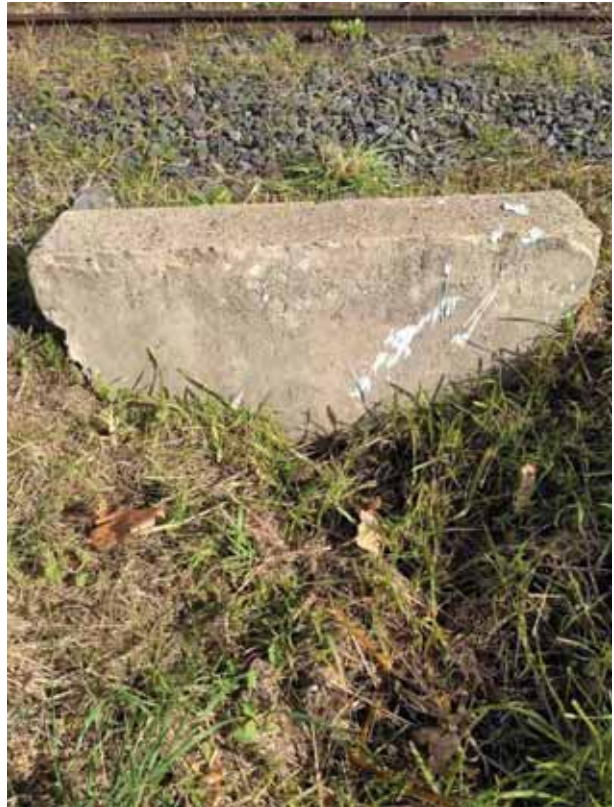
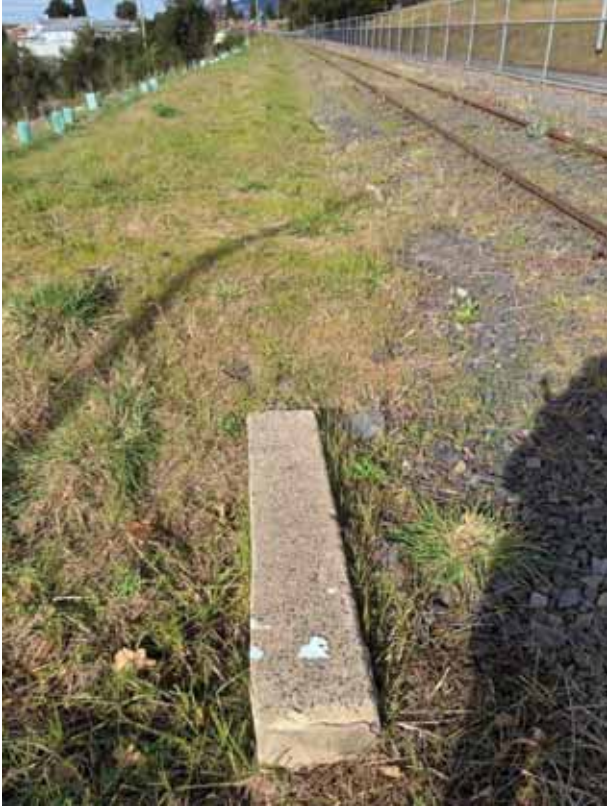
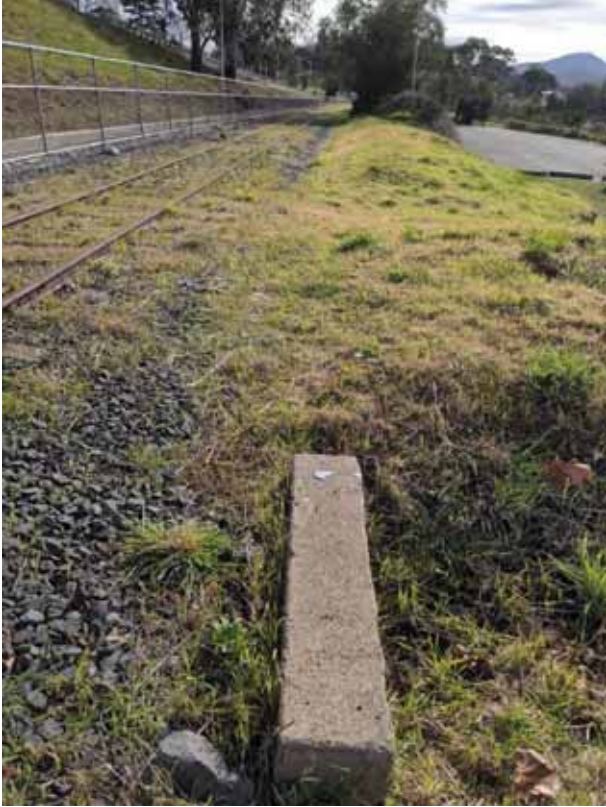
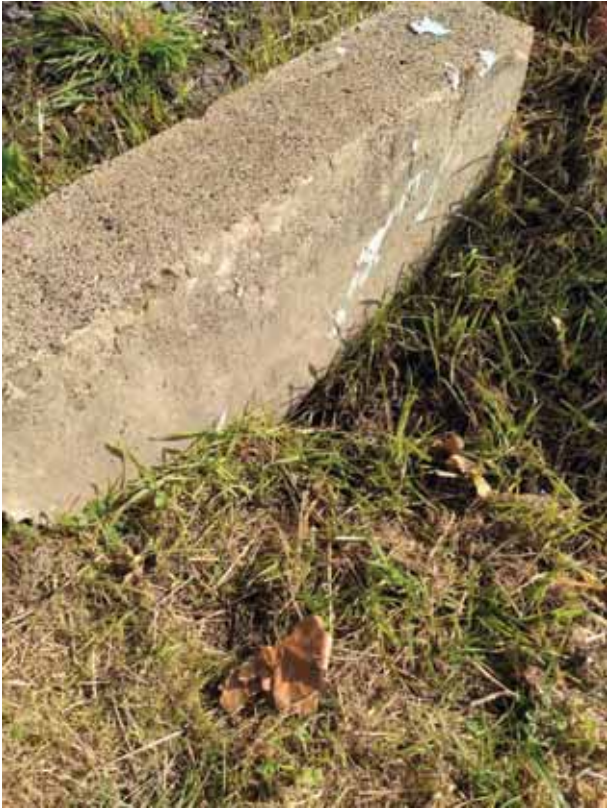
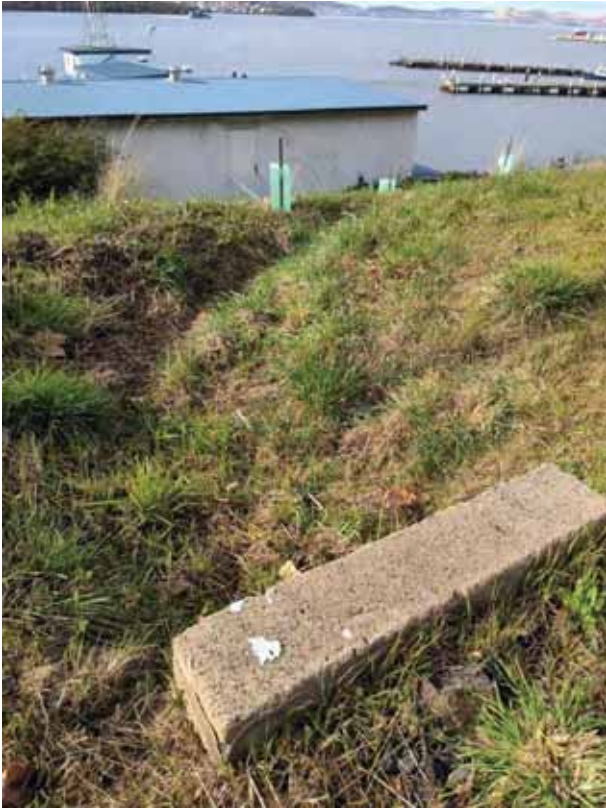
Photo Outlet

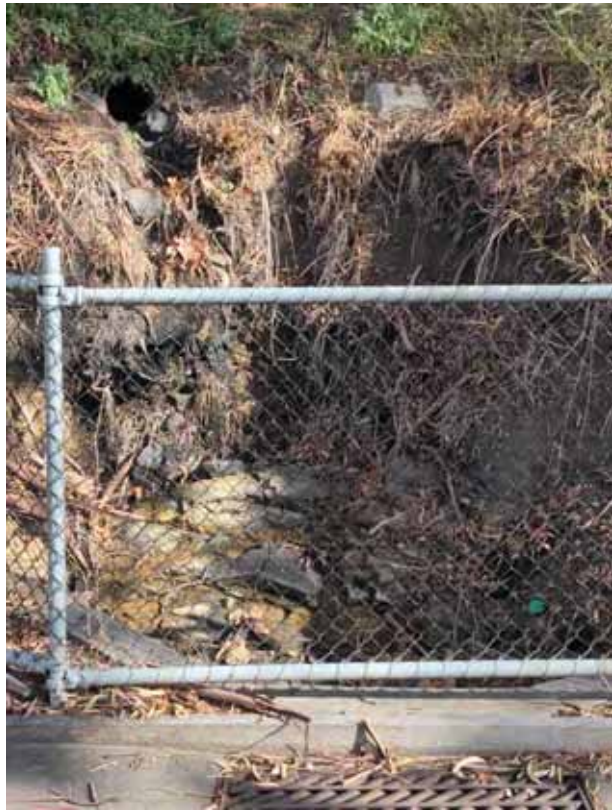
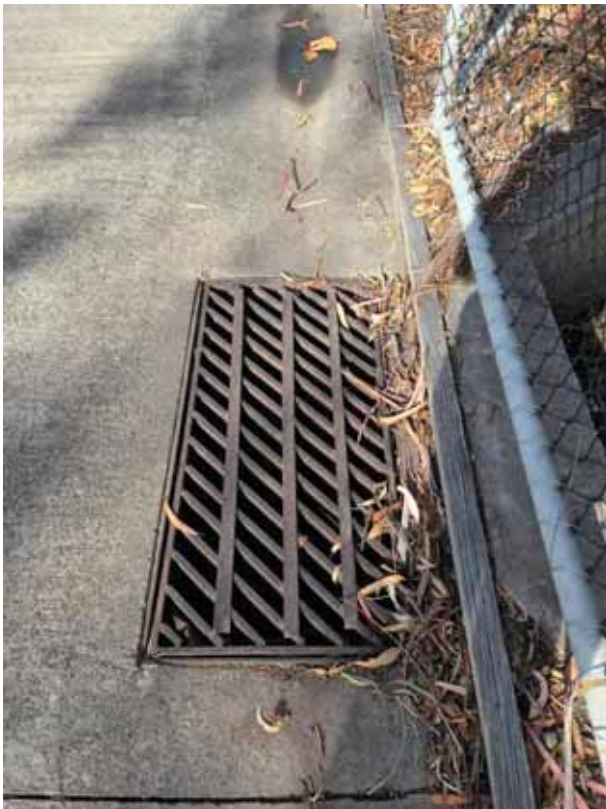
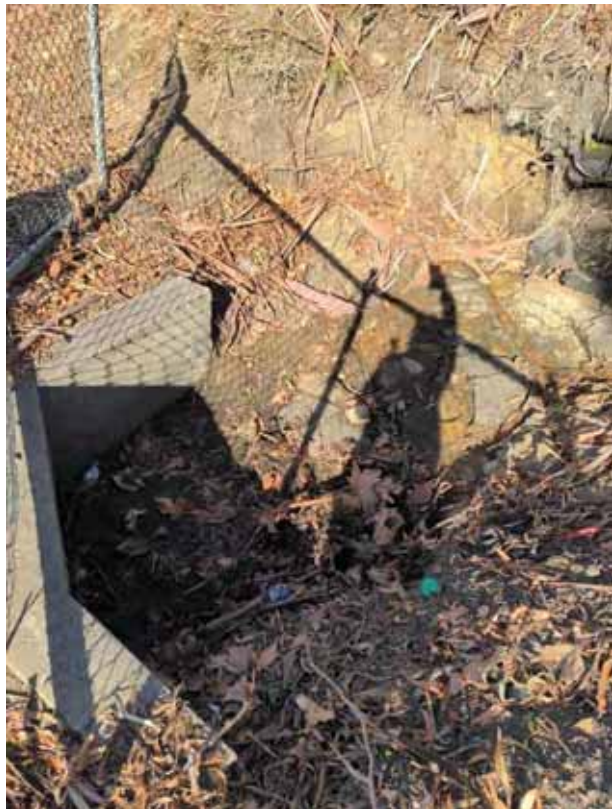
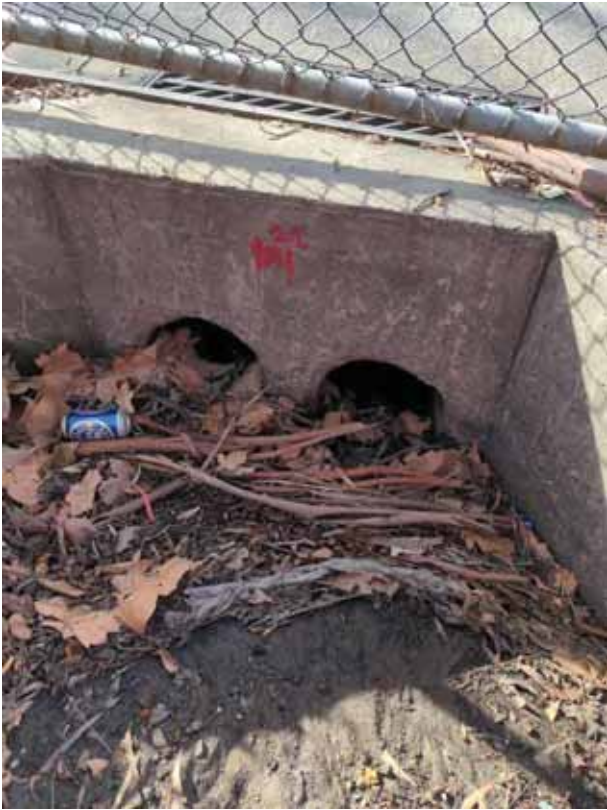
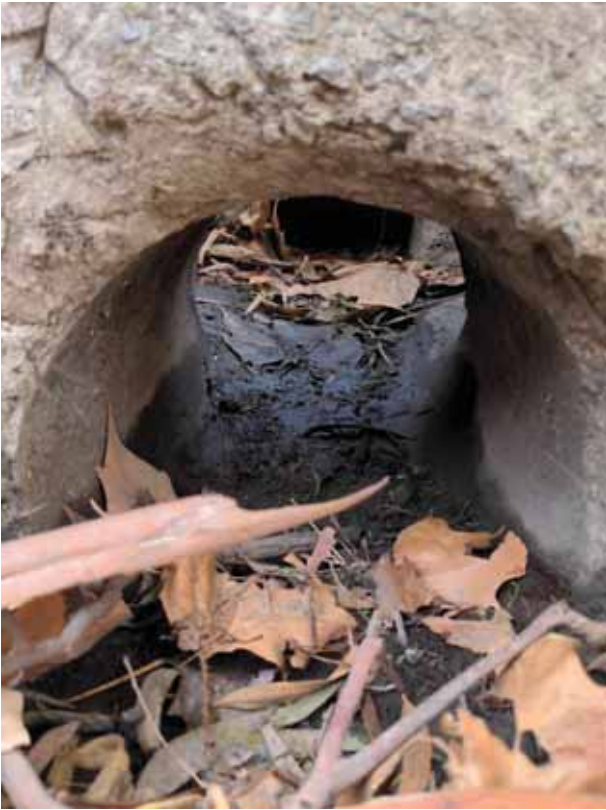
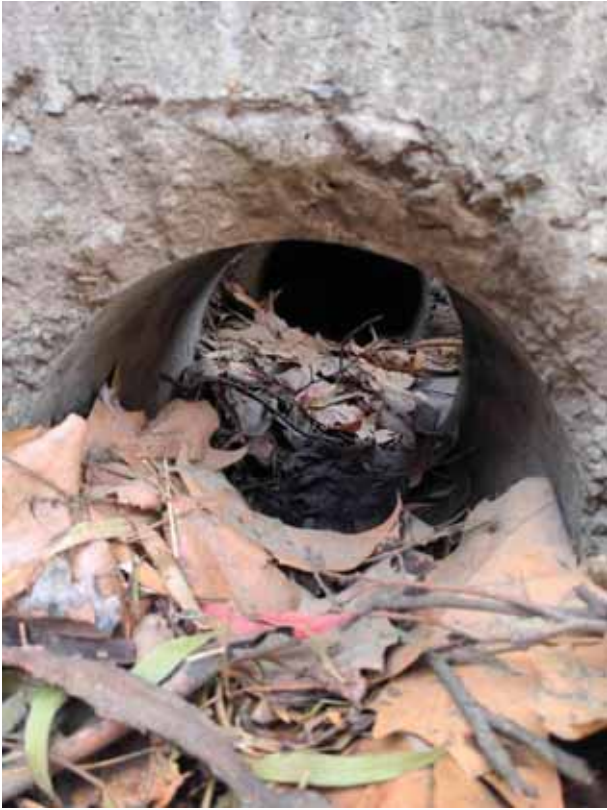
During this inspection is there water in the culvert?			No
Barrel flow	25% blocked	Inlet flow	
Outlet flow	75% blocked		25% blocked
Outlet condition	vegetation. Grated pit appears to be the low point within the area. Possible ponding during heavy rains		
Inlet condition	dirt and dry leaves partially covering pit invert. Scouring		
Structure condition	Dirt and leaves from embankment can easily get into the outlet. Grated pit cover rusty.		
Road surface condition	Refer to rail track condition assessment provided separately		
Batter condition	steeper on outlet side, flat on the northern and southern side		
What routine maintenance is required?	clear outlet of dirt and vegetation. Outlet flow direction unclear. Provide treatment for embankment scouring on inlet side

Photo Inlet

- condition at joints will need to be assessed for erosion, seepage, etc.
- blockage will need to be cleared to ensure smooth flows and avoid flooding

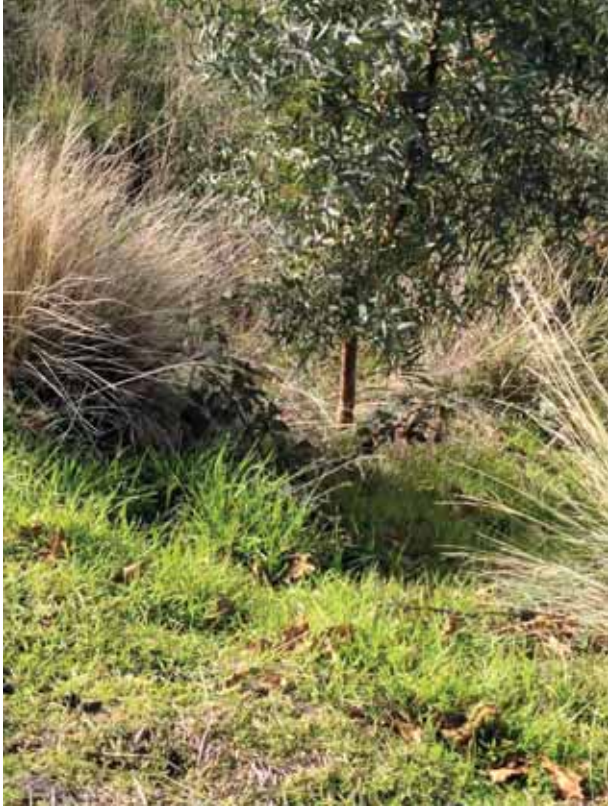
Photo Outlet

- further inspection may be required as outlet was not found during site inspection
- separation of pipe at joints evident

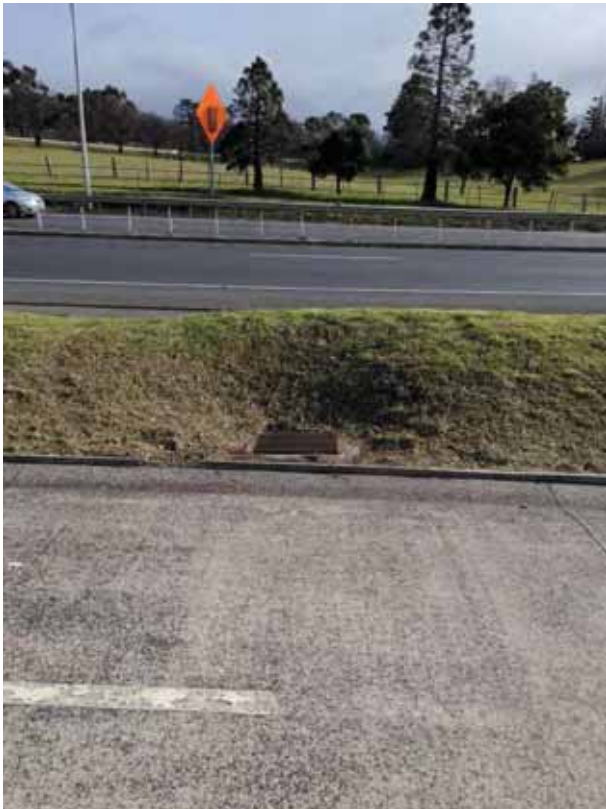
Photo Inlet – adjacent to the footpath

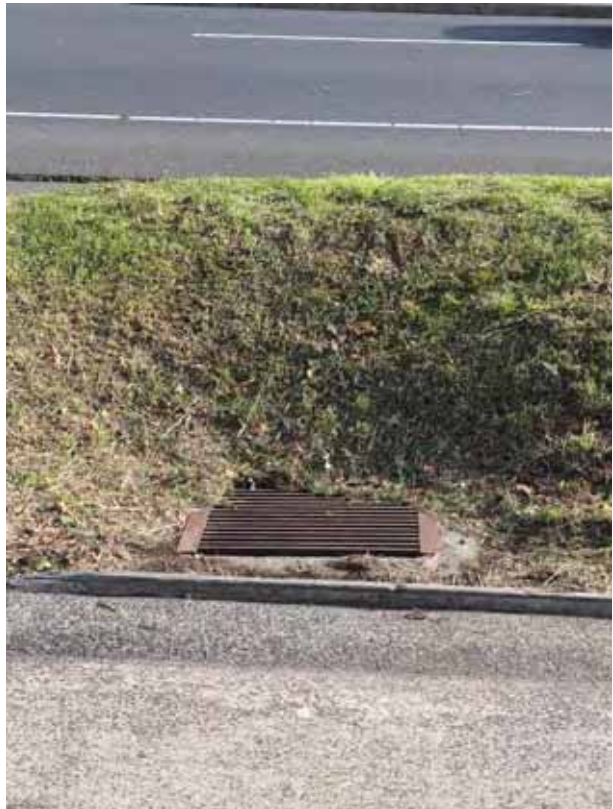
Photo Inlet – adjacent to the footpath

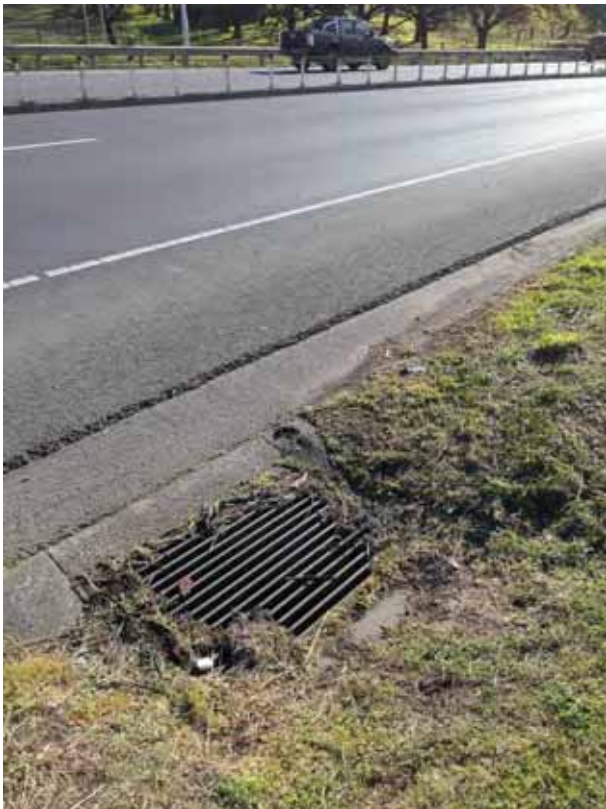
Photo Inlet – pit adjacent to the footpath appears to flow towards pit along the road

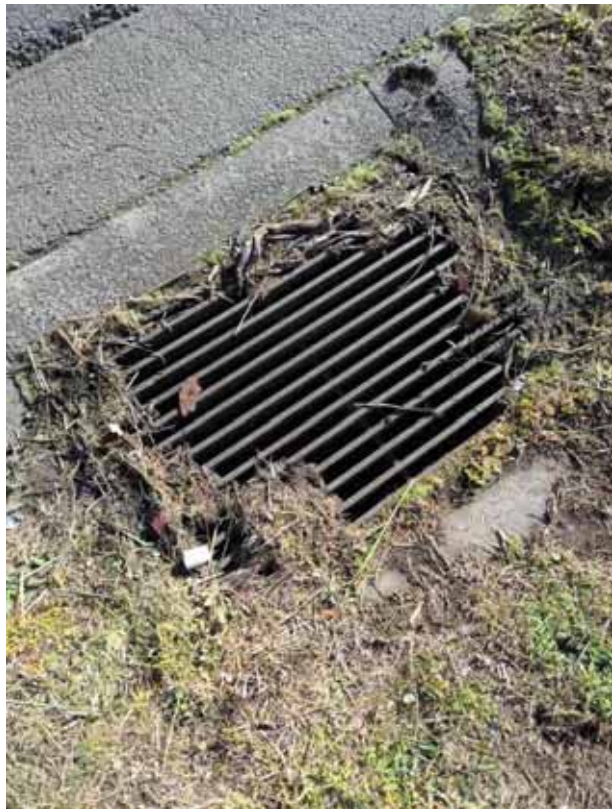
Photo Inlet – pit adjacent to the footpath appears to flow towards pit along the road

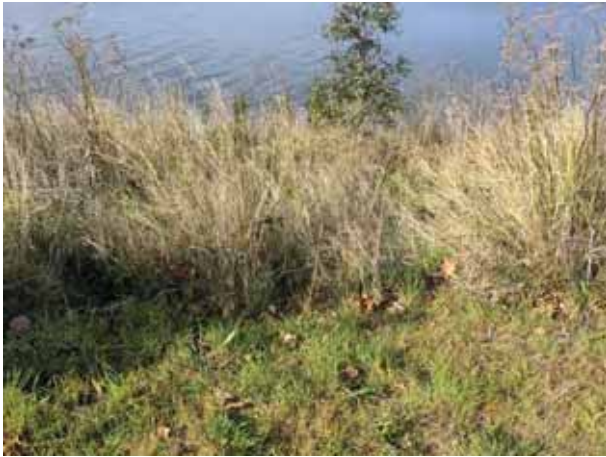
**Photo Outlet**

<b>During this inspection is there water in the culvert?</b>			cannot be determined
<b>Barrel flow</b>	cannot be determined	<b>Inlet flow</b>	
<b>Outlet flow</b>	cannot be determined		cannot be determined
<b>Outlet condition</b>	vegetation, cannot find outlet due to steep batters and vegetation		
<b>Inlet condition</b>	vegetation, possible dirt and debris. difficult to open pit along the road		
<b>Structure condition</b>	cannot be determined		
<b>Road surface condition</b>	Refer to rail track condition assessment provided separately		
<b>Batter condition</b>	Batters are flat for about 2 m approx. then steepens on the eastern side. batter on west side that is adjacent to the cycleway is flat		
<b>What routine maintenance is required?</b>	vegetation on outlet side may need to be cleared. outlet will need to be cleared and marked and pipe condition checked

- further inspection may be required for pipe condition as outlet not found and pit cover at inlet was difficult to lift
- condition at joints will need to be assessed for erosion, seepage, etc.
- blockage will need to be cleared to ensure smooth flows and avoid flooding

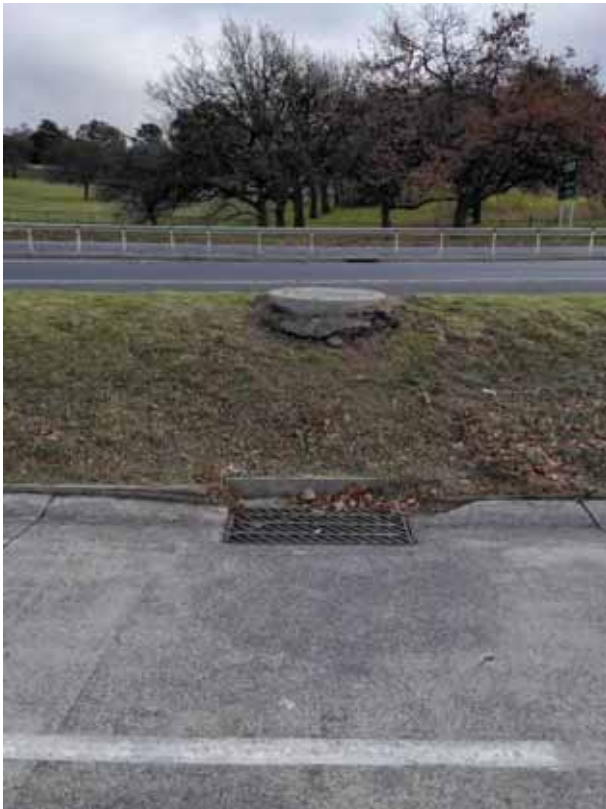
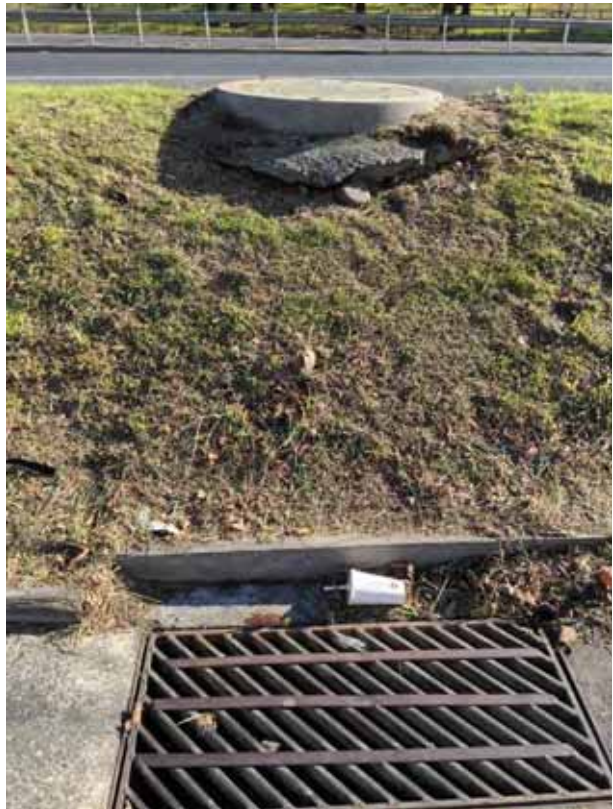
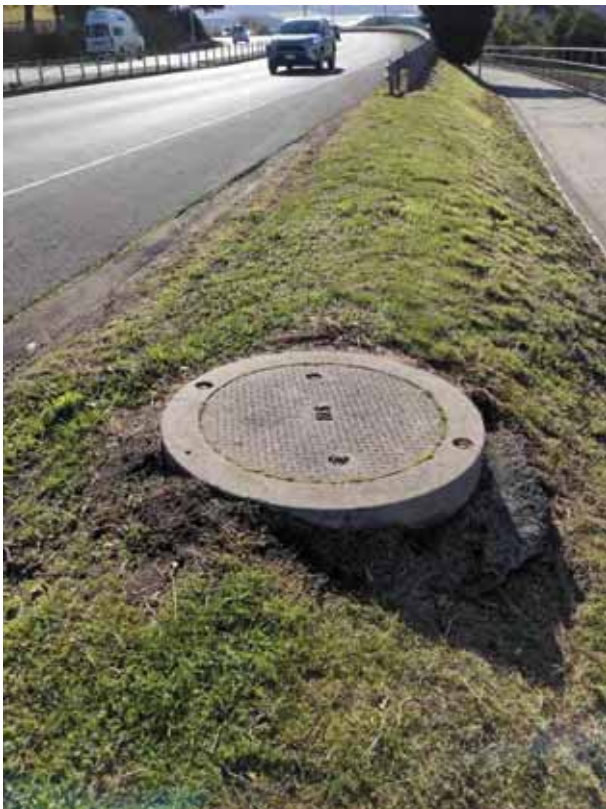
Photo Inlet

- further inspection may be required for pipe condition as outlet not found and pit cover at inlet was difficult to lift
- condition at joints will need to be assessed for erosion, seepage, etc.
- blockage will need to be cleared to ensure smooth flows and avoid flooding

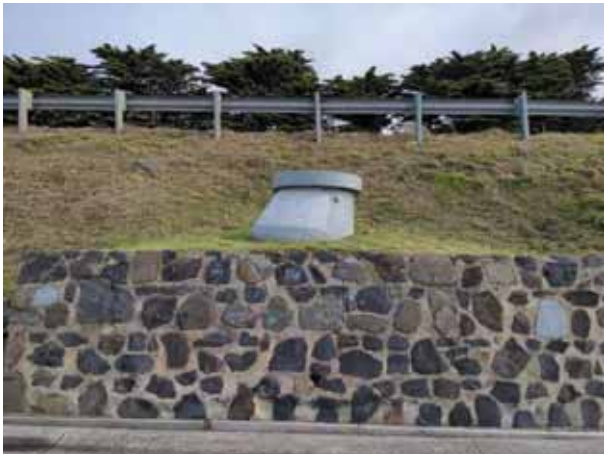
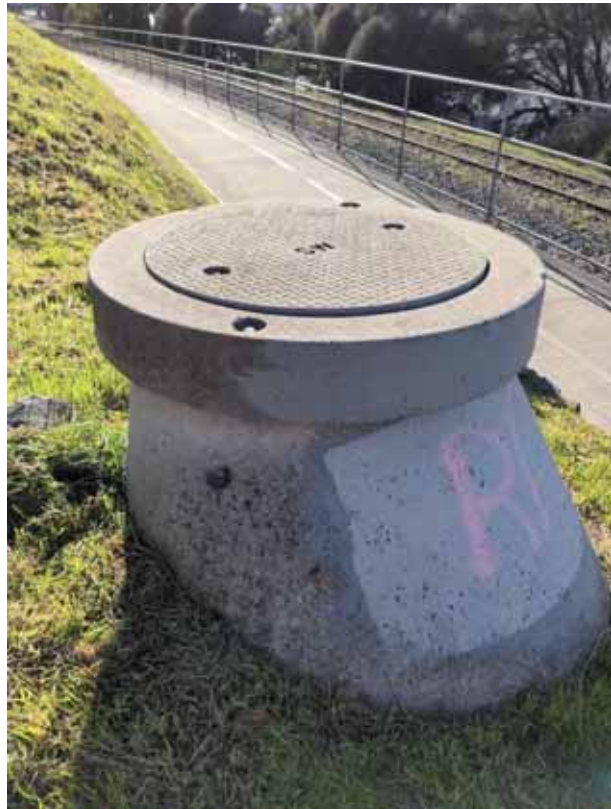
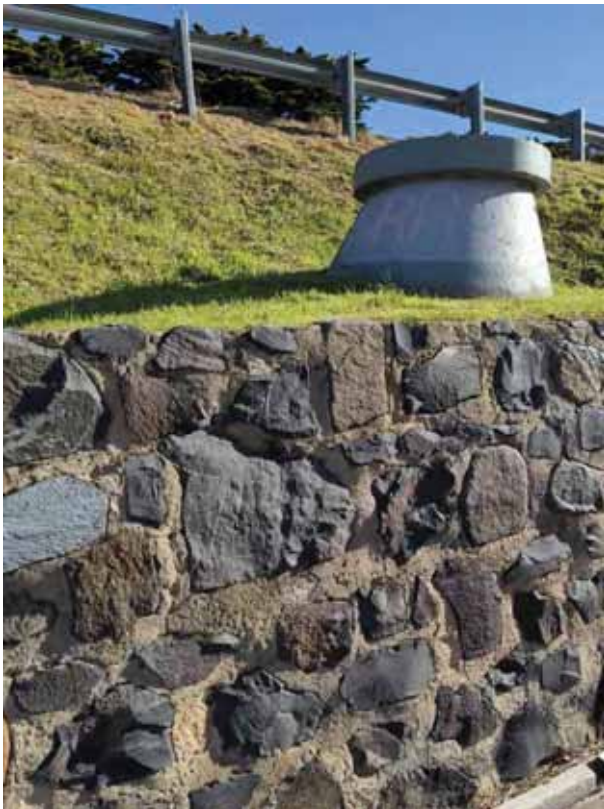
Photo Inlet

<b>During this inspection is there water in the culvert?</b>			cannot be determined
<b>Barrel flow</b>	cannot be determined	<b>Inlet flow</b>	
<b>Outlet flow</b>	cannot be determined		cannot be determined
<b>Outlet condition</b>	vegetation,difficult to access due to steep grades and vegetation. outlet flow path not evident		
<b>Inlet condition</b>	inlet is through junction pit on outer edge of cycleway. Difficult to open pit cover		
<b>Structure condition</b>	Cannot determine location of outlet / headwall/. Manhole / Junction pit appears to be in good condition.		
<b>Road surface condition</b>	Refer to rail track condition assessment provided separately		
<b>Batter condition</b>	Batters are flat for about 2 m approx. then steepens on the eastern side. batter on west side that is adjacent to the cycleway is flat		
<b>What routine maintenance is required?</b>	outlet may need to be cleared and marked. Outlet location was not determined. Pipe condition will need to be rechecked.

- further inspection may be required for pipe condition as outlet not found and pit cover at inlet was difficult to lift
- condition at joints will need to be assessed for erosion, seepage, etc.
- blockage will need to be cleared to ensure smooth flows and avoid flooding

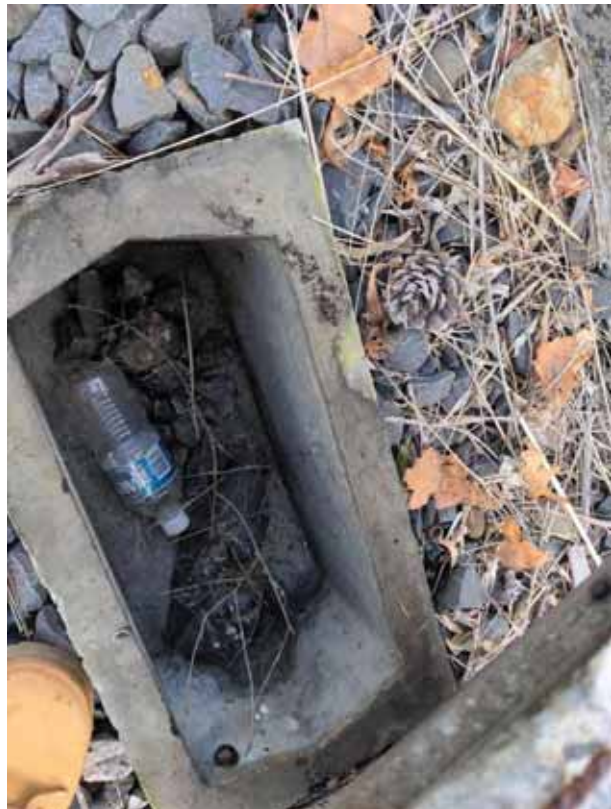
Photo Inlet – old inlet before shared path was constructed?

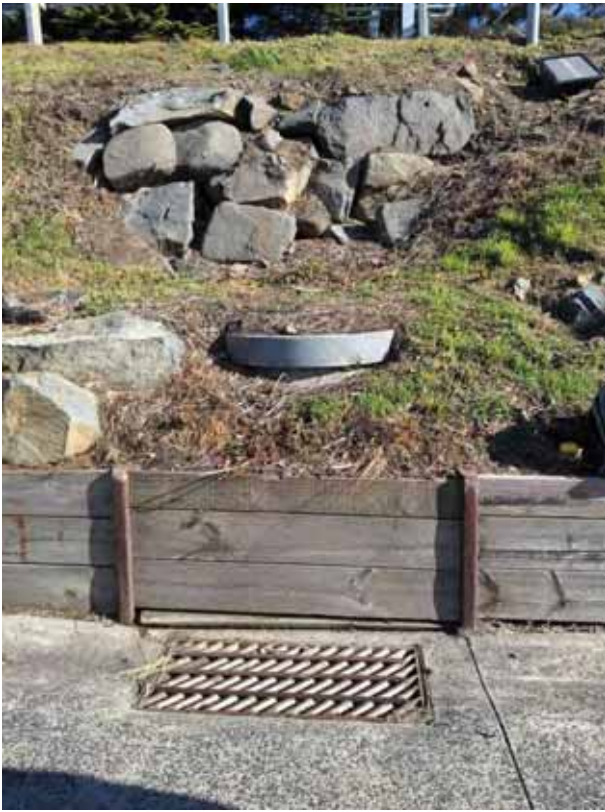
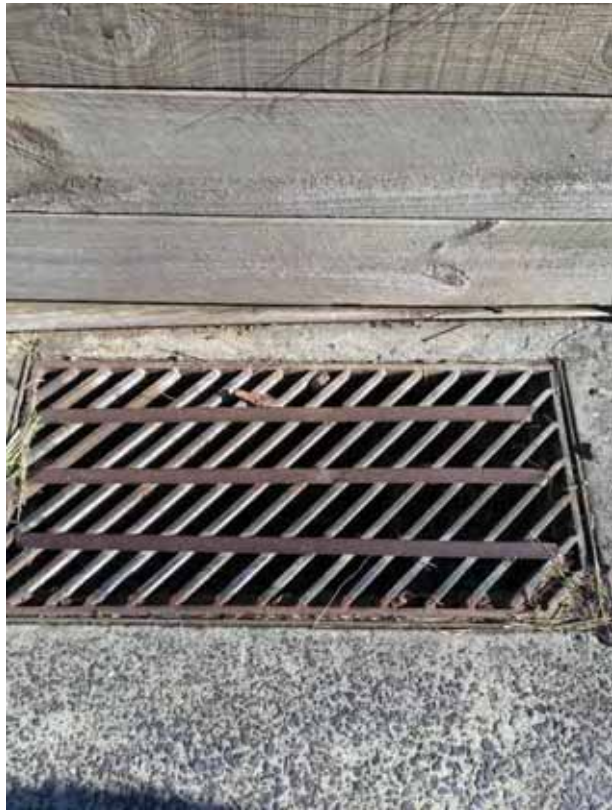
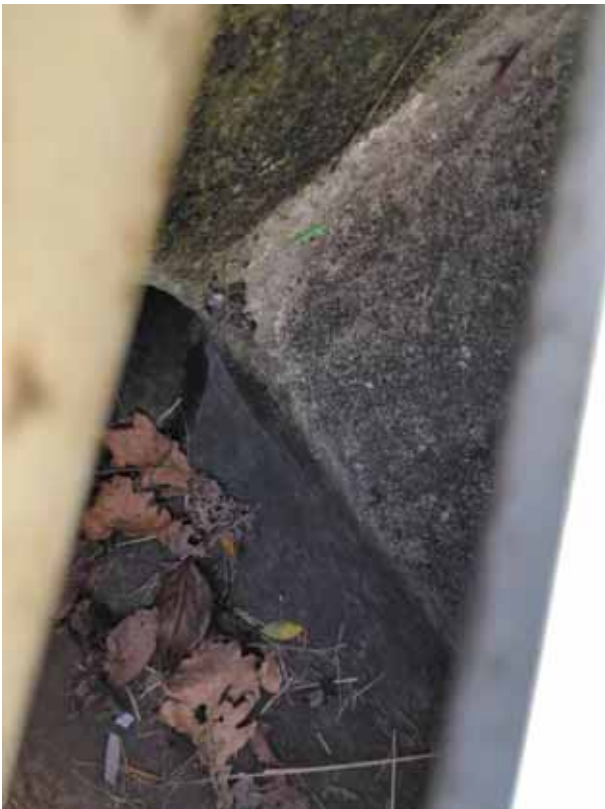
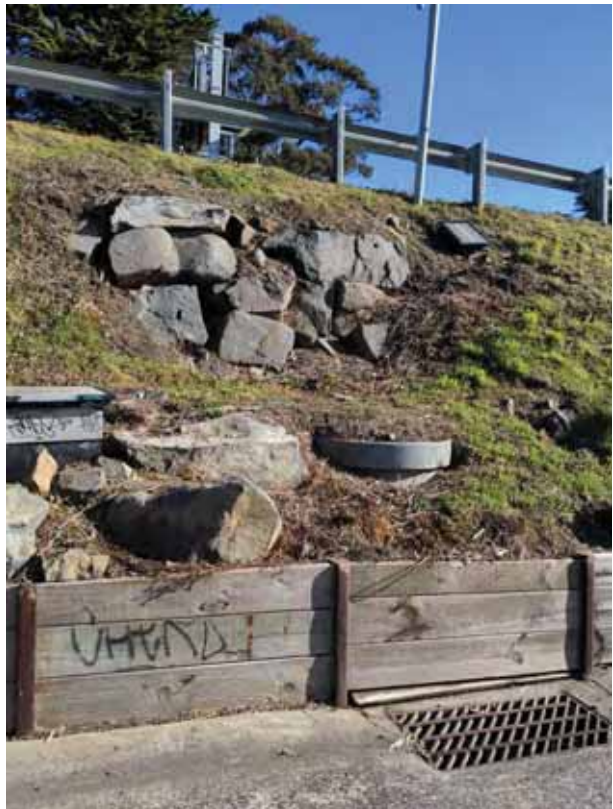
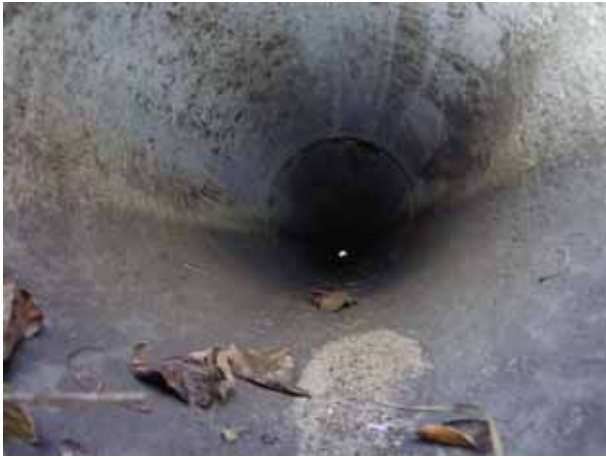
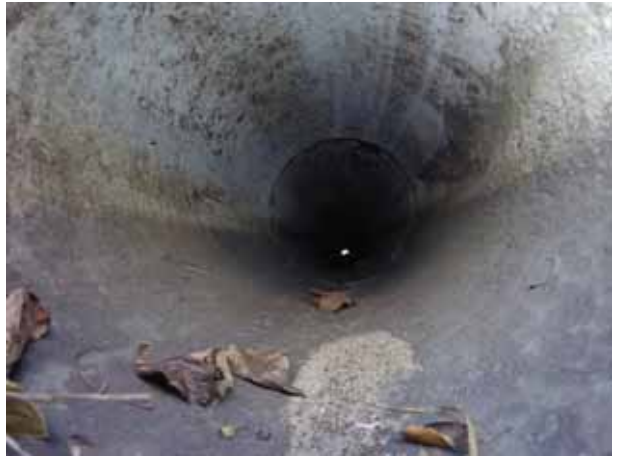
Photo Inlet

During this inspection is there water in the culvert?			Yes
Barrel flow	clear	Inlet flow	
Outlet flow	75% blocked		Clear
Outlet condition	silt and water covering more than half of outlet. water ponding at outlet. Surrounding areas around the outlet are at a higher level than invert of outlet. outlet adjacent to tree, vegetation		
Inlet condition	located on other side of cycleway. grated pit connected to junction pits upstream		
Structure condition	no headwall or wingwall at outlet		
Road surface condition	Refer to rail track condition assessment provided separately		
Batter condition	batters are flat on either side. batter steepen past 6-7m from track on eastern side		
What routine maintenance is required?	outlet will need to be cleared to ensure flow runs smoothly and to avoid ponding. headwall will need to be provided to ensure batter material does not flow to the outlet during rain events.

- condition at joints will need to be assessed for erosion, seepage, etc.
- blockage will need to be cleared at outlet to ensure smooth flows and avoid flooding
- headwall will need to be installed

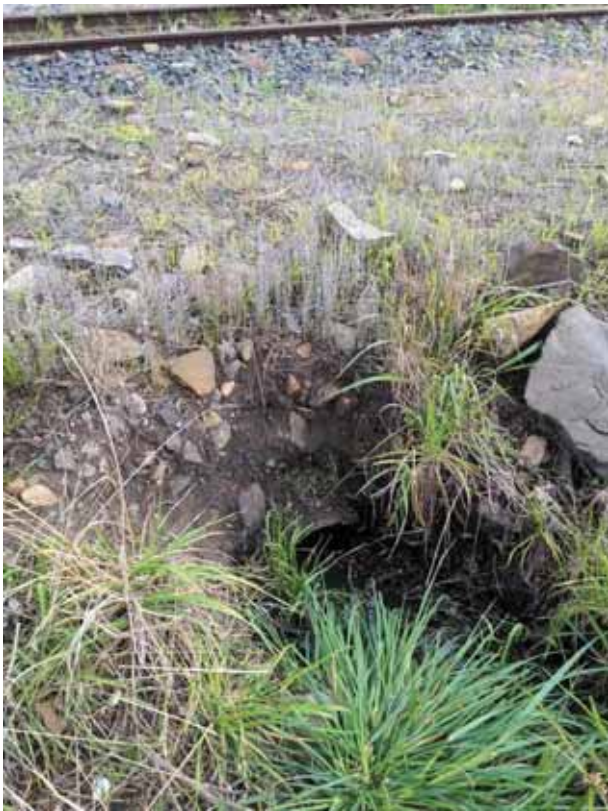
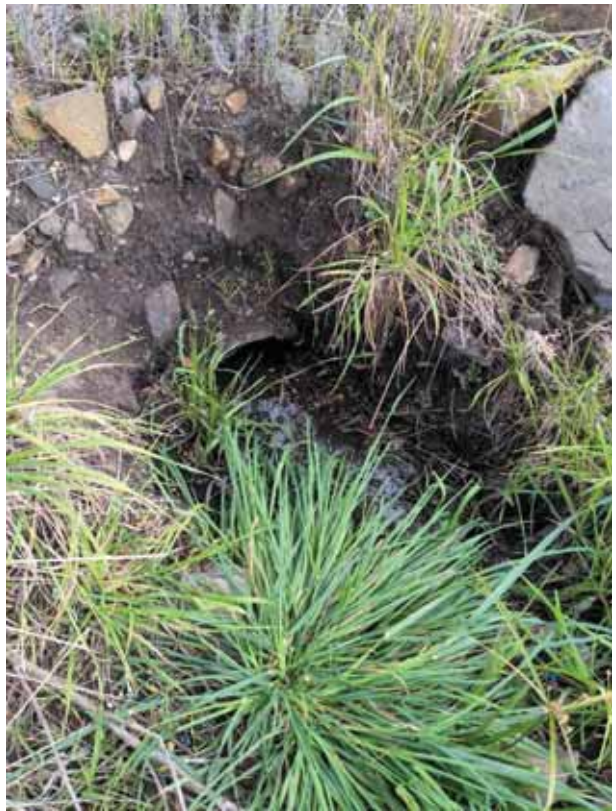
**Photo Condition**

Significant cracking and deformation of the internal walls
	Evidence of corrosion of steel reinforcement (eg. exposed reinforcement, iron staining, leaching)
	Spalling or delamination of concrete
Yes	Noticeable displacement or separation across joints (butt joints ≥ 20mm, spigot and socket joints ≥ 50mm)
	Evidence of groundwater entering into the pipe
	Evidence of water being lost out of joints or other defects in the pipe
	Evidence of erosion through joints (eg. seepage inflows carrying fines, soil accumulation at joints)
	Bowing of culvert
	Geometry change
Yes	Debris or vegetation inside culvert
	Acid sulfate soils and/or acid bearing rock

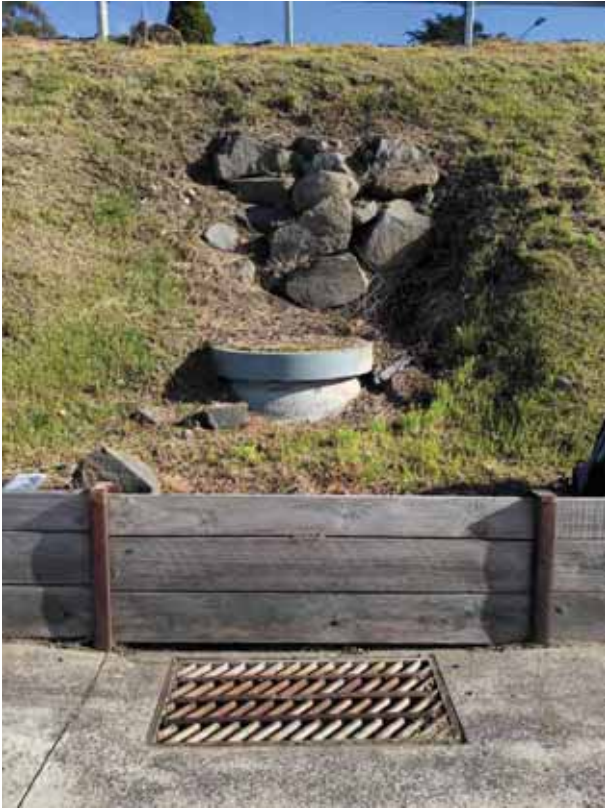
Photo Inlet

During this inspection is there water in the culvert?			No
Barrel flow	Clear	Inlet flow	
Outlet flow	25% blocked		Clear
Outlet condition	cannot find outlet due to steep batters and vegetation.		
Inlet condition	grated pit on opposite side of shared path and connected to junction pit upstream, cannot lift lid		
Structure condition	cannot determine outlet location. No headwall found. Grated pit cover at inlet appears to be in good condition		
Road surface condition	Refer to rail track condition assessment provided separately		
Batter condition	Batters are flat for about 3 m approx. then steepens on the eastern side. batter on west side that is adjacent to the cycleway is flat		
What routine maintenance is required?	access to outlet will need to be cleared for maintenance. outlet and pipe condition will need to be rechecked

- Rock armour does not appear secure and may pose a risk to cyclists and pedestrians over time
- Outlet will need to be cleared and marked
- condition at joints will need to be assessed for erosion, seepage, etc. Joint connection appears separated from inlet side.
- blockage will need to be cleared to ensure smooth flows and avoid flooding
