**General Arrangement Plan Drawings –  
Culvert Location**

Size <b>A3</b>	Row <b>A</b>	
Client <b>DEPARTMENT OF STATE GROWTH</b>		Drawing Title <b>GENERAL ARRANGEMENT PLAN</b>	
Project <b>NSTC CONDITION ASSESSMENT</b>		Status <b>S2</b>	
Project No. <b>12548571</b>		Drawing No. <b>12548571-SK003</b>

Department of State Growth  
Northern Suburbs Transit Corridor -  
Condition Assessment

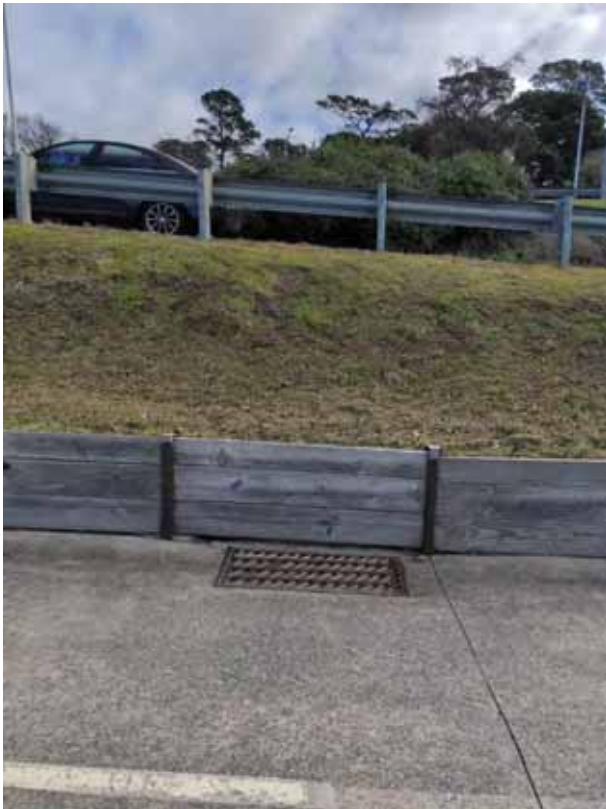
Photo Inlet

During this inspection is there water in the culvert?			No
Barrel flow	Clear	Inlet flow	
Outlet flow	100%		Clear
Outlet condition	vegetation, outlet not visible and difficult to access due to steep batters, no visible headwall		
Inlet condition	grated pit appears to be in good condition. located on other end of fenced shared path		
Structure condition	no visible headwall, difficult to assess outlet due to access issues		
Road surface condition	Refer to rail track condition assessment provided separately		
Batter condition	Batters are flat for about 2-3 m approx. then steepens on the eastern side. batter on west side that is adjacent to the cycleway is flat. shallow cess drain on left side of track		
What routine maintenance is required?	access to outlet will need to be cleared for maintenance. outlet condition to be rechecked

- Outlet will need to be determined, cleared, and marked for maintenance
- condition at joints throughout the length of the culvert will need to be assessed for erosion, seepage, etc. Joint connection appears separated from inlet side.
- blockage will need to be cleared to ensure smooth flows and avoid flooding

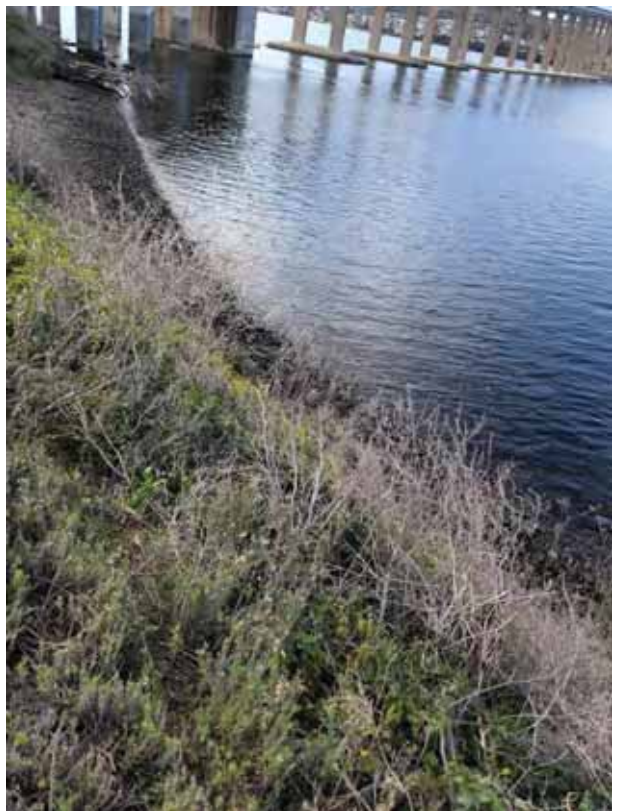
**Photo Condition**

Significant cracking and deformation of the internal walls
	Evidence of corrosion of steel reinforcement (eg. exposed reinforcement, iron staining, leaching)
	Spalling or delamination of concrete
Yes	Noticeable displacement or separation across joints (butt joints ≥ 20mm, spigot and socket joints ≥ 50mm)
	Evidence of groundwater entering into the pipe
	Evidence of water being lost out of joints or other defects in the pipe
	Evidence of erosion through joints (eg. seepage inflows carrying fines, soil accumulation at joints)
	Bowing of culvert
	Geometry change
Yes	Debris or vegetation inside culvert
	Acid sulfate soils and/or acid bearing rock

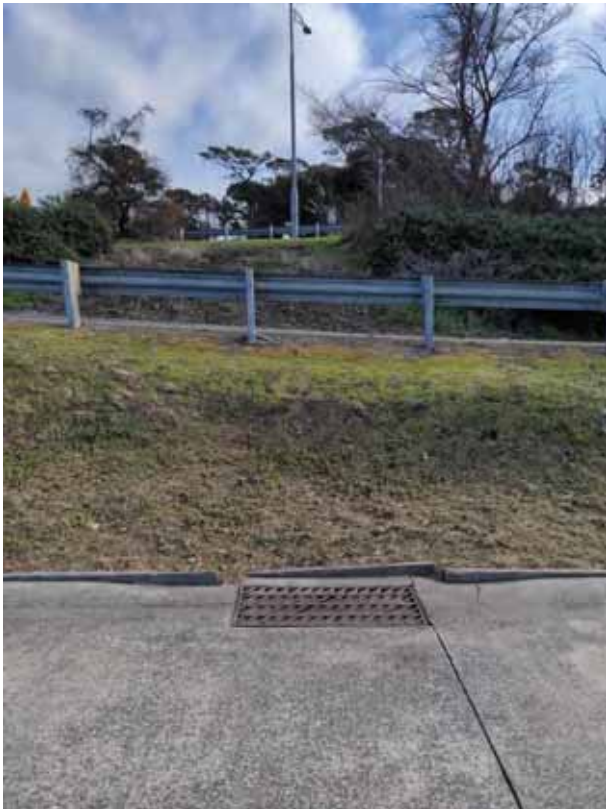
Photo Inlet

<b>During this inspection is there water in the culvert?</b>			cannot be determined
<b>Barrel flow</b>	cannot be determined	<b>Inlet flow</b>	
<b>Outlet flow</b>	cannot be determined		cannot be determined
<b>Outlet condition</b>	access difficult. condition difficult to assess. cannot find outlet,vegetation		
<b>Inlet condition</b>	grated pit appears to be clear of debris and in good condition. located on other side of gated shared path		
<b>Structure condition</b>	headwall or wingwall on outlet side is not visible from top of embankment.		
<b>Road surface condition</b>	Refer to rail track condition assessment provided separately		
<b>Batter condition</b>	Batters are flat for about 2-3 m approx. then steepens on the eastern side. batter on west side that is adjacent to the cycleway is flat.		
<b>What routine maintenance is required?</b>	access to outlet will need to be cleared for maintenance. culvert condition at outlet will need to be assessed

- Outlet will need to be determined, cleared, and marked for maintenance
- condition at joints throughout the length of the culvert will need to be assessed for erosion, seepage, etc.
- blockage will need to be cleared to ensure smooth flows and avoid flooding

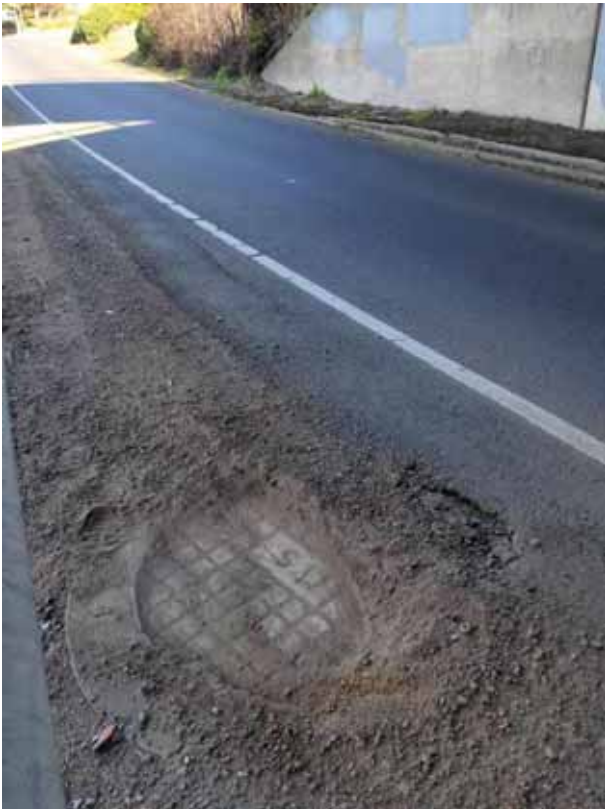
Photo Inlet

<b>During this inspection is there water in the culvert?</b>			cannot be determined
<b>Barrel flow</b>	cannot be determined	<b>Inlet flow</b>	
<b>Outlet flow</b>	100% blocked		cannot be determined
<b>Outlet condition</b>	cannot find outlet, no visible headwall, vegetation		
<b>Inlet condition</b>	Cannot lift manhole cover		
<b>Structure condition</b>	Manhole cover appears to be in good condition. Outlet covered by vegetation		
<b>Road surface condition</b>	Refer to rail track condition assessment provided separately		
<b>Batter condition</b>	Batters are flat for about 3-4 m approx. then steepens on the eastern side. batter on west side that is adjacent to the cycleway is flat		
<b>What routine maintenance is required?</b>	access to outlet will need to be cleared for maintenance. outlet condition to be rechecked.

- Outlet will need to be determined, cleared, and marked for maintenance
- condition at joints throughout the length of the culvert will need to be assessed for erosion, seepage, etc.
- blockage will need to be cleared to ensure smooth flows and avoid flooding

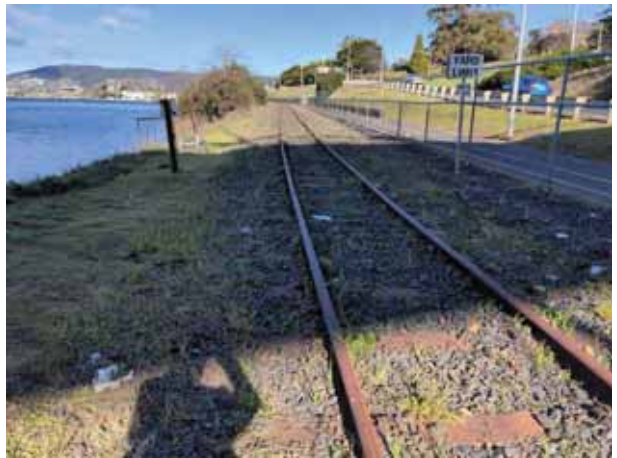
Photo Road

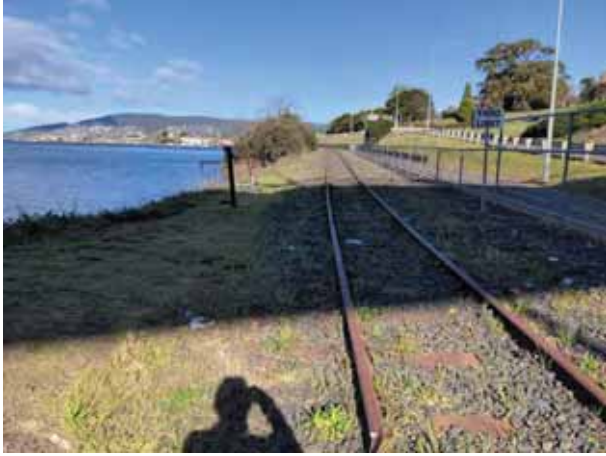
Photo Batter

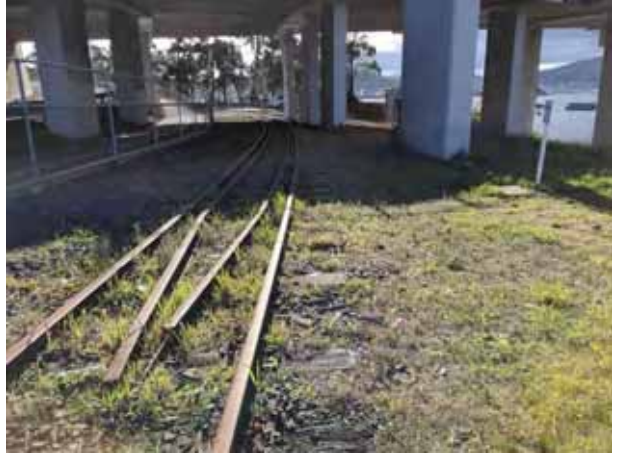
Photo Batter

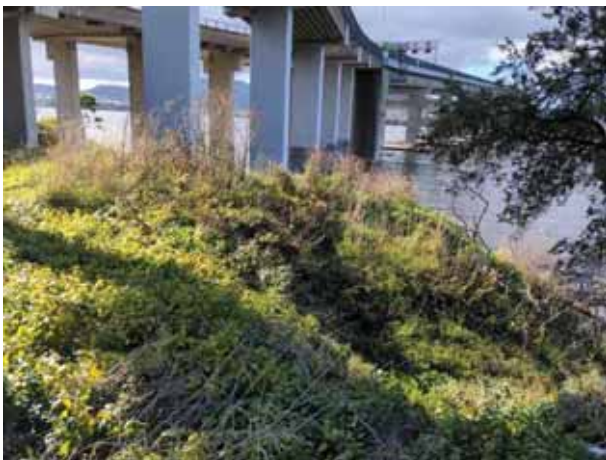
Photo Batter

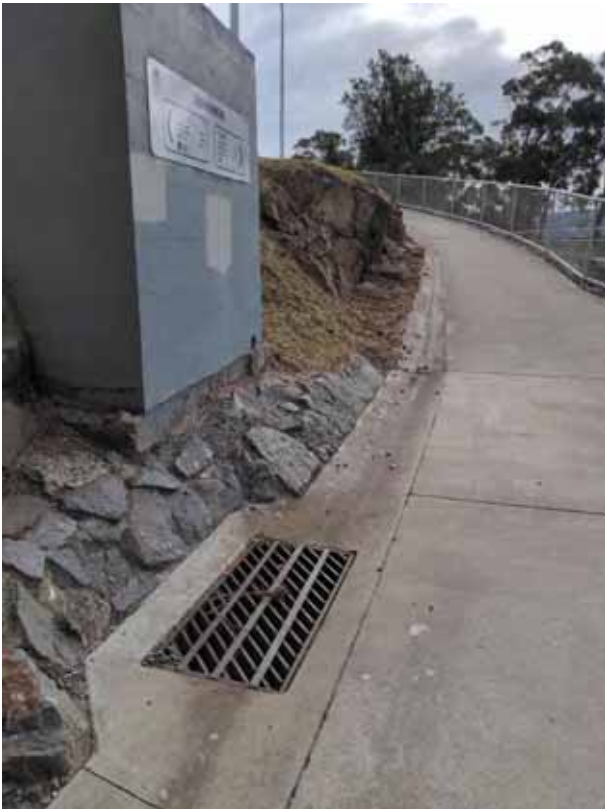
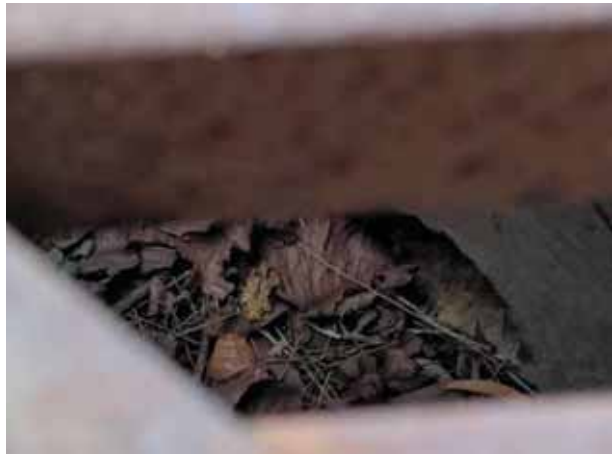
Photo Inlet

During this inspection is there water in the culvert?		No	
Barrel flow	75% blocked	Inlet flow	
Outlet flow	100% blocked		75% blocked
Outlet condition	cannot find outlet, no visible headwall, area covered with dirt		
Inlet condition	Inlet covered with dirt and dried leaves. Difficult to open pit.		
Structure condition	Inlet pit cover appears to be in good condition, no visible headwall at outlet.		
Road surface condition	<ul style="list-style-type: none"> <li>- Refer to rail track condition assessment provided separately.</li> <li>- bridge columns on the sides of the track.</li> <li>- Shared path crossing made of wood and concrete</li> </ul>		
Batter condition	batters are flat on either side.		
What routine maintenance is required?	outlet will need to be cleared and pipe checked for condition. outlet not found during site inspection

- further inspection may be required if pipe is being used.
- Area underneath Tasman bridge
- condition at joints will need to be assessed for erosion, seepage, etc.
- blockage will need to be cleared to ensure smooth flows and avoid flooding
- Outlet will need to be determined, cleared, and marked for maintenance

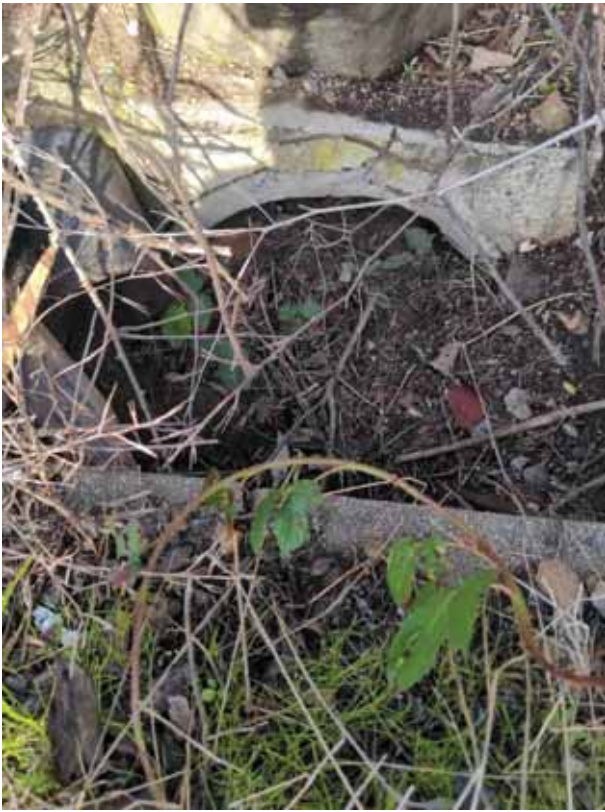
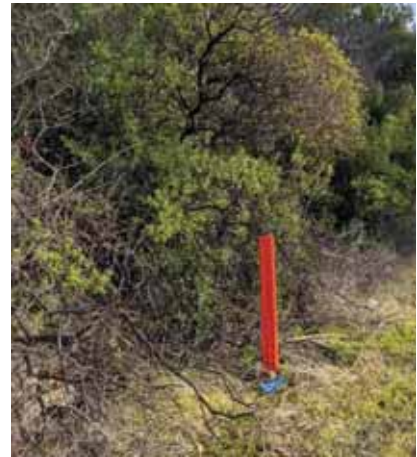
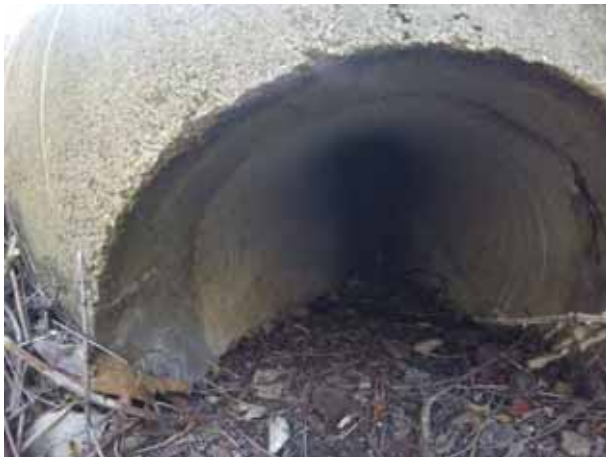
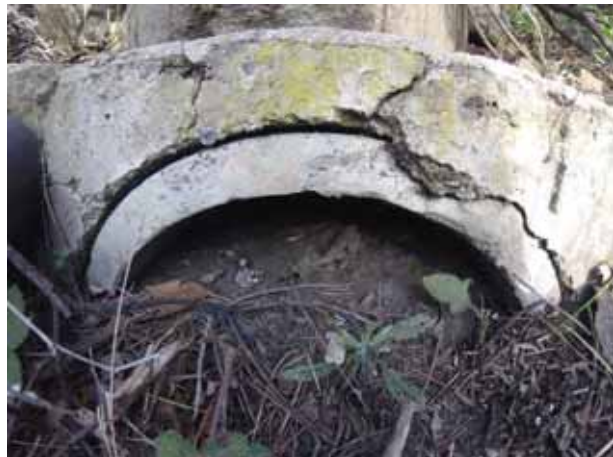
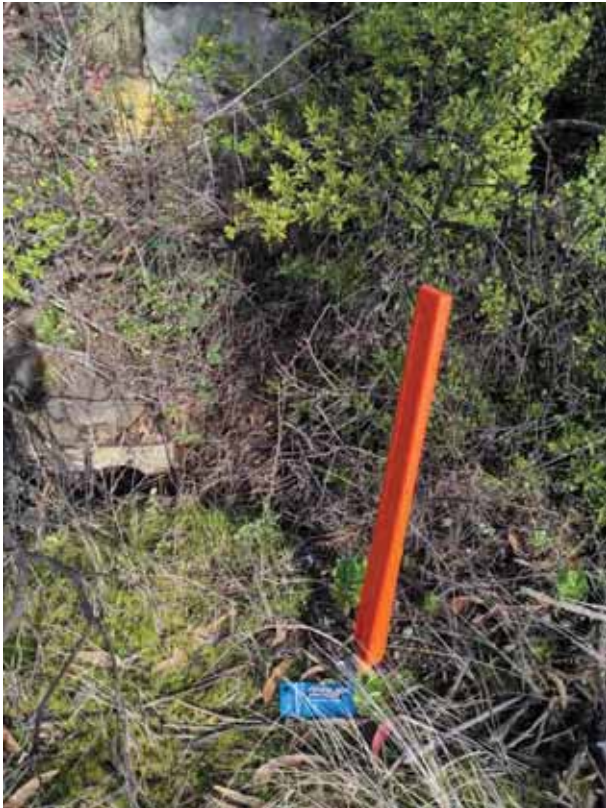
During this inspection is there water in the culvert?		No
Barrel flow	75% blocked	Inlet flow
Outlet flow	Clear	
Outlet condition	vegetation, difficult to access outlet to check condition. no headwall or wingwall visible	
Inlet condition	inlet marked by orange guide post. flow coming from another outlet pipe 400mm away that is 75percent blocked. no wingwall or headwall. area covered by dried tree branches, vegetation	
Structure condition	no headwall or wingwall at outlet. Inlet difficult to access due to vegetation	
Road surface condition	Refer to rail track condition assessment provided separately	
Batter condition	batter is flat on either side	
What routine maintenance is required?	inlet will need to be cleared of debris and vegetation. outlet and culvert condition will need to be checked. access will need to be cleared at outlet for maintenance

Photo Inlet – Upstream outlet 400mm from culvert inlet

- further inspection may be required if culvert is being used.
- condition at joints will need to be assessed for erosion, seepage, etc.
- blockage will need to be cleared to ensure smooth flows and avoid flooding
- Outlet will need to be determined, cleared, and marked for maintenance

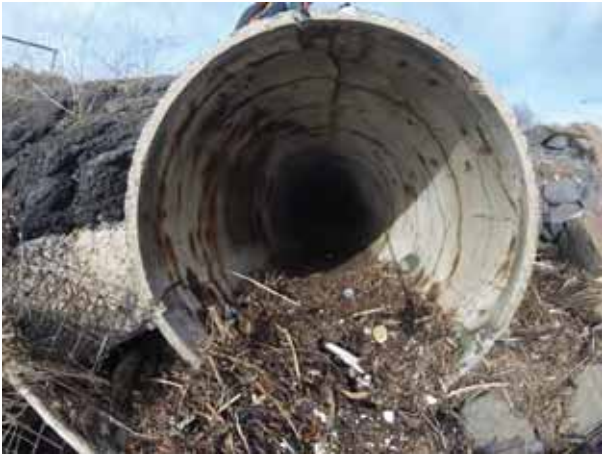
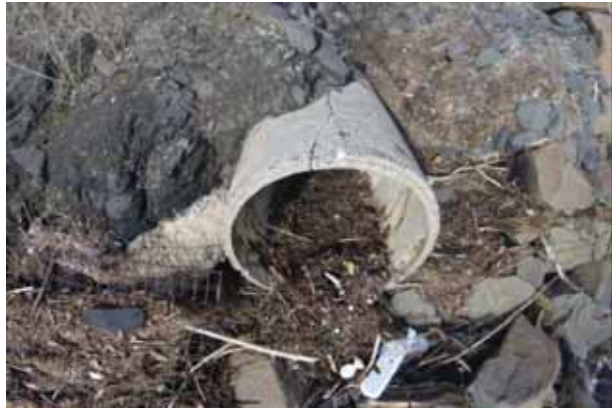
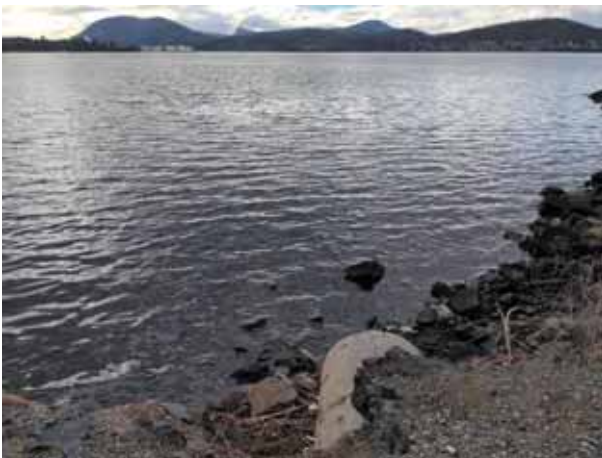
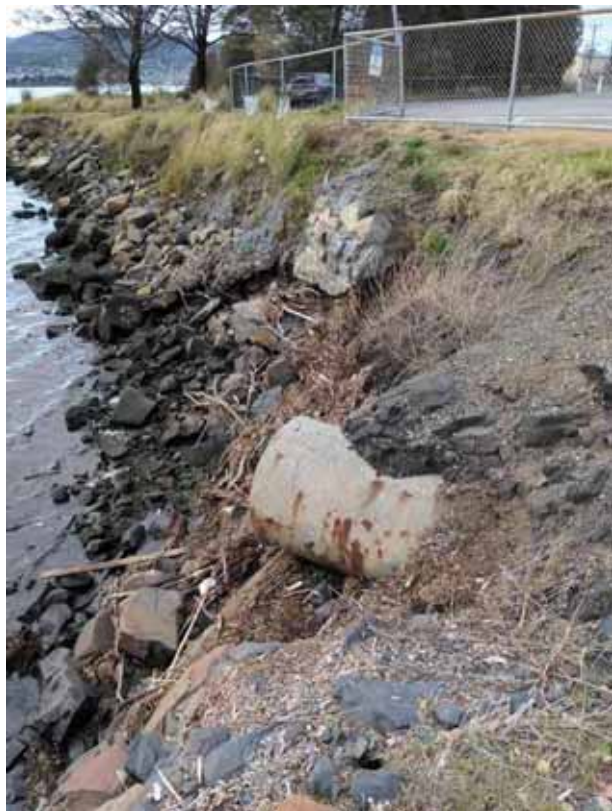
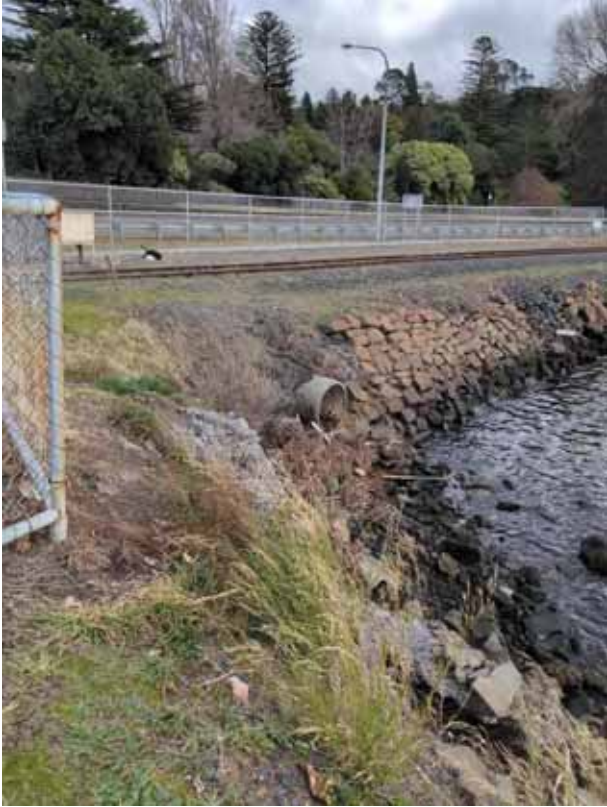
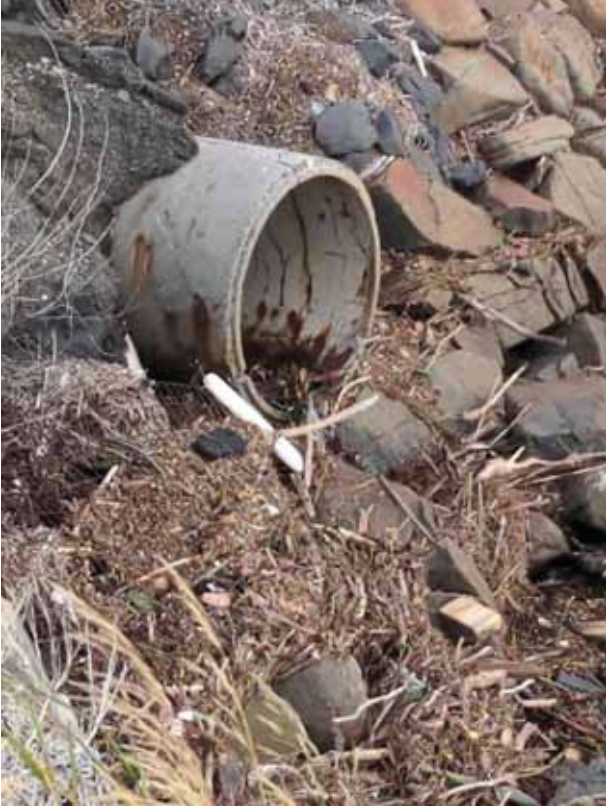
Photo Outlet

During this inspection is there water in the culvert?			No
Barrel flow	25% blocked	Inlet flow	
Outlet flow	25% blocked		Clear
Outlet condition	loose gravel leading to outlet, scouring, cracks and rusting evident inside the pipe, dirt and debris along the outlet,		
Inlet condition	inlet clear during time of inspection. Pit lid difficult to lift		
Structure condition	No headwall/wingwall at outlet. cracks and rusting are evident inside the pipe, loose rock armour		
Road surface condition	Refer to rail track condition assessment provided separately		
Batter condition	Batters are flat for about 3 m approx. then steepens on the eastern side. batter on west side that is adjacent to the cycleway is flat.		
What routine maintenance is required?	pipe condition underneath the track will need to be reassessed. clearing of debris on outlet side may be required. pipe support (i.e. headwall or wingwall) may be required, pipe may need to be replaced.

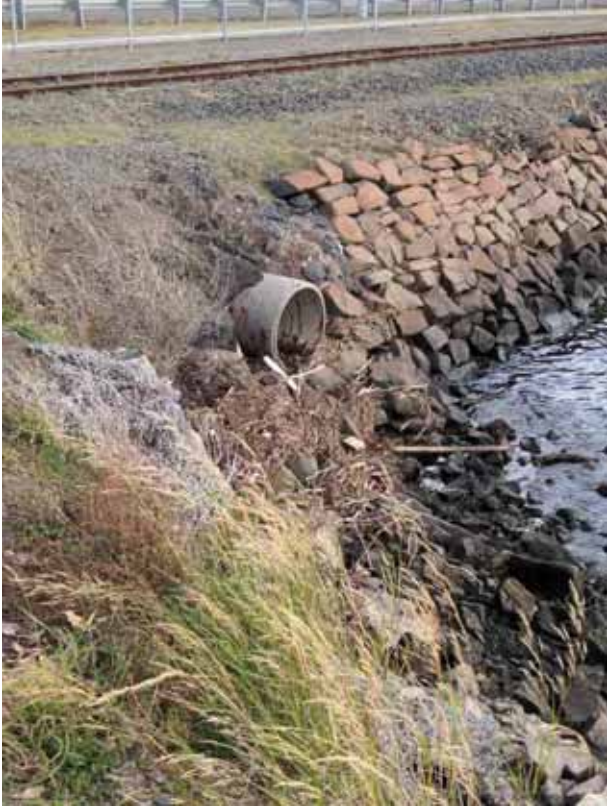
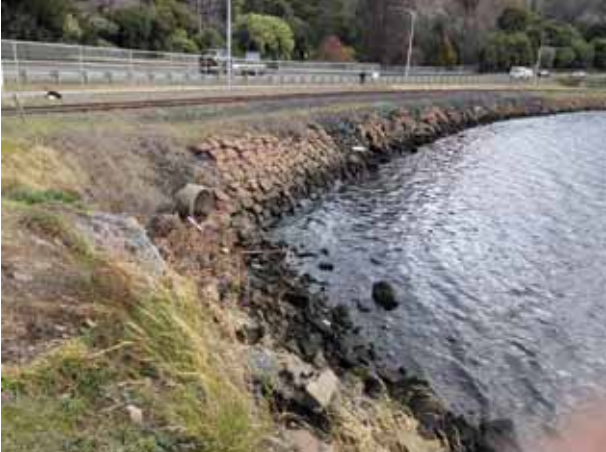
Photo Condition

Yes	Significant cracking and deformation of the internal walls
Yes	Evidence of corrosion of steel reinforcement (eg. exposed reinforcement, iron staining, leaching)
	Spalling or delamination of concrete
	Noticeable displacement or separation across joints (butt joints ≥ 20mm, spigot and socket joints ≥ 50mm)
	Evidence of groundwater entering into the pipe
	Evidence of water being lost out of joints or other defects in the pipe
	Evidence of erosion through joints (eg. seepage inflows carrying fines, soil accumulation at joints)
	Bowing of culvert
	Geometry change
Yes	Debris or vegetation inside culvert
	Acid sulfate soils and/or acid bearing rock

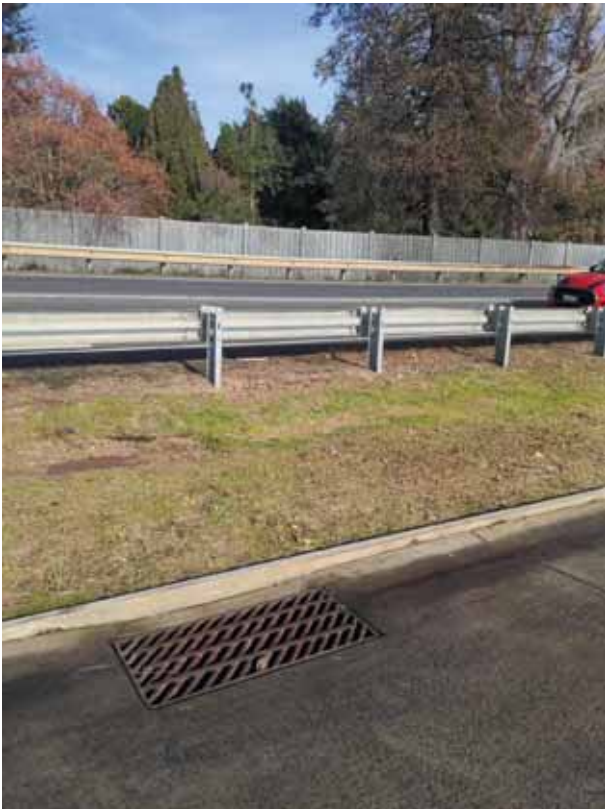
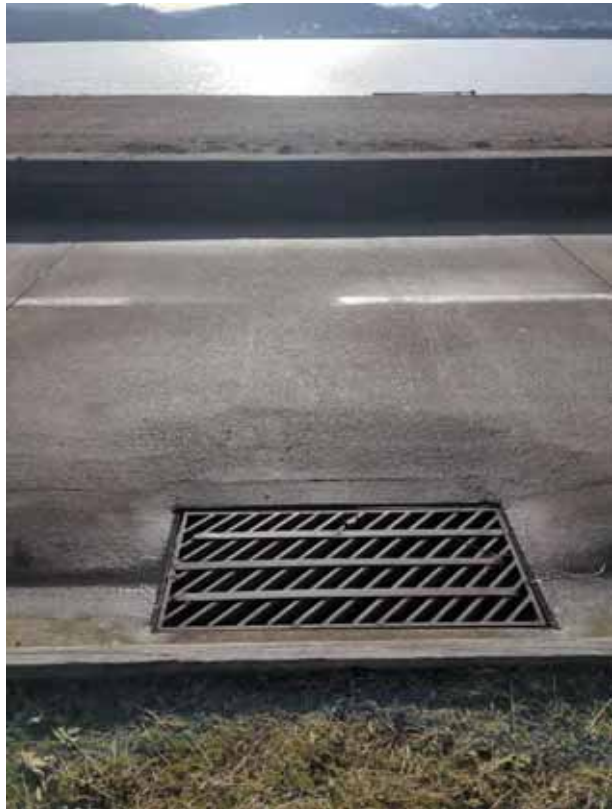
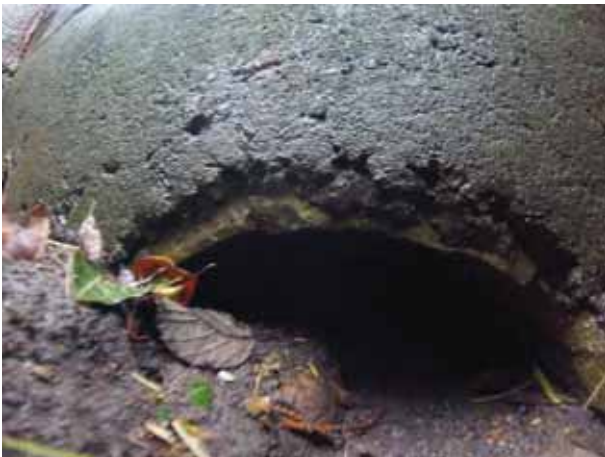
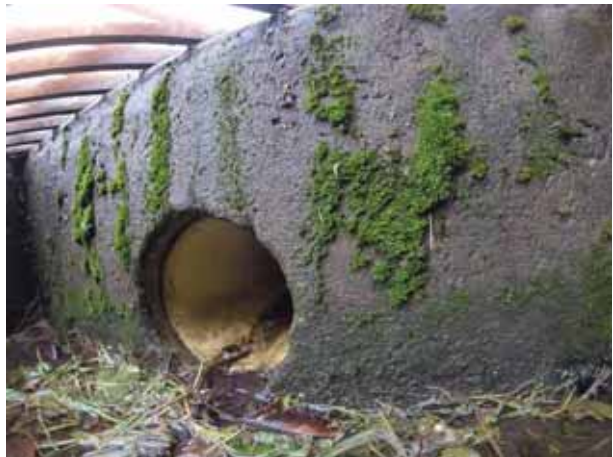
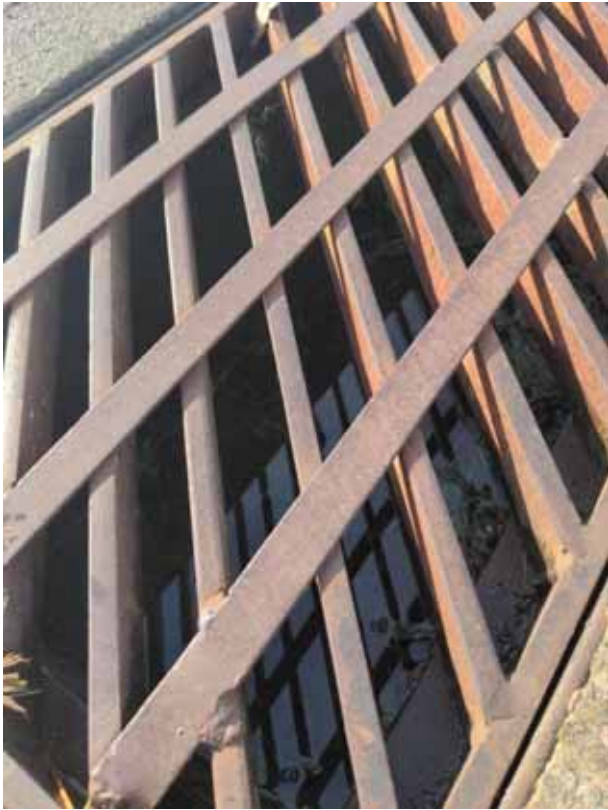
During this inspection is there water in the culvert?			Yes
Barrel flow	25% blocked	Inlet flow	
Outlet flow	Clear		100% blocked
Outlet condition	no headwall or wingwall. end of culvert damaged. Some rocks found inside the pipe		
Inlet condition	inlet pit covered with dirt. difficult to determine pipe condition on this end. inlet pit on the left side of the shared path. 100mm PVC pipe connected to the pit and coming from the upstream side of the inlet. difficult to lift pit cover		
Structure condition	No headwall/wingwalls, outlet pipe damage. Pipe outlet has cracks, chips and rusting, rock armour does not appear secure		
Road surface condition	Refer to rail track condition assessment provided separately		
Batter condition	Flat batter adjacent to the shared path. Batters are steep on the eastern side		
What routine maintenance is required?	pipe condition underneath the track will need to be reassessed. clearing of dirt and debris will be required. pipe support (i.e. headwall or wingwall) may be required, pipe may need to be replaced. inlet condition will need to be reassessed. Rock armour will need to be reconstructed

- condition at joints will need to be assessed for erosion, seepage, etc.
- blockage will need to be cleared to ensure smooth flows and avoid flooding
- consider replacing pipe
- reconstruct rock armour along the outlet side

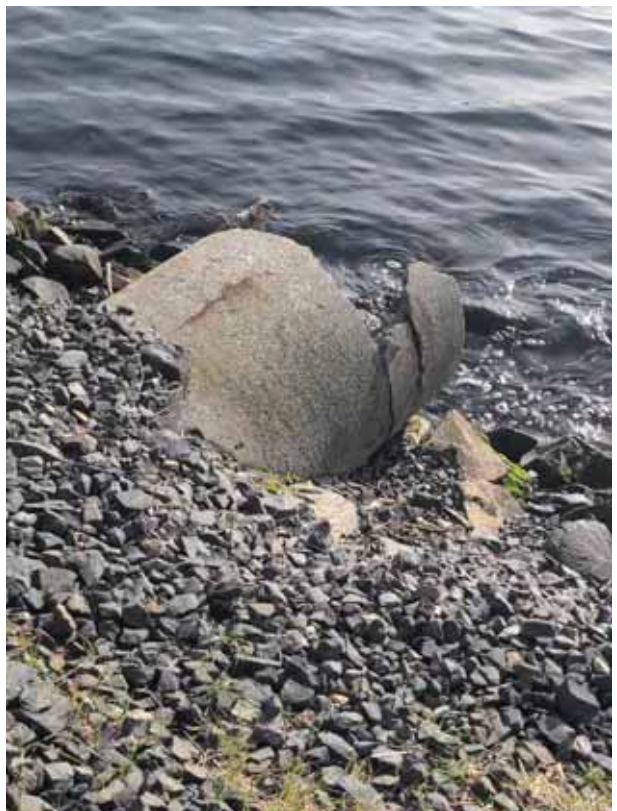
Photo Condition

Yes	Significant cracking and deformation of the internal walls
Yes	Evidence of corrosion of steel reinforcement (eg. exposed reinforcement, iron staining, leaching)
	Spalling or delamination of concrete
	Noticeable displacement or separation across joints (butt joints $\geq$ 20mm, spigot and socket joints $\geq$ 50mm)
	Evidence of groundwater entering into the pipe
	Evidence of water being lost out of joints or other defects in the pipe
	Evidence of erosion through joints (eg. seepage inflows carrying fines, soil accumulation at joints)
	Bowing of culvert
	Geometry change
Yes	Debris or vegetation inside culvert
	Acid sulfate soils and/or acid bearing rock

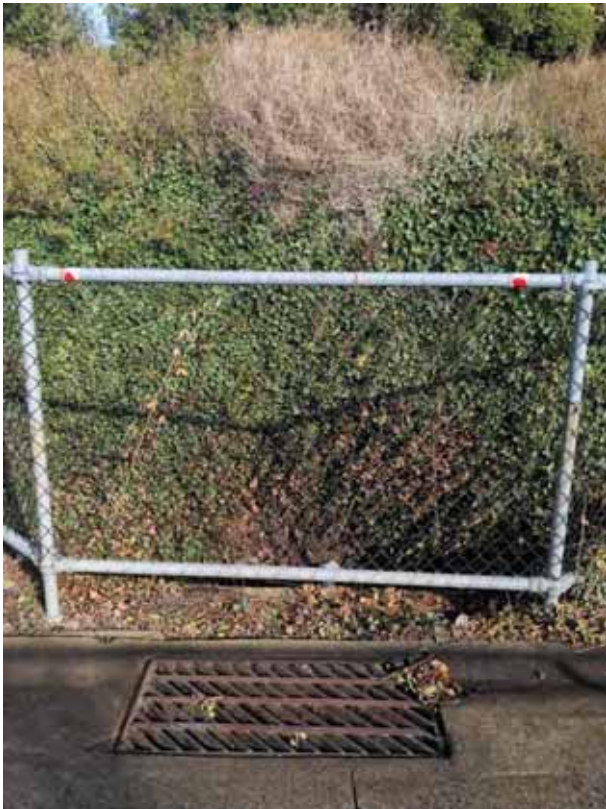
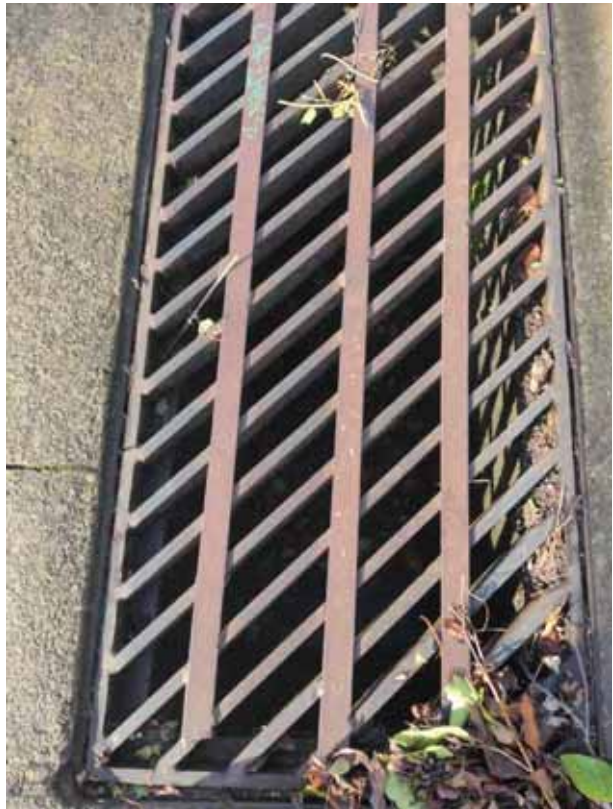
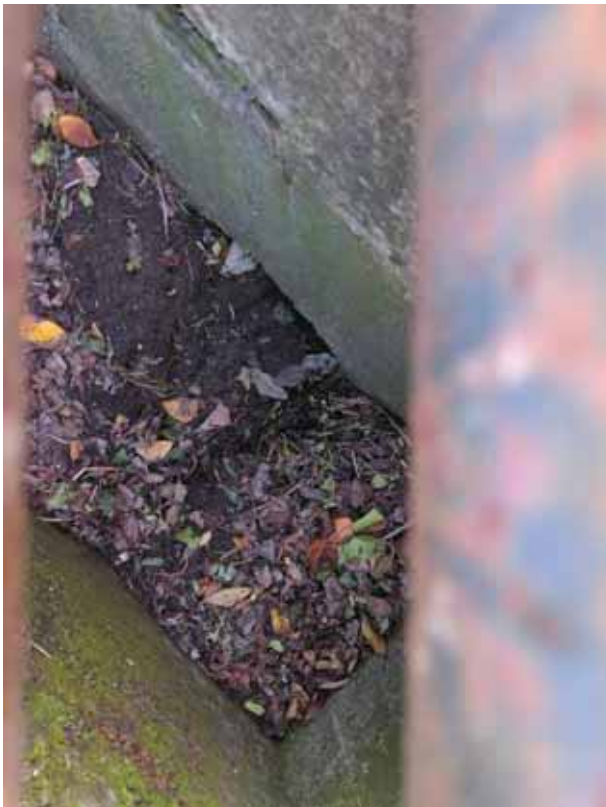
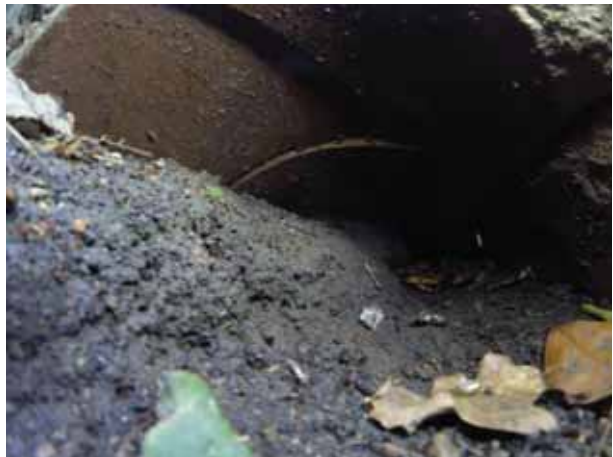
During this inspection is there water in the culvert?			No
Barrel flow	75% blocked	Inlet flow	
Outlet flow	100% blocked		75% blocked
Outlet condition	vegetation, outlet was not found due to vegetation and debris in the way		
Inlet condition	Vegetation and dirt covering pipe, scour, inlet pit filled with dirt		
Structure condition	cannot find headwall for outlet. covered by vegetation and debris. no evident flow path		
Road surface condition	Refer to rail track condition assessment provided separately		
Batter condition	Batters are flat for about 2 m approx. then steepens on the eastern side. batter on west side that is adjacent to the shared path is flat		
What routine maintenance is required?	outlet will need to be assessed. cannot determine location clearing of debris will be required. pipe support (i.e. headwall or wingwall) may be required, pipe may need to be replaced

- condition at joints will need to be assessed for erosion, seepage, etc.
- blockage will need to be cleared to ensure smooth flows and avoid flooding
- consider replacing pipe
- dirt on inlet side comes from steep road batter. Consider adding a rock armour along road batters.

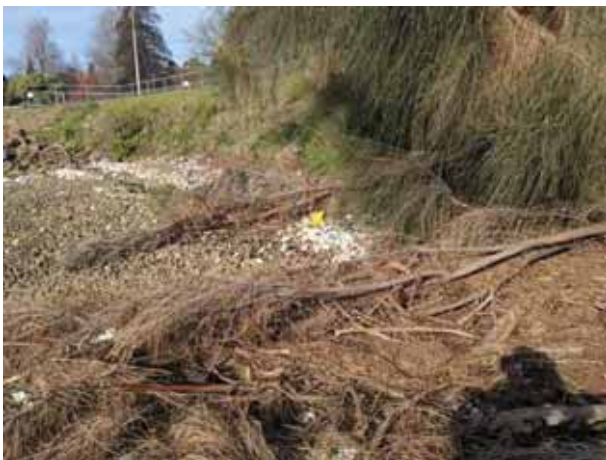
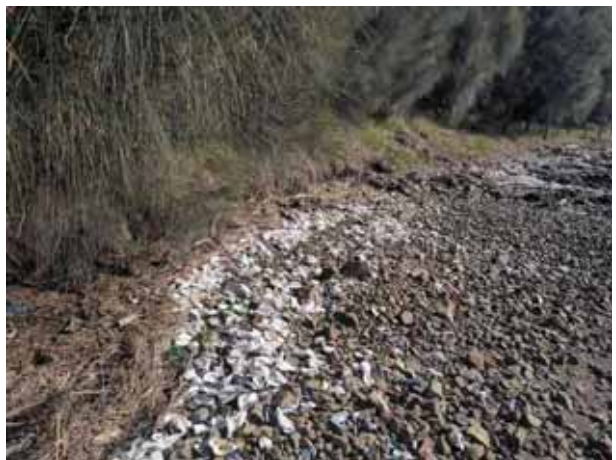
Significant cracking and deformation of the internal walls
	Evidence of corrosion of steel reinforcement (eg. exposed reinforcement, iron staining, leaching)
	Spalling or delamination of concrete
Yes	Noticeable displacement or separation across joints (butt joints ≥ 20mm, spigot and socket joints ≥ 50mm)
	Evidence of groundwater entering into the pipe
	Evidence of water being lost out of joints or other defects in the pipe
	Evidence of erosion through joints (eg. seepage inflows carrying fines, soil accumulation at joints)
Yes	Bowing of culvert
	Geometry change
Yes	Debris or vegetation inside culvert
	Acid sulfate soils and/or acid bearing rock

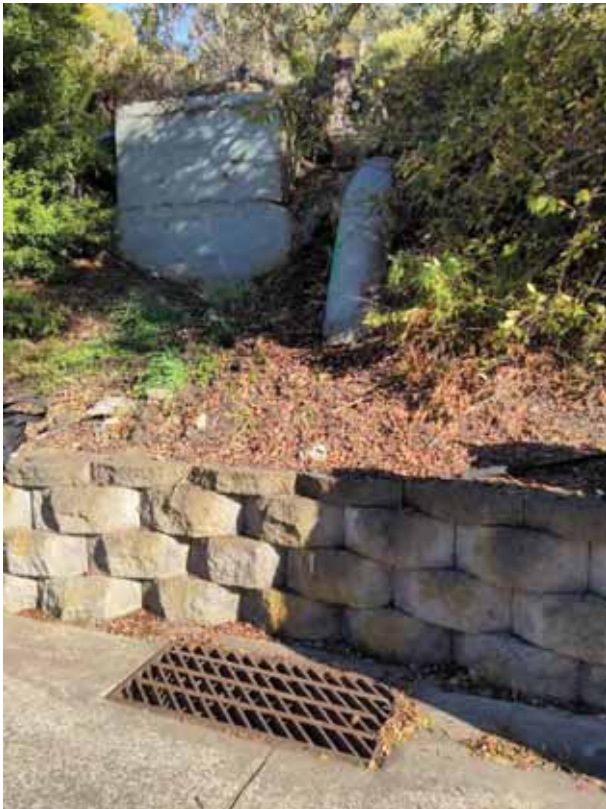
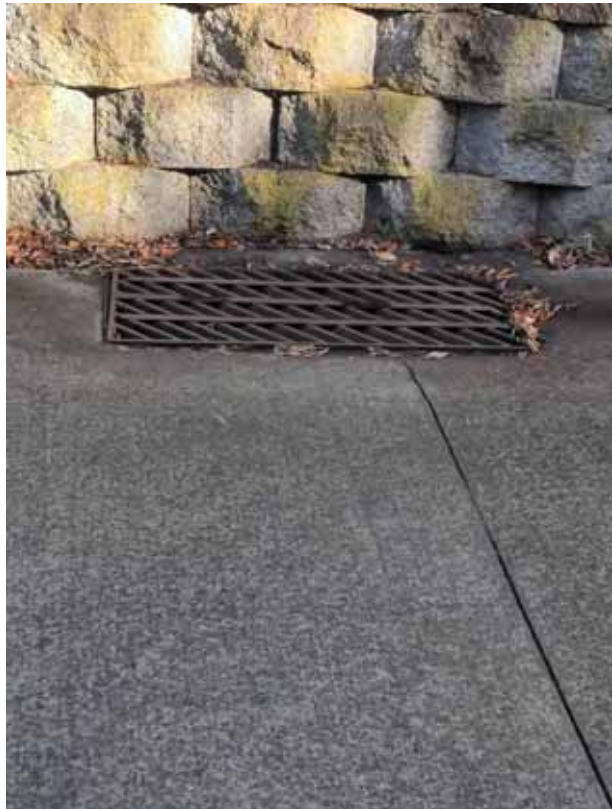
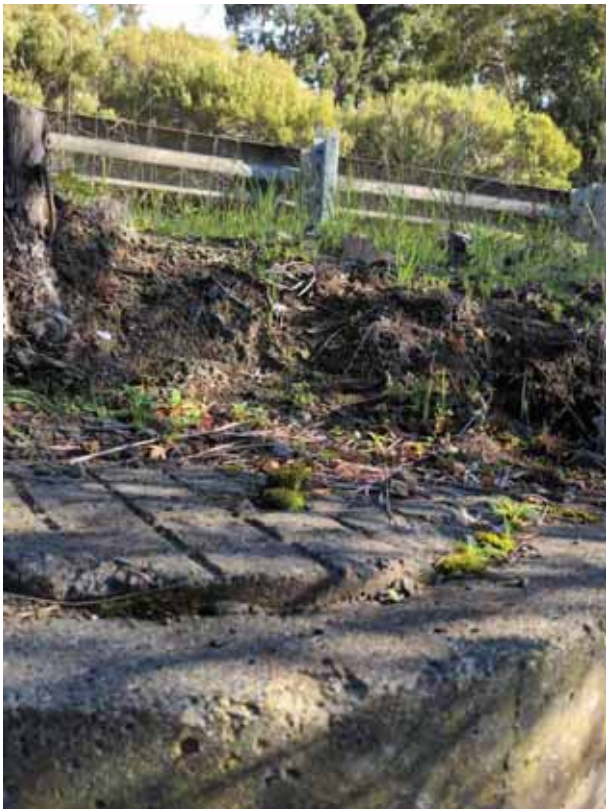
During this inspection is there water in the culvert?			cannot be determined
Barrel flow	cannot be determined	Inlet flow	
Outlet flow	cannot be determined		cannot be determined
Outlet condition	vegetation, cannot determine location of outlet		
Inlet condition	Pipe from grated pit appears to be connected to manhole / junction pit. Unable to lift manhole cover. Pipe will need to be checked		
Structure condition	grated pit appears to be in good condition. cannot find headwall or wingwall for outlet.		
Road surface condition	Refer to rail track condition assessment provided separately		
Batter condition	appears flat on either side. a number of trees on the eastern side towards the beach		
What routine maintenance is required?	pipe condition underneath the track will need to be reassessed. clearing of debris/vegetation on outlet side will be required. pipe support (i.e. headwall or wingwall) may be required.

- condition at joints will need to be assessed for erosion, seepage, etc.
- blockage will need to be cleared to ensure smooth flows and avoid flooding
- pipe and outlet condition will need to be assessed.

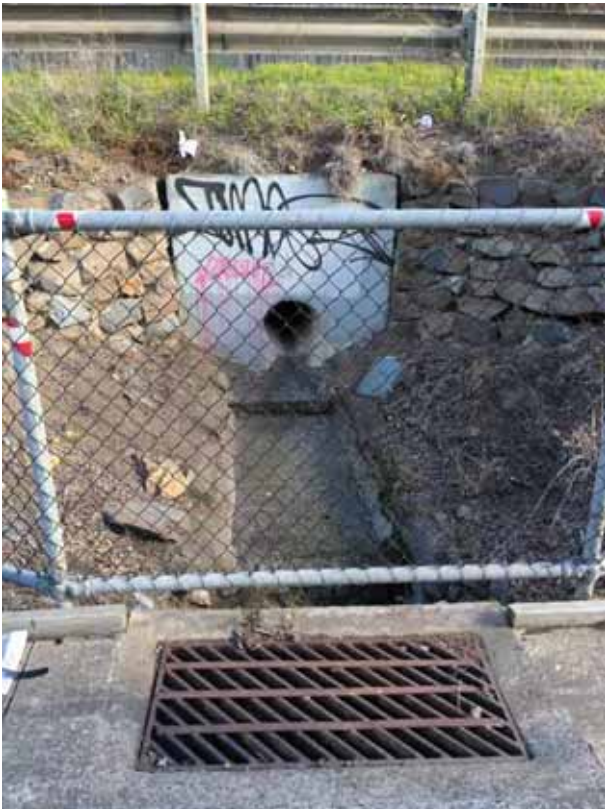
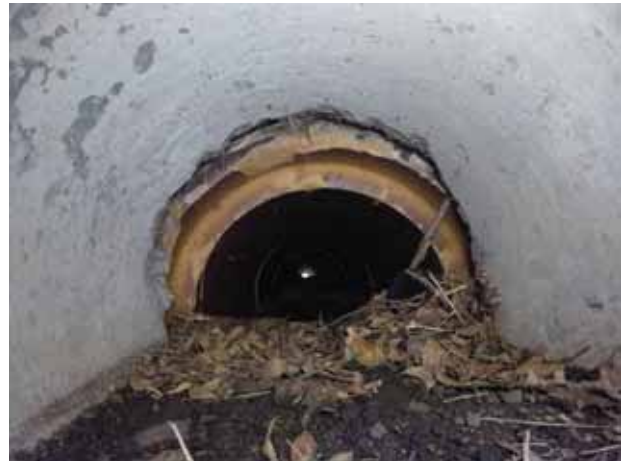
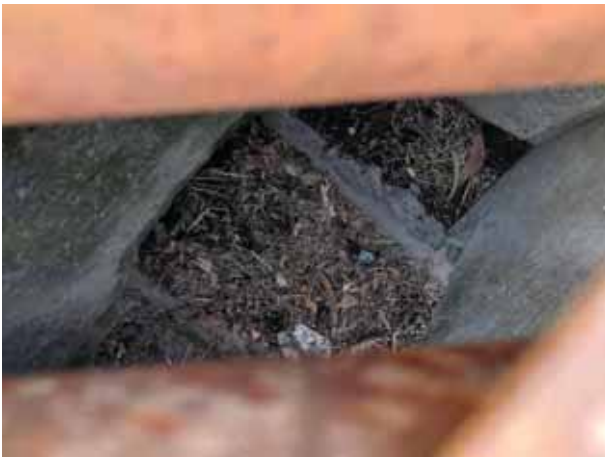
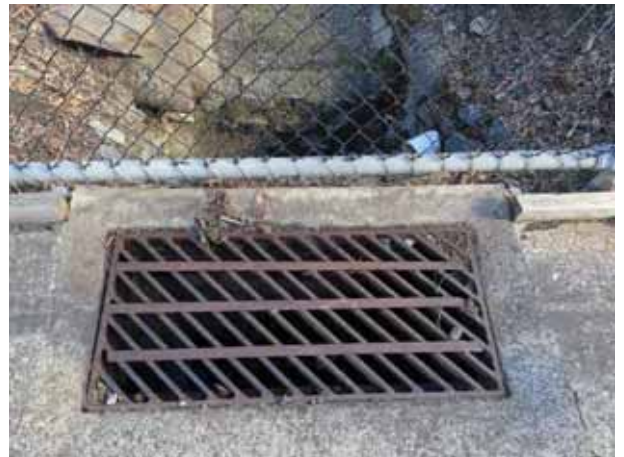
During this inspection is there water in the culvert?			No
Barrel flow	50% blocked	Inlet flow	
Outlet flow	50% blocked		50% blocked
Outlet condition	Tree and vegetation near the headwall. Outlet covered with dirt and debris		
Inlet condition	Inlet grated pit appears to be in good condition. Pit covered with dirt and debris.		
Structure condition	Inlet grated pit appears to be in good condition. Outlet headwall appears to be in good condition. Dirt and debris along the length of the culvert will need to be cleared.		
Road surface condition	Refer to rail track condition assessment provided separately		
Batter condition	flat on western side adjacent to the shared path. Batter steepens on eastern side		
What routine maintenance is required?	pipe condition underneath the track will need to be reassessed. clearing of dirt and debris on both ends will be required. RCP pipe appears to be connected to steel (?) pipe underneath the shared path. pipe may need to be replaced

- condition at joints will need to be assessed for erosion, seepage, etc.
- blockage will need to be cleared to ensure smooth flows and avoid flooding
- consider replacing pipe
- dirt on the inlet side appears to come from adjacent embankment material

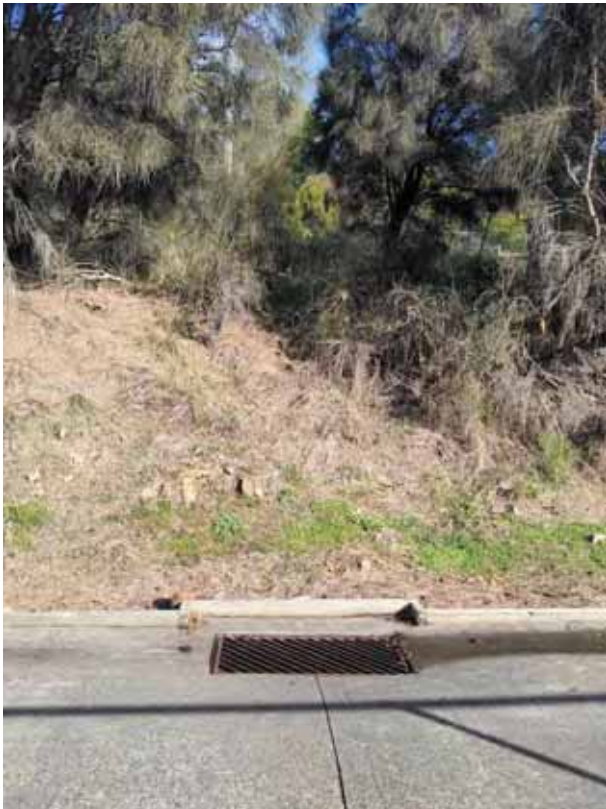
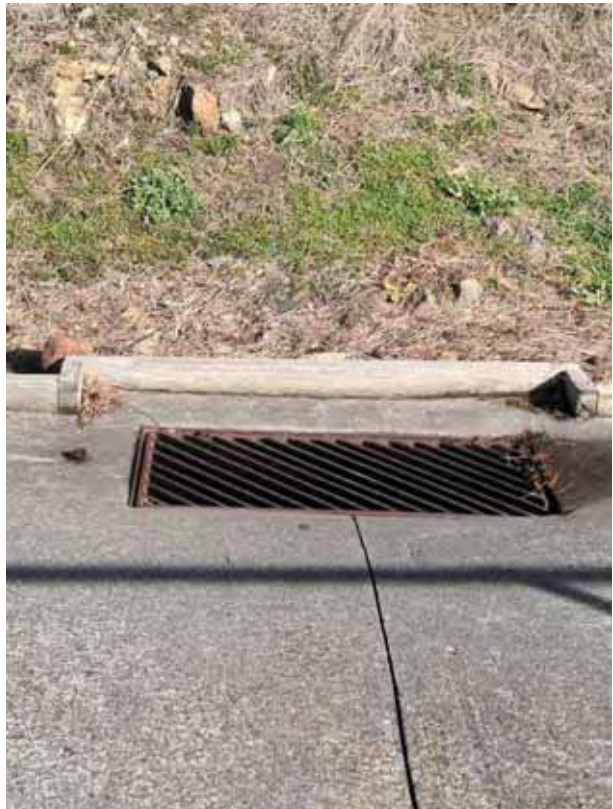
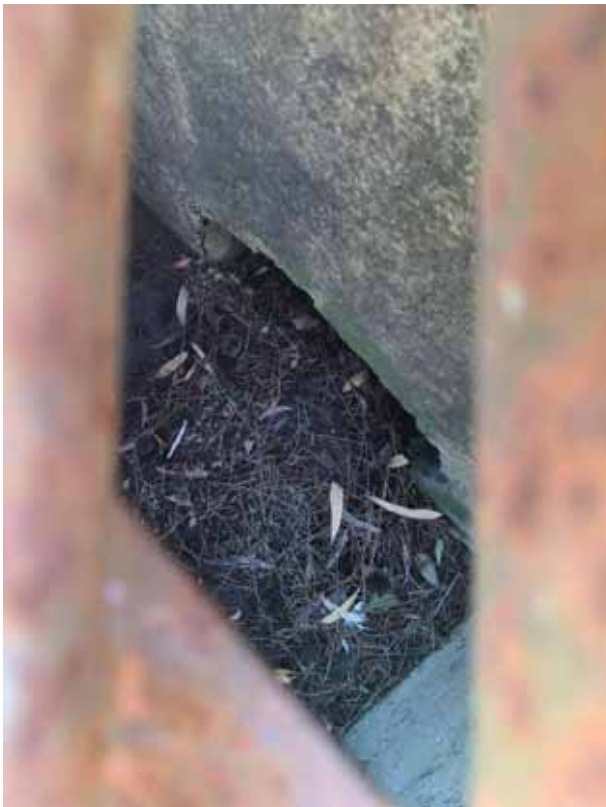
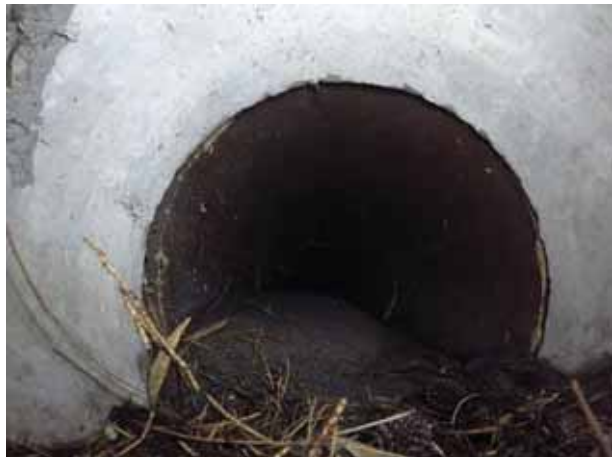
During this inspection is there water in the culvert?			No
Barrel flow	100% blocked	Inlet flow	
Outlet flow	100% blocked		25% blocked
Outlet condition	outlet covered with rocks/ballast material and vegetation. cannot see outlet pipe		
Inlet condition	pit cover appears to be in good condition. Pit invert covered with dried leaves and dirt		
Structure condition	No wingwalls at outlet. area covered with rock and vegetation		
Road surface condition	Refer to rail track condition assessment provided separately ack looks okay		
Batter condition	Batters are flat for about 3 m approx. then steepens on the eastern side towards the river. batter on west side that is adjacent to the shared path is flat.		
What routine maintenance is required?	pipe condition underneath the track will need to be reassessed. clearing of rock and vegetation on outlet side is required. clearing of rock dirt and dried leaved on inlet side is required. pipe support (i.e. wingwall) may be required, inlet condition will need to be assessed.

- condition at joints will need to be assessed for erosion, seepage, etc.
- blockage will need to be cleared to ensure smooth flows and avoid flooding
- consider adding wingwalls to limit rocks/dirt encroaching the outlet.
