**General Arrangement Plan Drawings –  
Culvert Location**

Size <b>A3</b>	Row <b>A</b>	
Client <b>DEPARTMENT OF STATE GROWTH</b>		Drawing Title <b>GENERAL ARRANGEMENT PLAN</b>	
Project <b>NSTC CONDITION ASSESSMENT</b>		Status <b>S2</b>	
Project No. <b>12548571</b>		Drawing No. <b>12548571-SK003</b>

Department of State Growth  
Northern Suburbs Transit Corridor -  
Condition Assessment

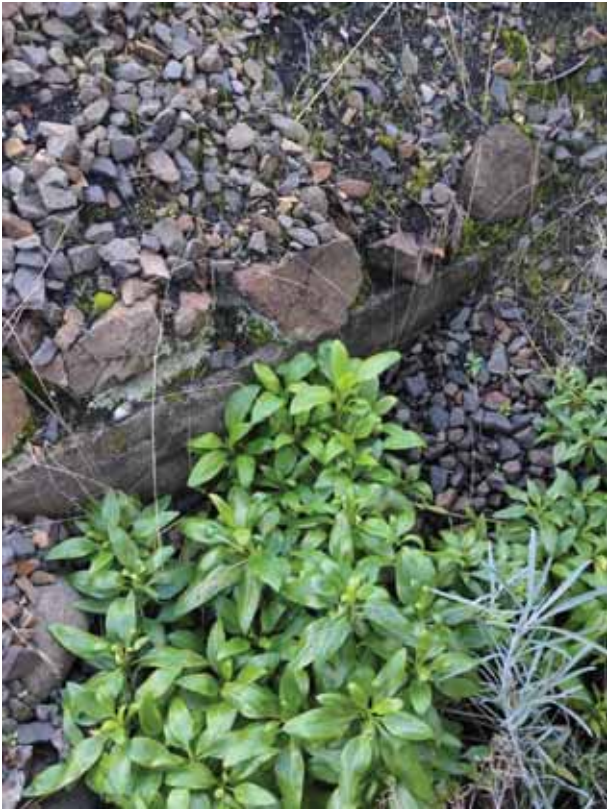
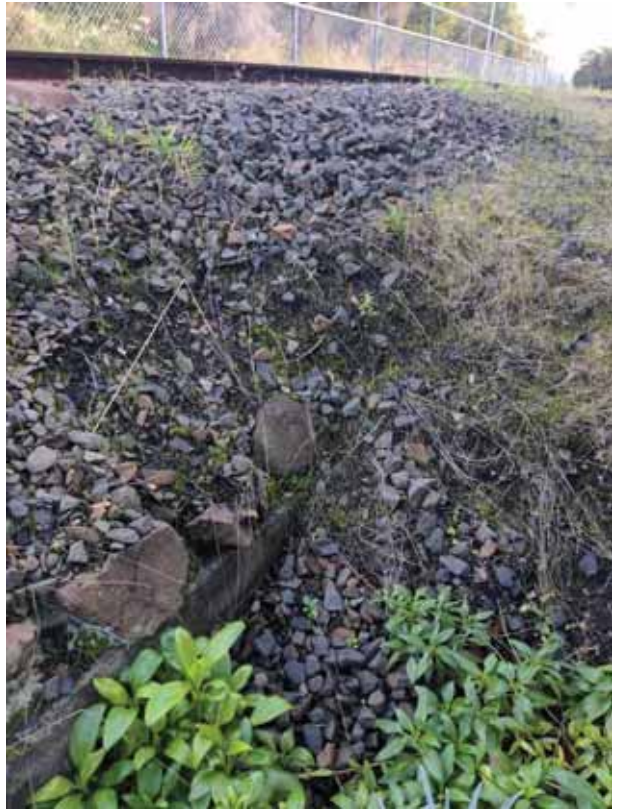
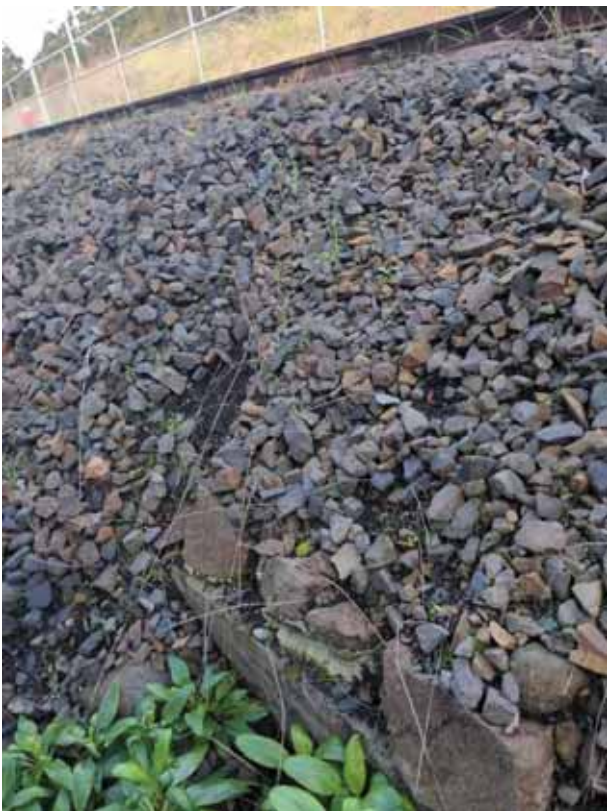
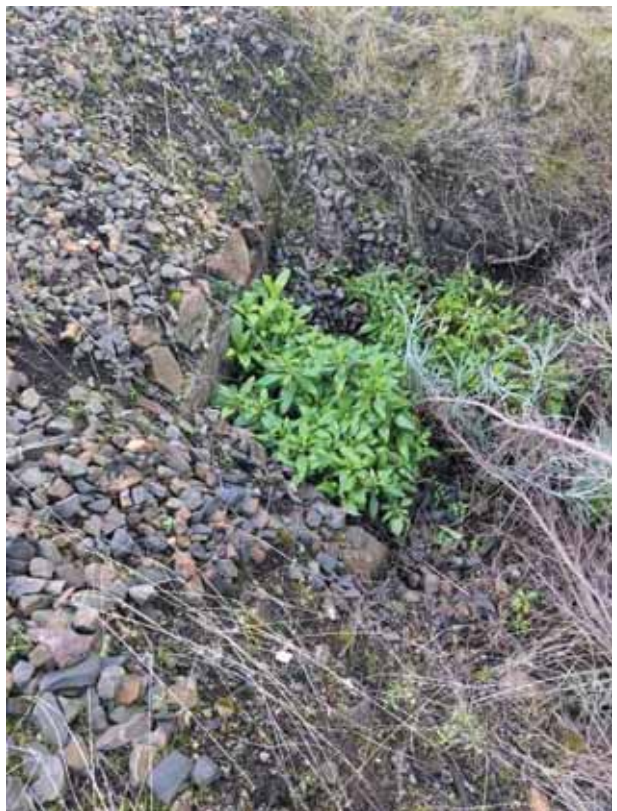
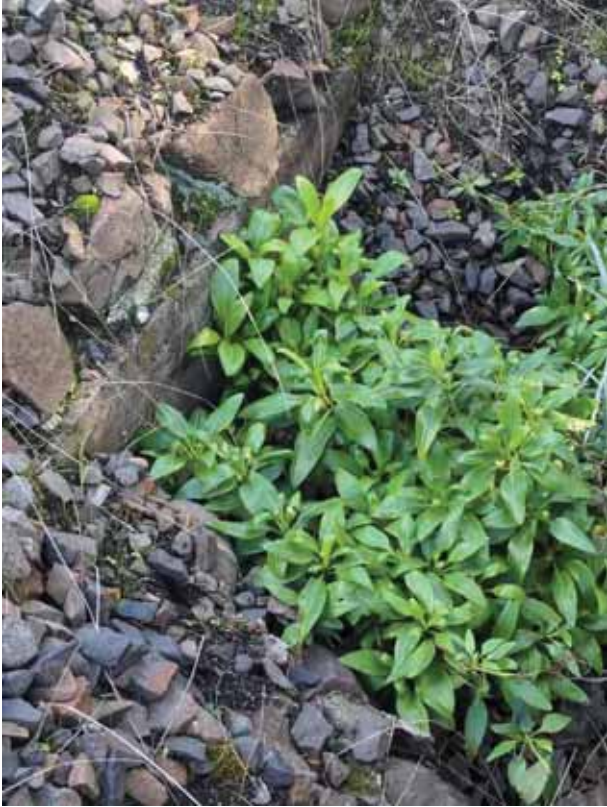
During this inspection is there water in the culvert?			No
Barrel flow	100% blocked	Inlet flow	
Outlet flow	100% blocked		25% blocked
Outlet condition	outlet covered with rocks/ballast material and vegetation. cannot see outlet pipe		
Inlet condition	pit cover appears to be in good condition. Pit invert covered with dried leaves and dirt		
Structure condition	No wingwalls at outlet. area covered with rock and vegetation		
Road surface condition	Refer to rail track condition assessment provided separately ack looks okay		
Batter condition	Batters are flat for about 3 m approx. then steepens on the eastern side towards the river. batter on west side that is adjacent to the shared path is flat.		
What routine maintenance is required?	pipe condition underneath the track will need to be reassessed. clearing of rock and vegetation on outlet side is required. clearing of rock dirt and dried leaved on inlet side is required. pipe support (i.e. wingwall) may be required, inlet condition will need to be assessed.

- condition at joints will need to be assessed for erosion, seepage, etc.
- blockage will need to be cleared to ensure smooth flows and avoid flooding
- consider adding wingwalls to limit rocks/dirt encroaching the outlet.

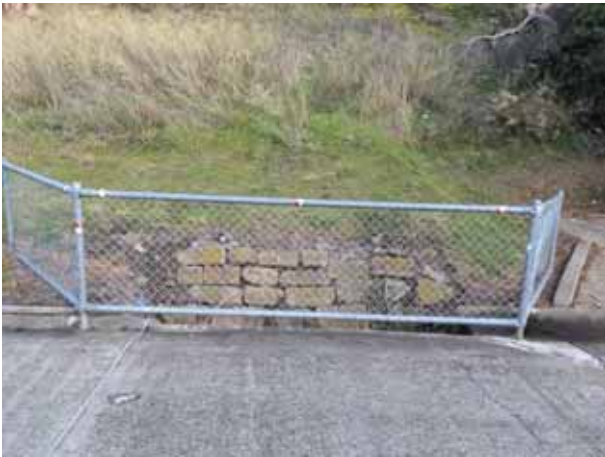
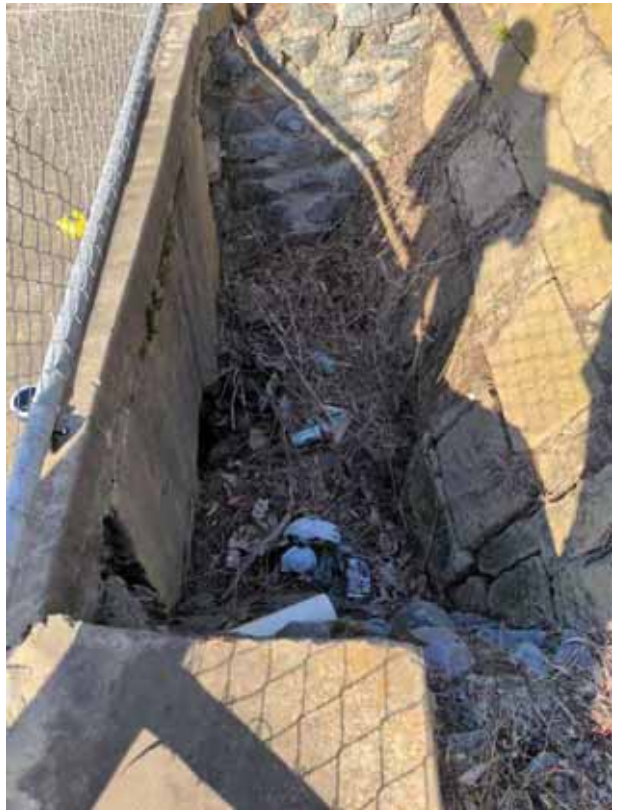
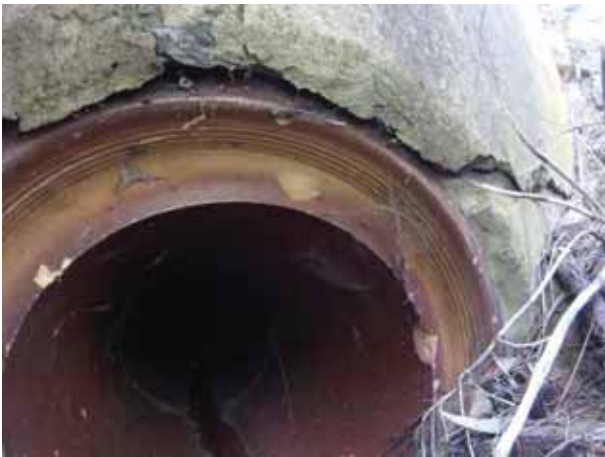
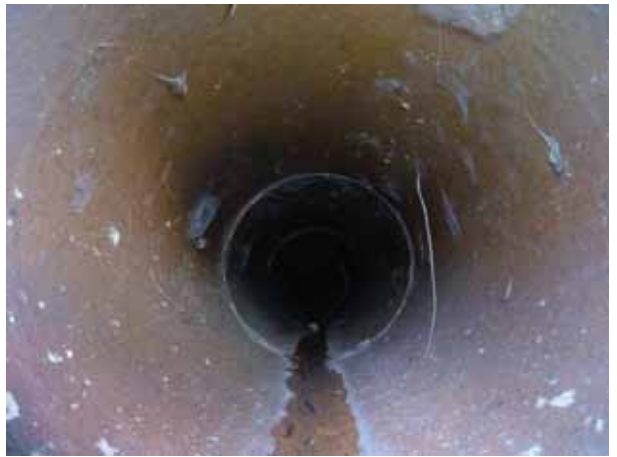
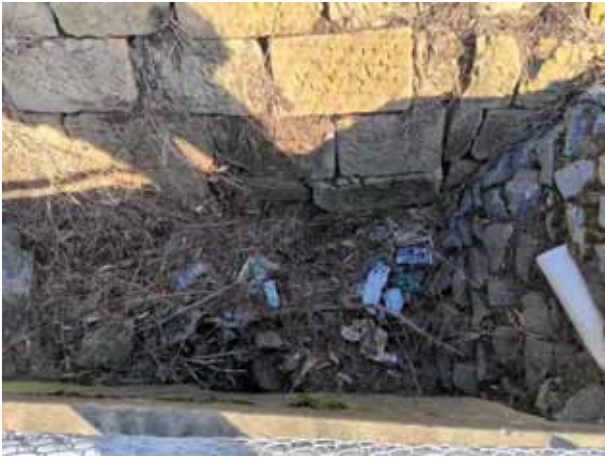
During this inspection is there water in the culvert?			No
Barrel flow	Clear	Inlet flow	
Outlet flow	100% blocked		25% blocked
Outlet condition	vegetation, cannot find outlet		
Inlet condition	Appears to be in good condition. Dirt and debris towards outlet will need to be cleared.		
Structure condition	No evidence of headwall/wingwall at outlet. Clear vegetation to determine location of outlet. Inlet structure appears to be in good condition.		
Road surface condition	Refer to rail track condition assessment provided separately		
Batter condition	flat on left side. steep on right side		
What routine maintenance is required?	outlet and pipe condition will need to be assessed. cannot find outlet, clear debris and vegetation on either side.

- condition at joints will need to be assessed for erosion, seepage, etc.
- blockage will need to be cleared to ensure smooth flows and avoid flooding
- consider replacing pipe
- pipe appears to be separated along the length of the culvert

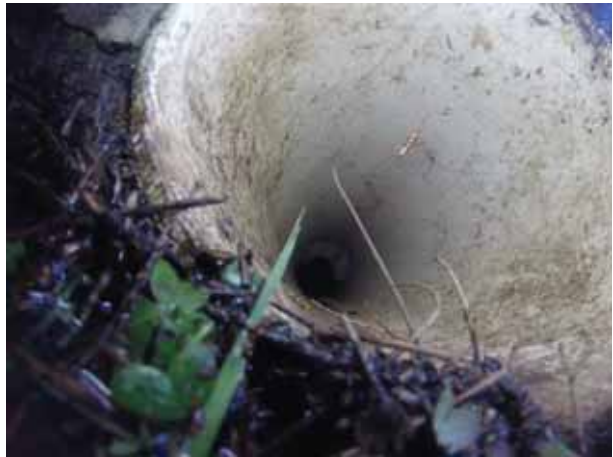
Photo Inlet

During this inspection is there water in the culvert?			No
Barrel flow	50% blocked	Inlet flow	
Outlet flow	50% blocked		clear
Outlet condition	Outlet will need to be cleared of debris and dirt		
Inlet condition	Pipe connection appears warped. Pit cover appears in good condition		
Structure condition	Ballast material encroaching outlet side		
Road surface condition	Refer to rail track condition assessment provided separately		
Batter condition	Flat on left side. steep on right side		
What routine maintenance is required?	it appears that the existing pipe was extended with a different pipe type when the shared path was constructed. clearing of debris/dirt/vegetation on either side is required. Pipe connection on inlet side will need to be replaced. Appears warped at connection

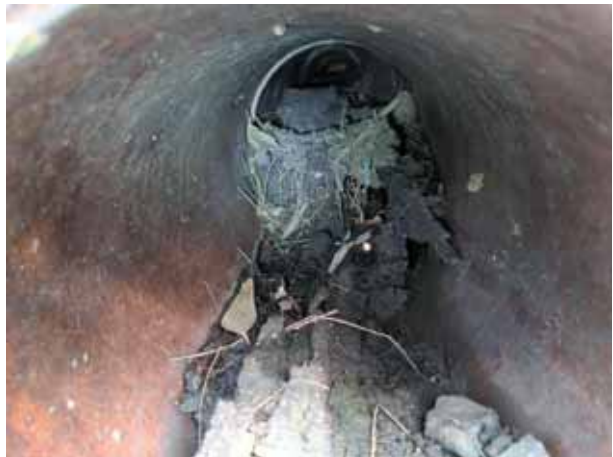
Photo Outlet

Pipe displacement at joints  
Vegetation, dried leaves, dirt will need to be cleared on the outlet side.  
Scouring at outlet side

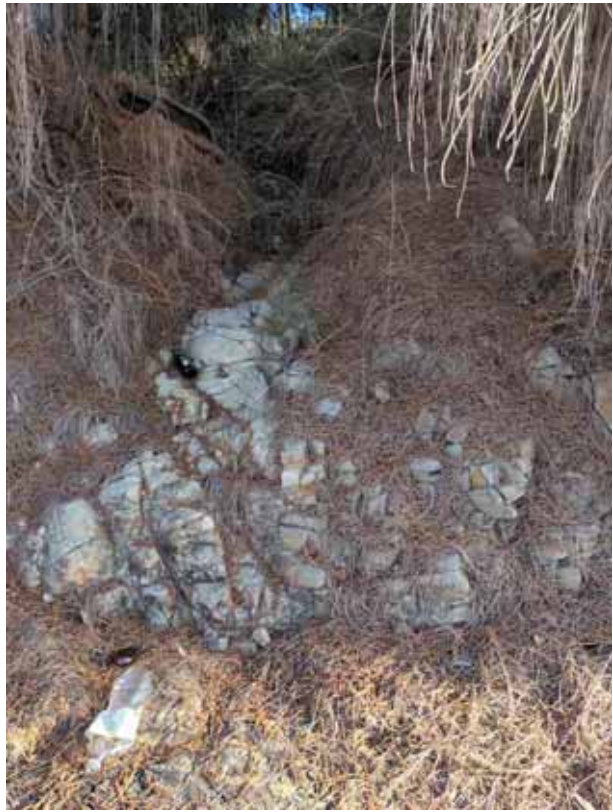
Photo Inlet

During this inspection is there water in the culvert?			No
Barrel flow	50% blocked	Inlet flow	
Outlet flow	50% blocked		50% blocked
Outlet condition	dirt and vegetation blocking right side outlet pipe. Vegetation along outlet path. Headwall in good condition		
Inlet condition	it appears the inlet is covered with dirt/dried leaves.		
Structure condition	Headwall/endwalls in good condition		
Road surface condition	Refer to rail track condition assessment provided separately		
Batter condition	Batters are flat for about 4 m approx. then steepens on the eastern side. batter on west side that is adjacent to the cycleway is flat.		
What routine maintenance is required?	clear outlet of dirt and vegetation it appears that the existing pipe was extended with a different pipe type when the shared path was constructed. clearing of debris/dirt/vegetation on either side is required.

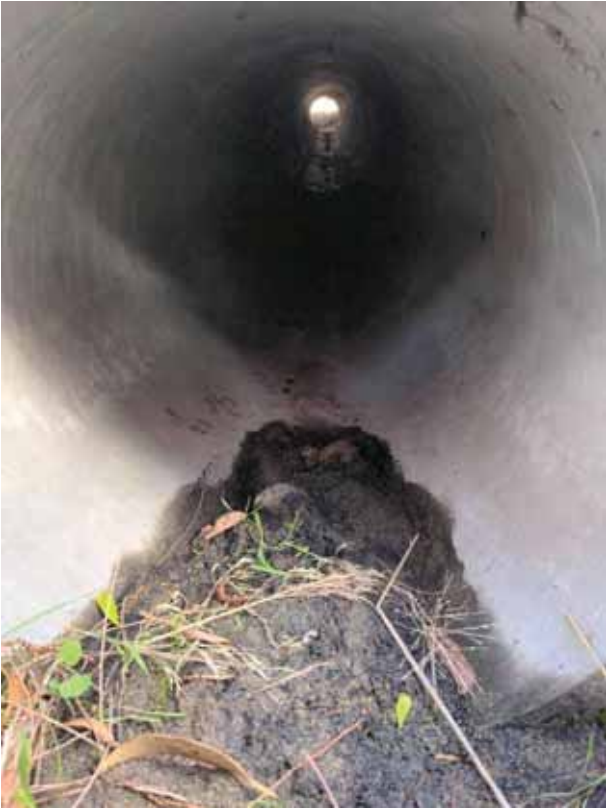
**Photo Outlet**

Pipe displacement where the different pipe types connect  
 Vegetation, dried leaves, dirt will need to be cleared on either side.  
 Rock outcrop appears to be secure

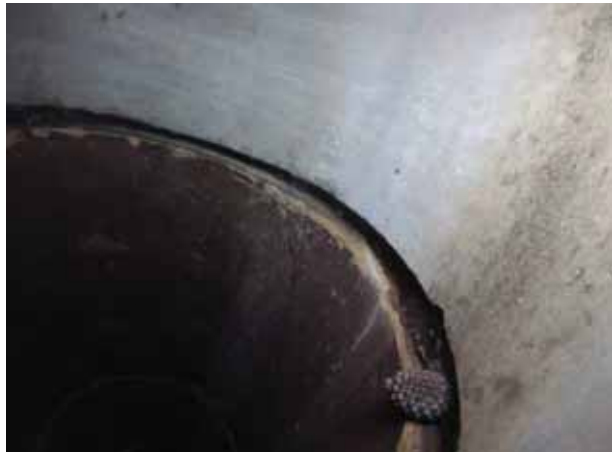
Photo Inlet

During this inspection is there water in the culvert?			No
Barrel flow	Clear	Inlet flow	
Outlet flow	25% blocked		Clear
Outlet condition	access via walking track parallel the rail track		
Inlet condition	2 materials RCP and AC (?)		
Structure condition	outlet covered with vegetation. crocodile cracks along footpath where outflow goes, wingwall_damage, headwall_damage		
Road surface condition	Refer to rail track condition assessment provided separately		
Batter condition	Flat on left side. steep on right side		
What routine maintenance is required?	it appears that the existing pipe was extended with a different pipe type when the shared path was constructed. clearing of debris/dirt/vegetation on either side is required

Pipe displacement where the different pipe types connect  
Vegetation, dried leaves, dirt will need to be cleared on either side.  
Scouring of rock armour surrounding the inlet

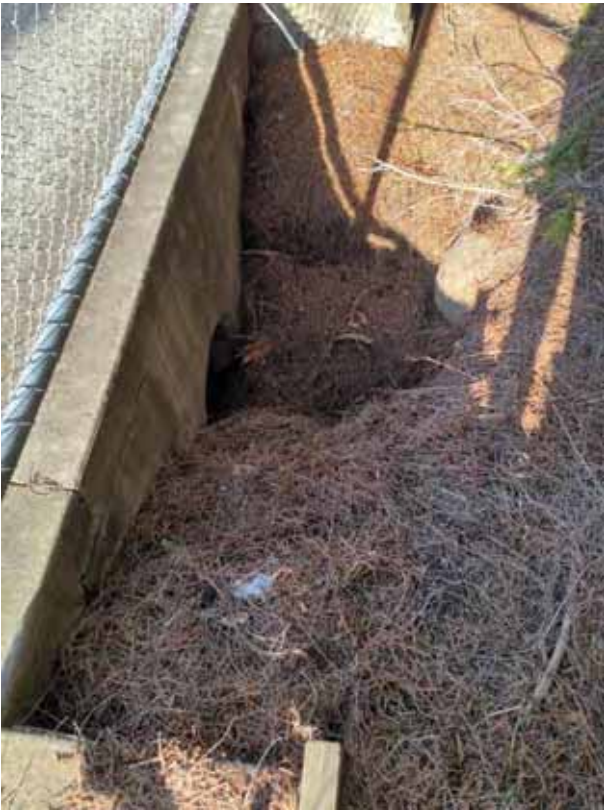
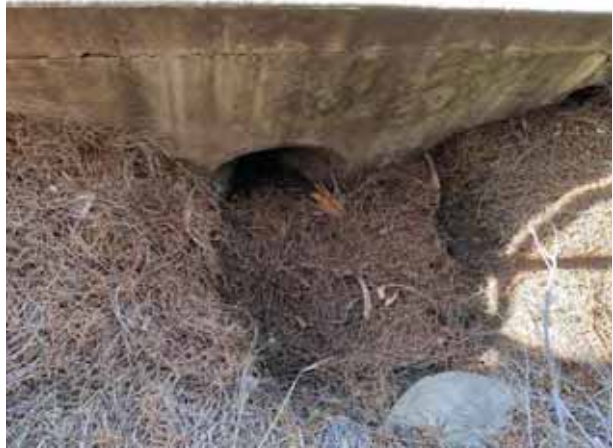
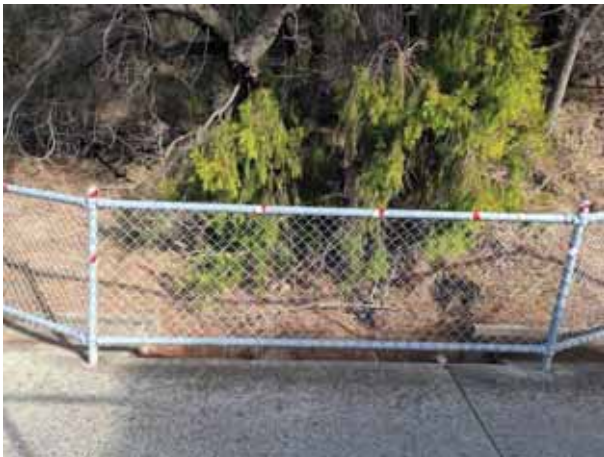
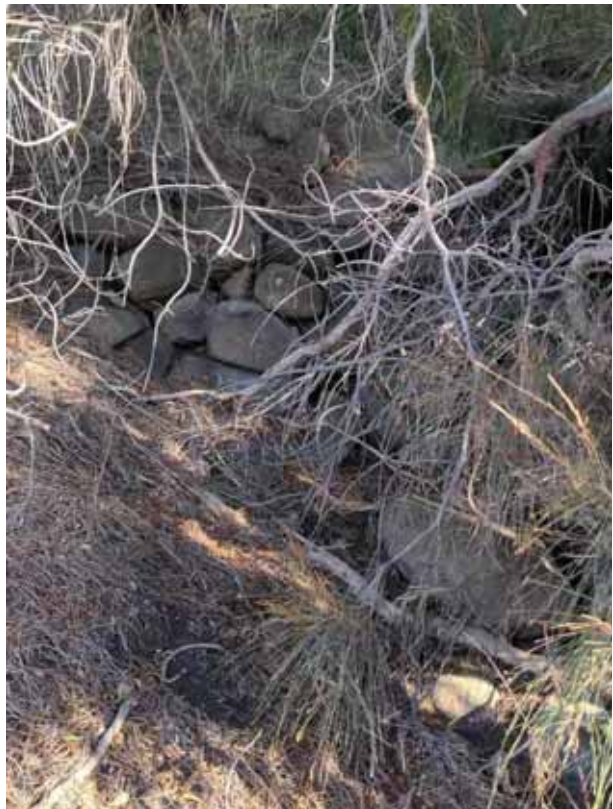
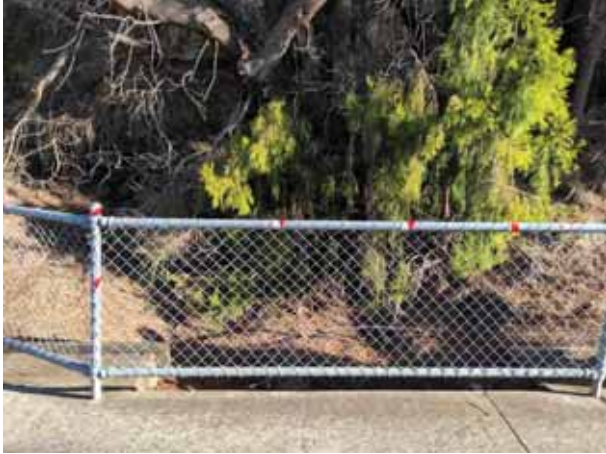
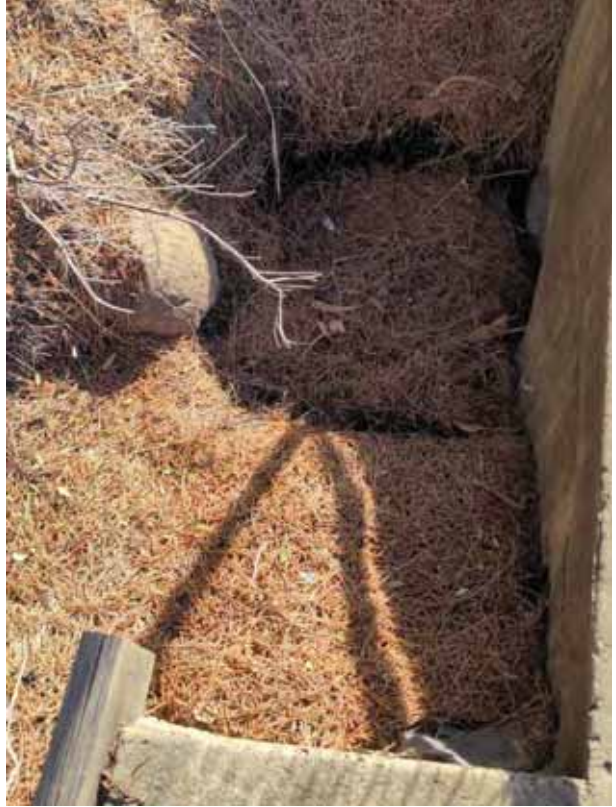
Pipe displacement where the different pipe types connect  
 Vegetation, dried leaves, dirt will need to be cleared on either side.  
 rock armour surrounding the inlet appear loose. May pose a risk during heavy rains.  
 Consider replacing culvert

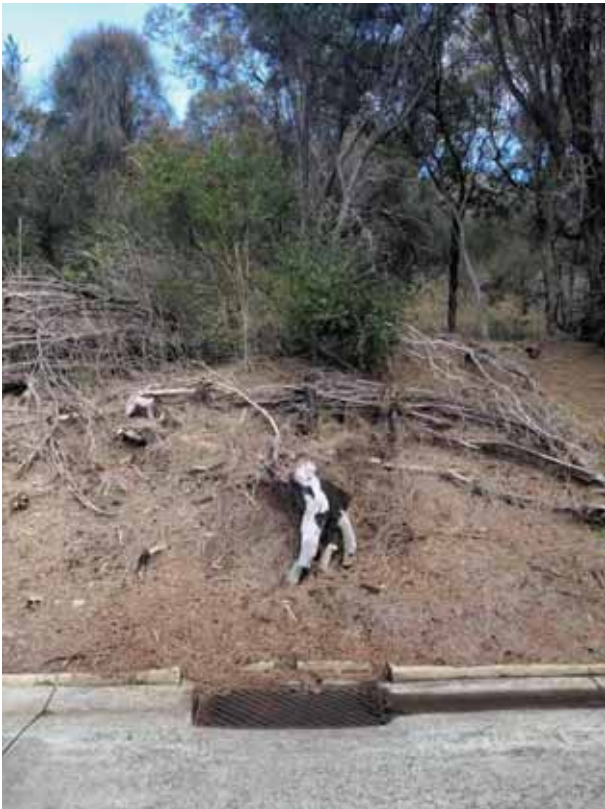
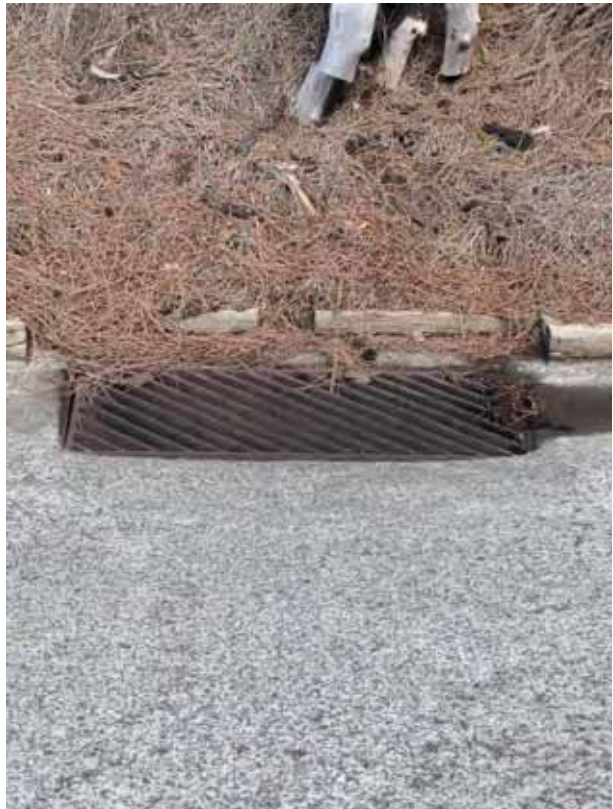
During this inspection is there water in the culvert?			Yes
Barrel flow	75% blocked	Inlet flow	
Outlet flow	75% blocked		75% blocked
Outlet condition	difficult to locate outlet. cess drain on right side appears to flow to an outlet, but cannot find outlet/headwall, vegetation		
Inlet condition	stagnant water at halfway level of pipe. possibly blocked at end		
Structure condition	cannot find outlet. outlet may be located under walking track and somewhere along existing boat sheds / road		
Road surface condition	Refer to rail track condition assessment provided separately		
Batter condition	flat on either side. Cess drain on the right side running parallel the track		
What routine maintenance is required?	culvert and outlet condition will need to be checked and cleared of obstructions/dirt. clear inlet side. check pipe blockage causing the stagnant water

Pipe condition will need to be checked.  
Vegetation, dried leaves, dirt will need to be cleared on either side.

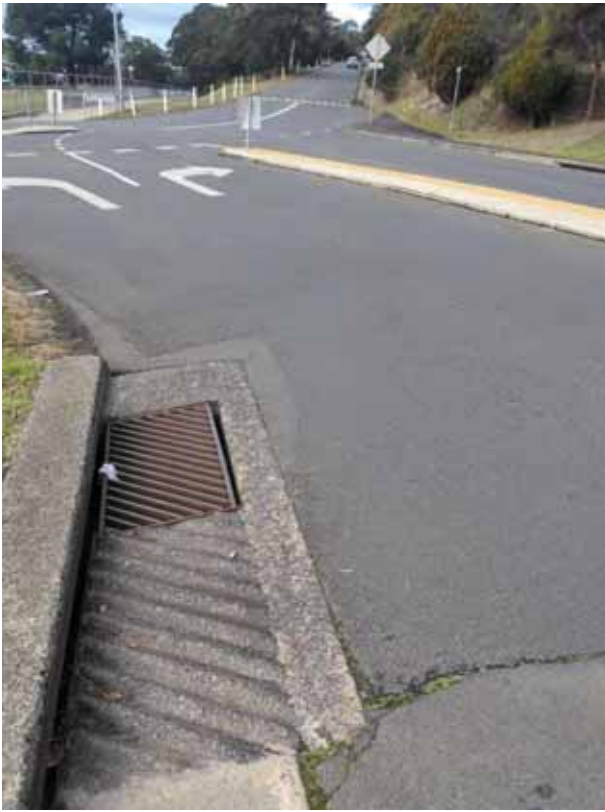
During this inspection is there water in the culvert?			No
Barrel flow	Clear	Inlet flow	
Outlet flow	Clear		50% blocked
Outlet condition	vegetation in the way of outflow. length only taken from closest pit to outlet, vegetation		
Inlet condition	Side entry pit filled with dried leaves and debris. part of catchment comes from pipe along Domain Highway. pit connected to junction pit		
Structure condition	Pit covers appear to be in good condition apart from requirement for clearing of debris. top part of outlet headwall has a crack, pipe_box_damage		
Road surface condition	Refer to rail track condition assessment provided separately		
Batter condition	flat either side		
What routine maintenance is required?	Side entry pit inlet will need to be cleared of dried leaves and debris. outlet will need to be cleared of vegetation. no wingwall or headwall, thus dirt from sides encroaches the outlet path

Pipe condition underneath the road will need to be checked.  
Vegetation, dried leaves, dirt will need to be cleared on either side.

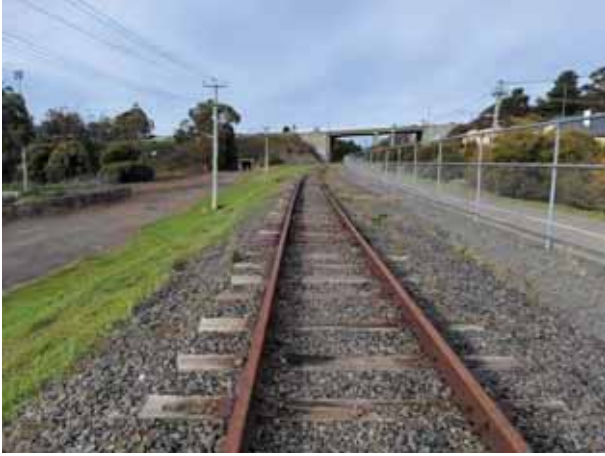
Photo Road

<input type="checkbox"/>	Subsidence in the road
<input type="checkbox"/>	Significant patching of the road above the culvert
<input checked="" type="checkbox"/>	Significant cracking or deformation of the road above the culvert
<input type="checkbox"/>	Holes or cavities in the road fill around the inlet or outlet or above the culvert
<input type="checkbox"/>	Embankment failure at the culvert outlet eg slumping, cracking
<input type="checkbox"/>	Seepage emerging around the outside of the pipe
<input type="checkbox"/>	Significant scour erosion of the road fill batters
<input type="checkbox"/>	Significant scour erosion below the outlet or at the inlet

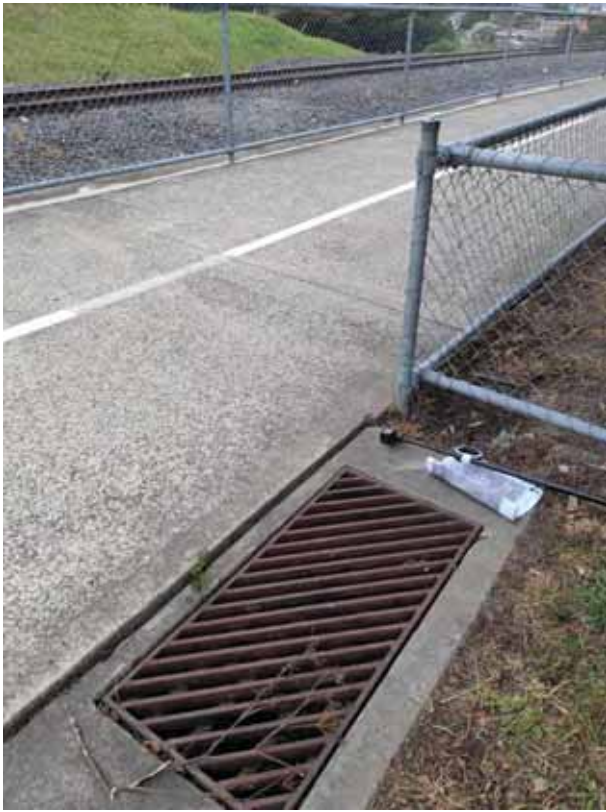
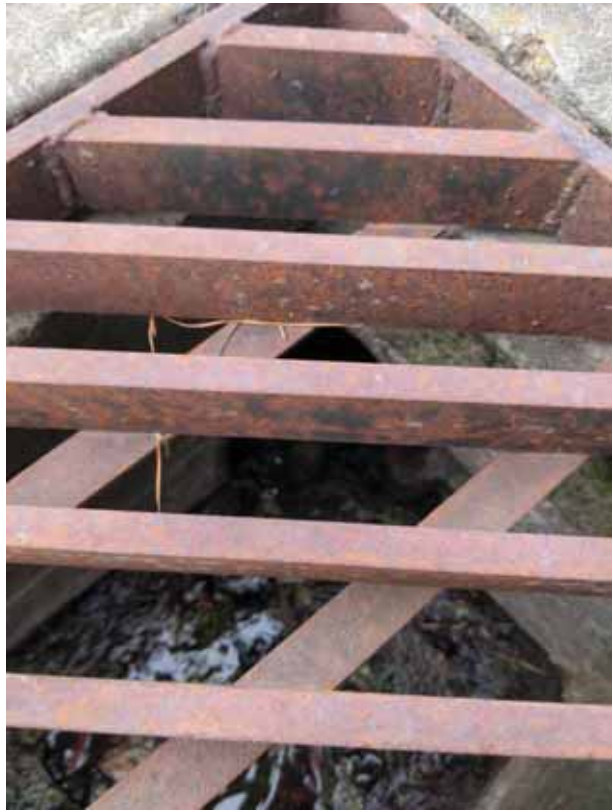
Photo Inlet

During this inspection is there water in the culvert?			Yes
Barrel flow	25% blocked	Inlet flow	
Outlet flow	cannot be determined		25% blocked
Outlet condition	cannot locate outlet. cess drain on right side of track		
Inlet condition	cannot lift grate. unsure of flow direction if parallel to shared path or at angle under the track		
Structure condition	pit cover appears to be in good condition.		
Road surface condition	Refer to rail track condition assessment provided separately		
Batter condition	flat on either side and made mostly of ballast material		
What routine maintenance is required?	culvert and outlet condition will need to be checked and cleared of obstructions/dirt.

Pipe condition will need to be checked.  
Vegetation, dried leaves, dirt will need to be cleared on either side.

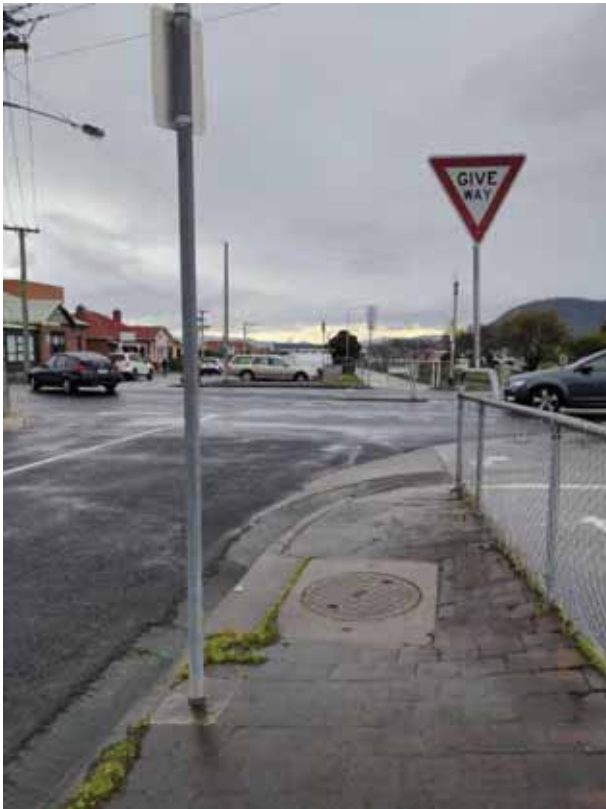
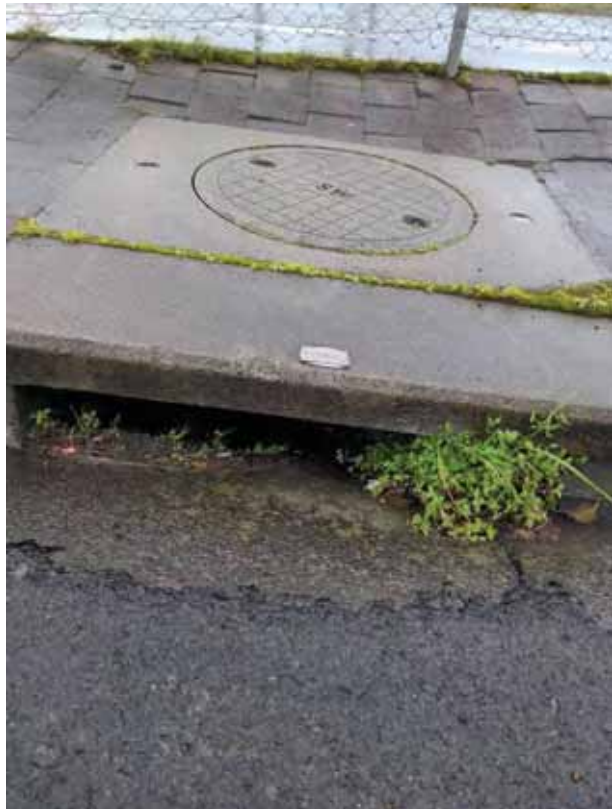
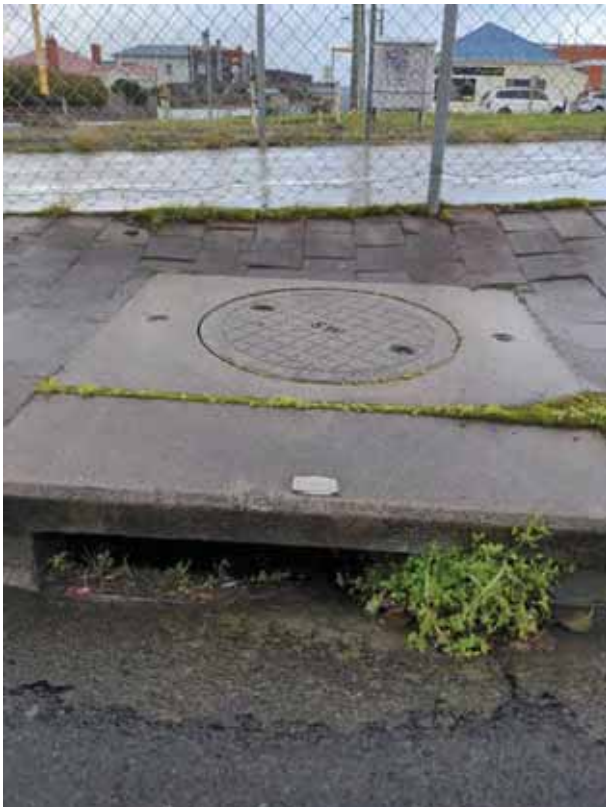
Photo Inlet

<b>During this inspection is there water in the culvert?</b>		Yes
<b>Barrel flow</b>	cannot be determined	<b>Inlet flow</b>
<b>Outlet flow</b>	25% blocked	
<b>Outlet condition</b>	cannot lift side entry pit cover. water inside pit at time of inspection, although it doesn't appear to be flowing anywhere. outlet might be blocked	
<b>Inlet condition</b>	difficult to open manhole cover. inlet condition will need to be reassessed. a few vegetation in the way of the inlet. located on the left side of the shared path and track	
<b>Structure condition</b>	pit covers appear to be in good condition. invert and outlet may need to be cleared of dirt or debris to ensure smooth flows	
<b>Road surface condition</b>	Refer to rail track condition assessment provided separately. track and road pavement connection may need to be fixed.	
<b>Batter condition</b>	batters are flat and grassed	
<b>What routine maintenance is required?</b>	check pipe condition and clear of blockages if any

Pipe and manhole condition will need to be checked.  
Vegetation, dried leaves, dirt will need to be cleared on either side.

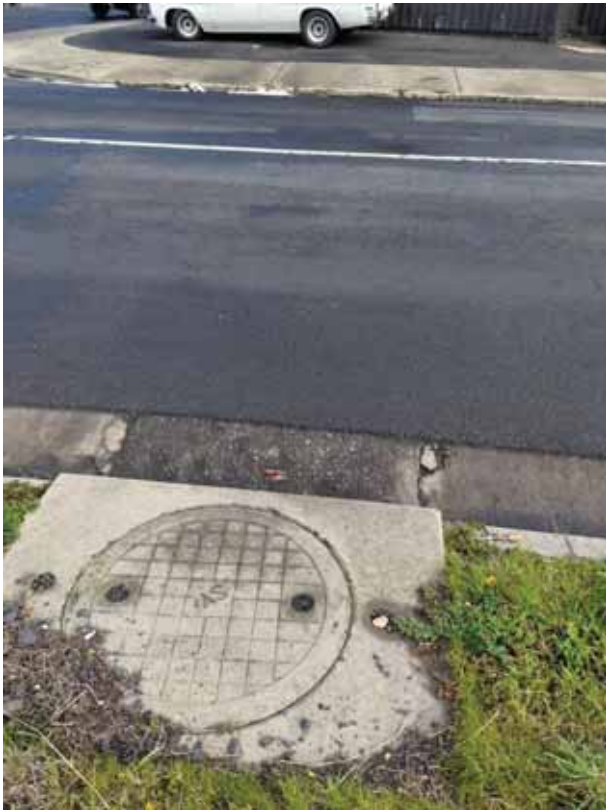
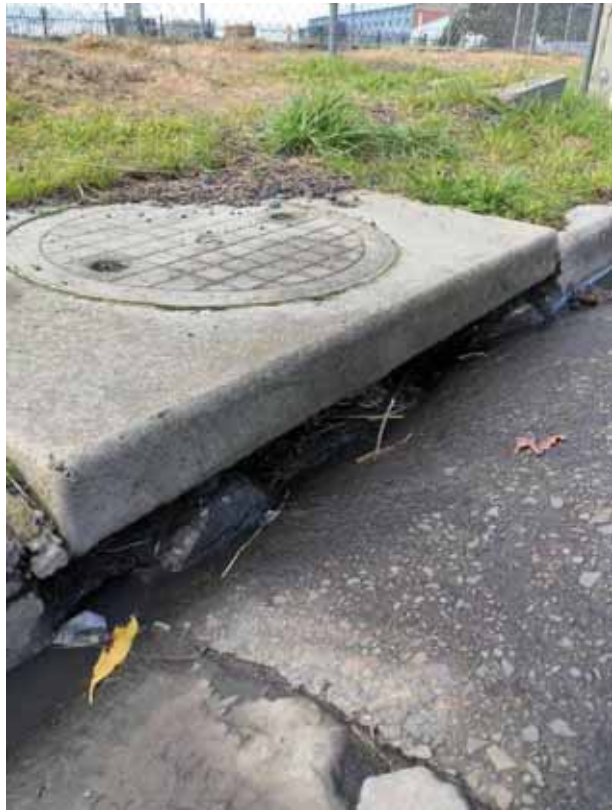
Photo Inlet

<b>During this inspection is there water in the culvert?</b>	cannot be determined	
<b>Barrel flow</b>	cannot be determined	<b>Inlet flow</b>
<b>Outlet flow</b>	cannot be determined	
<b>Outlet condition</b>	cannot lift pit cover. pit located along centre of the road. Significant pavement cracks along the road	
<b>Inlet condition</b>	inlet partly blocked by dirt and debris. cannot lift pit cover. Cannot assess pipe condition	
<b>Structure condition</b>	Culvert/pipe condition will need to be reassessed. Pavement cracks will need to be assessed and rectified	
<b>Road surface condition</b>	Refer to rail track condition assessment provided separately.	
<b>Batter condition</b>	flat on either side	
<b>What routine maintenance is required?</b>	check pipe condition and clear of blockages if any

Pipe and manhole condition will need to be checked.  
Vegetation, dried leaves, dirt will need to be cleared on either side.

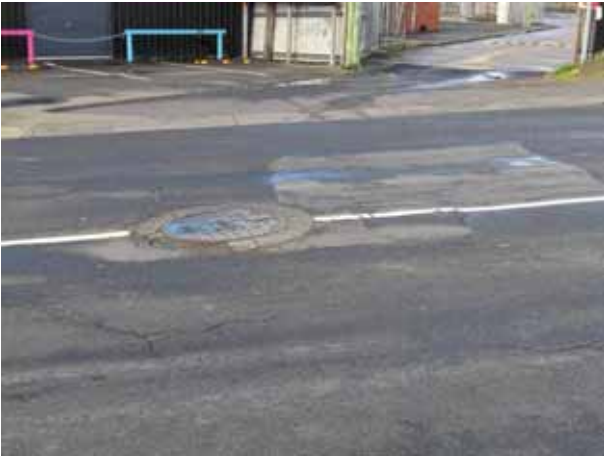
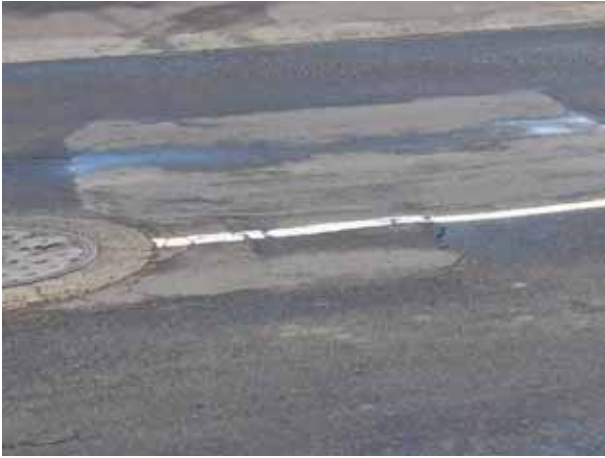
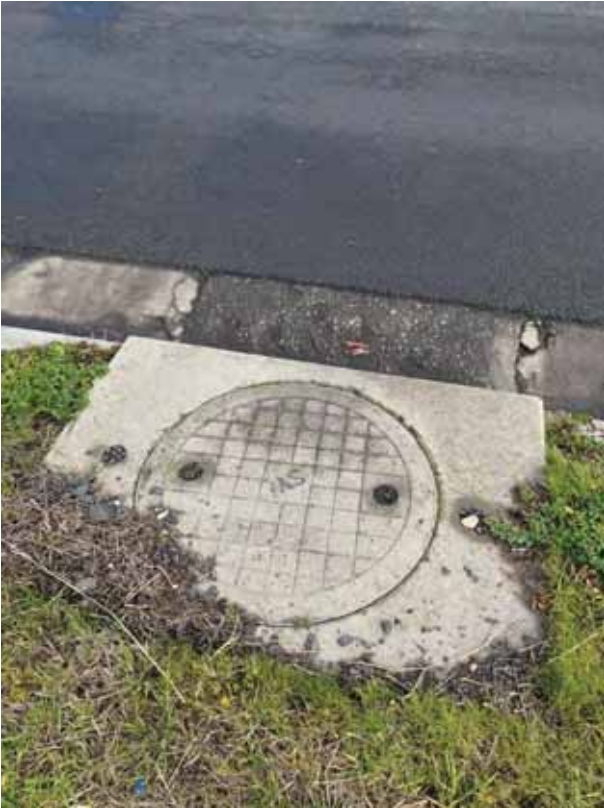
**Photo Condition**

Subsidence in the road
	Significant patching of the road above the culvert
Yes	Significant cracking or deformation of the road above the culvert
	Holes or cavities in the road fill around the inlet or outlet or above the culvert
	Embankment failure at the culvert outlet eg slumping, cracking
	Seepage emerging around the outside of the pipe
	Significant scour erosion of the road fill batters
	Significant scour erosion below the outlet or at the inlet
	Headwalls missing or displaced

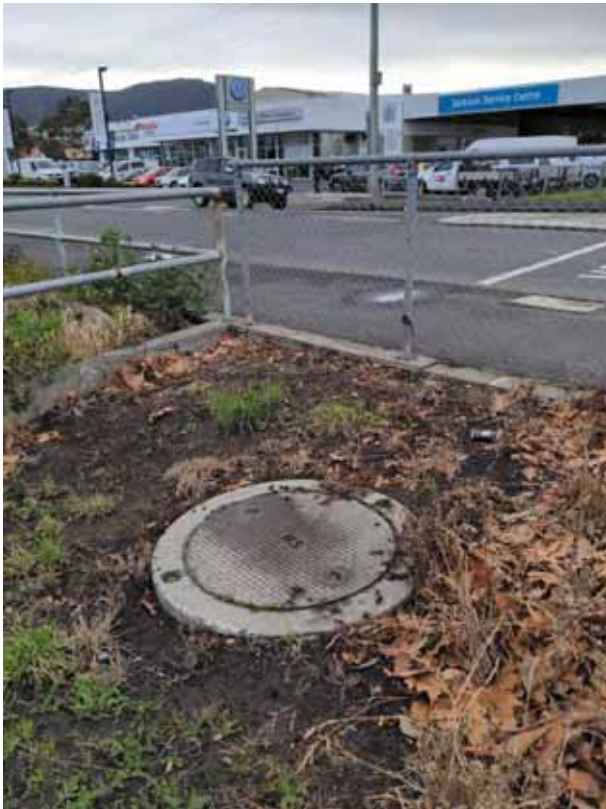
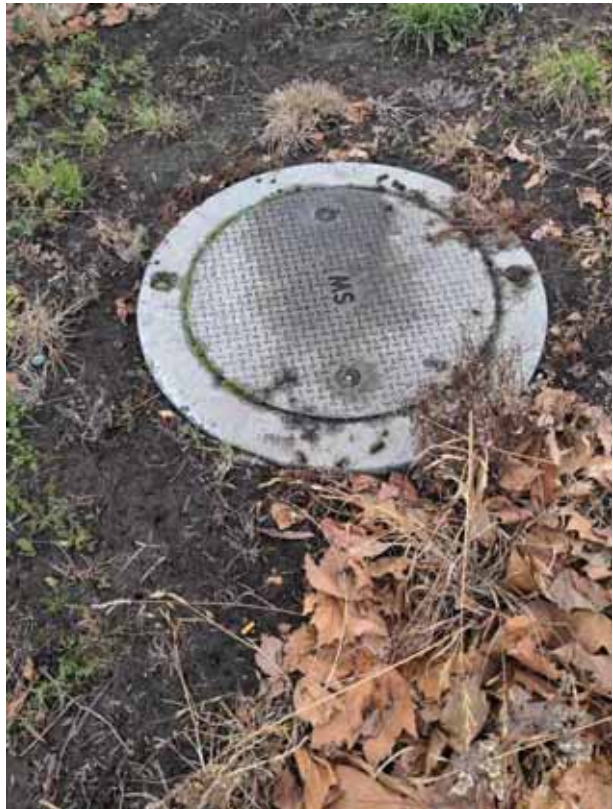
Photo Inlet

Pipe and manhole condition will need to be checked.  
Vegetation, dried leaves, dirt will need to be cleared on either side  
Ponding along the track sides is evident. no defined cess drain. ballast material missing along connection to the road

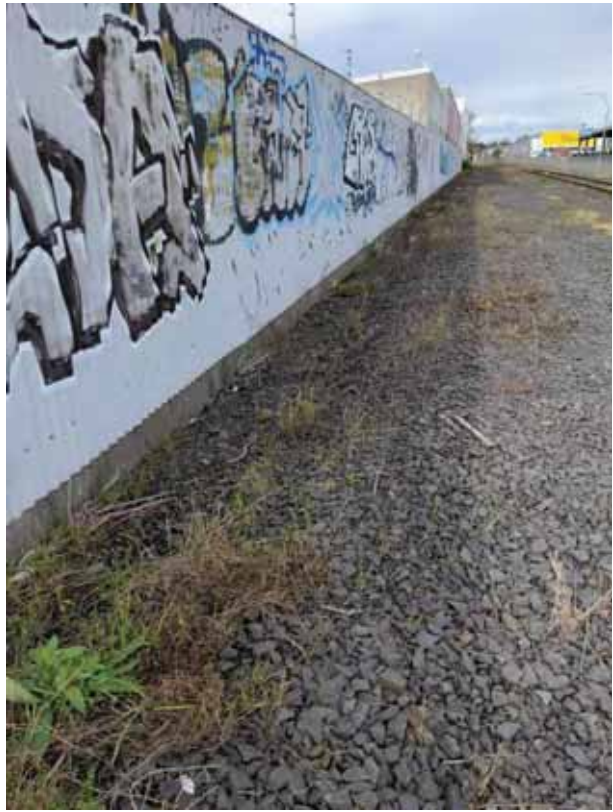
Photo Outlet

Pipe and manhole condition will need to be checked. Vegetation, dried leaves, dirt will need to be cleared on either side. outlet was not located as it was outside rail corridor
-----------------------------------------------------------------------------------------------------------------------------------------------------------------------------------------

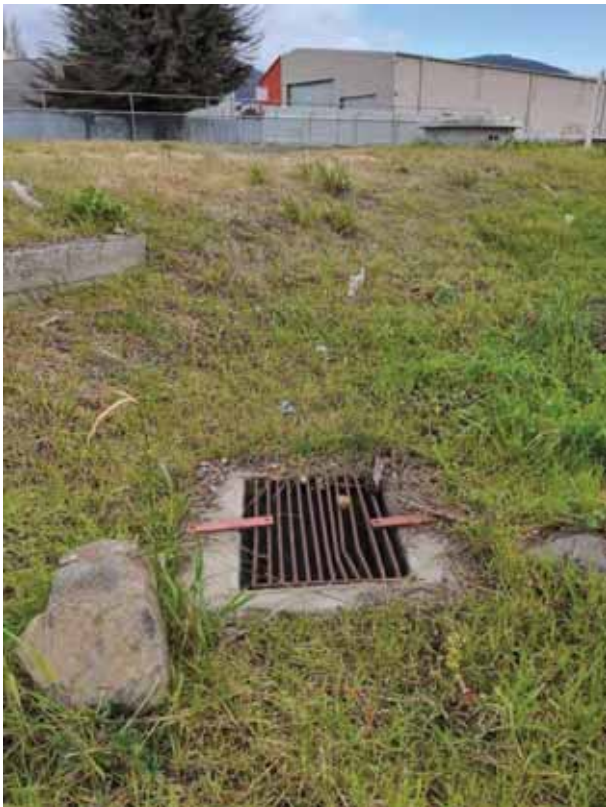
Photo Outlet

Exposed reinforcement and iron staining evident on the outlet side of the culvert  
Joint connections will need to be reassessed. Along the outlet pit, chipping of the concrete connection was observed

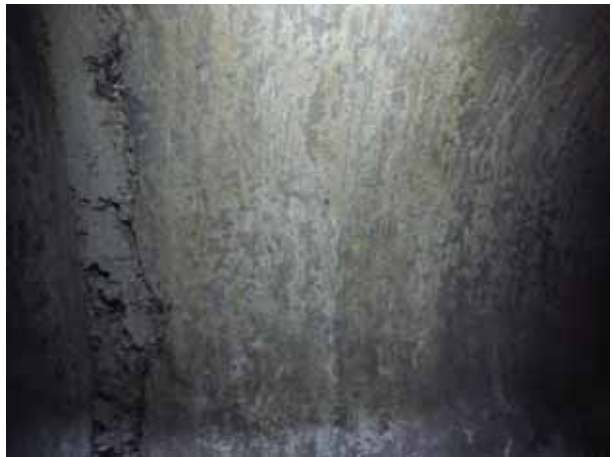
Photo Outlet – joint connection

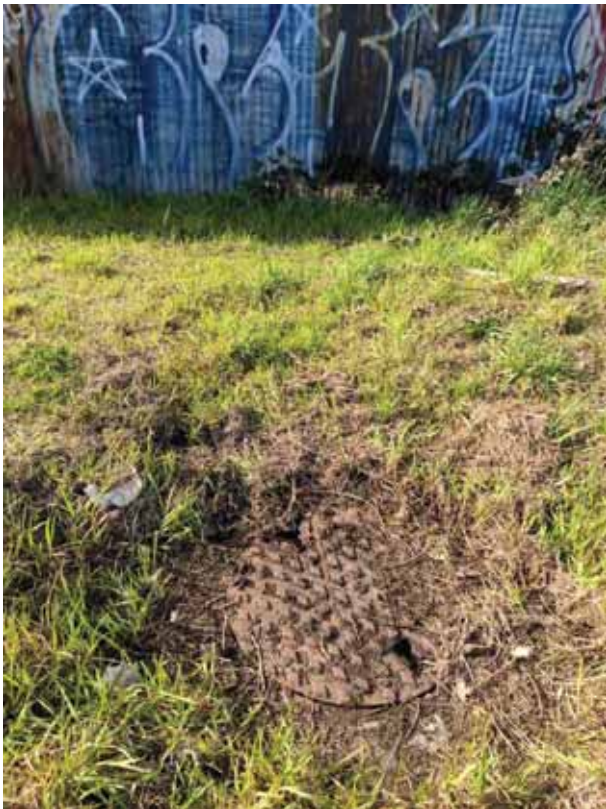
Photo Outlet

During this inspection is there water in the culvert?			cannot be determined
Barrel flow	cannot be determined	Inlet flow	
Outlet flow	cannot be determined		cannot be determined
Outlet condition	manhole cover on outlet side difficult to lift. Manhole cover was covered with dirt during time of inspection. Possible ponding on pit cover because it is at the low point		
Inlet condition	manhole cover on inlet side difficult to lift.		
Structure condition	Manhole cover at appears to be in okay condition. Culvert/pipe condition will need to be reassessed.		
Road surface condition	Refer to rail track condition assessment provided separately.		
Batter condition	flat either side comprised of grassed embankment and ballast material		
What routine maintenance is required?	check pipe condition and clear of blockages if any

Pipe and manhole condition will need to be checked.  
Vegetation, dried leaves, dirt will need to be cleared on either side.

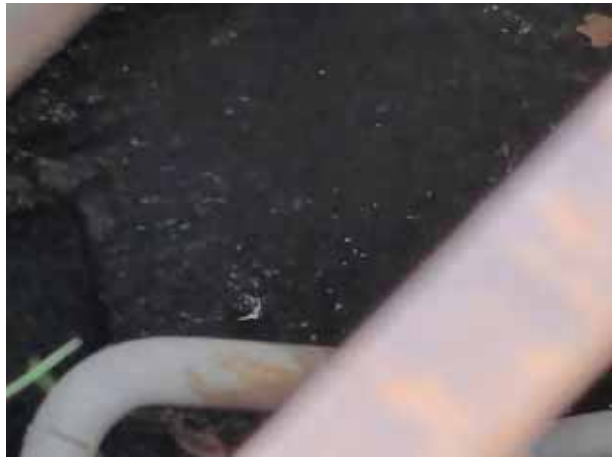
**Photo Inlet**

<b>During this inspection is there water in the culvert?</b>		Yes
<b>Barrel flow</b>	cannot be determined	<b>Inlet flow</b>
<b>Outlet flow</b>	cannot be determined	
<b>Outlet condition</b>	manhole cover on outlet side difficult to lift. Significant pavement cracks along the road around the manhole. outlet manhole in the middle of the road	
<b>Inlet condition</b>	Weeds growing within pit. manhole cover on inlet side difficult to lift. appears to have stagnant water and dirt inside the side entry pit. inlet SEP partially blocked, unable to verify pipe size and condition	
<b>Structure condition</b>	Manhole cover at appears to be in okay condition. Culvert/pipe condition will need to be reassessed.	
<b>Road surface condition</b>	Refer to rail track condition assessment provided separately.	
<b>Batter condition</b>	flat either side	
<b>What routine maintenance is required?</b>	check pipe condition and clear of blockages if any remediate pavement issues

Pipe and manhole condition will need to be checked.  
 Vegetation, dried leaves, dirt will need to be cleared on either side.  
 Pavement issues will need to be remediated

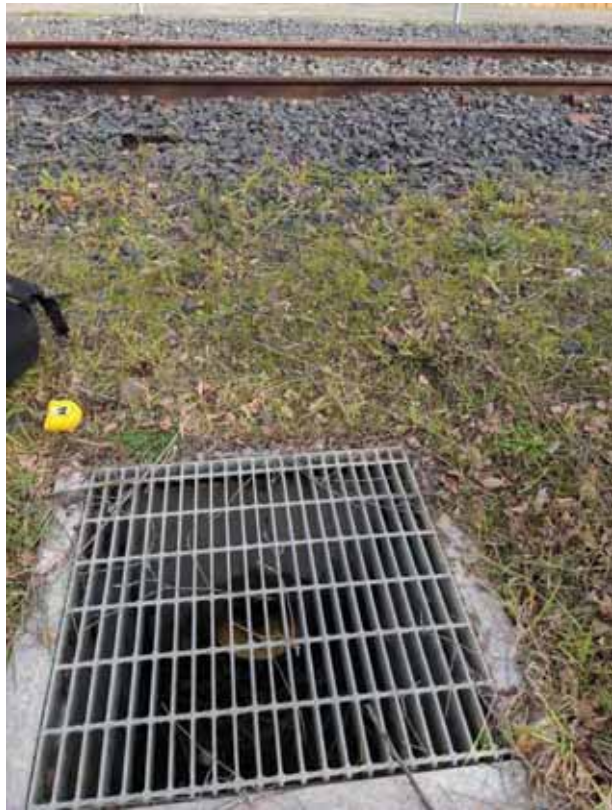
Photo Inlet

During this inspection is there water in the culvert?			No
Barrel flow	Clear	Inlet flow	
Outlet flow	Clear		cannot be determined
Outlet condition	cannot lift pit cover. pit invert is covered with dirt and grass. Possibly acting as a soakage pit?		
Inlet condition	cannot lift pit cover. Pipe condition was not assessed on the inlet side. Unable to fit in camera to check pipe condition.		
Structure condition	Appears to be in good condition		
Road surface condition	Refer to rail track condition assessment provided separately		
Batter condition	flat on either side. Made of ballast material		
What routine maintenance is required?	culvert and inlet condition will need to be checked and cleared of obstructions/dirt. clear inlet side.

Pipe condition will need to be checked.  
Vegetation, dried leaves, dirt will need to be cleared on either side.
