**General Arrangement Plan Drawings –  
Culvert Location**

Size <b>A3</b>	Row <b>A</b>	
Client <b>DEPARTMENT OF STATE GROWTH</b>		Drawing Title <b>GENERAL ARRANGEMENT PLAN</b>	
Project <b>NSTC CONDITION ASSESSMENT</b>		Status <b>S2</b>	
Project No. <b>12548571</b>		Drawing No. <b>12548571-SK003</b>

Department of State Growth  
Northern Suburbs Transit Corridor -  
Condition Assessment

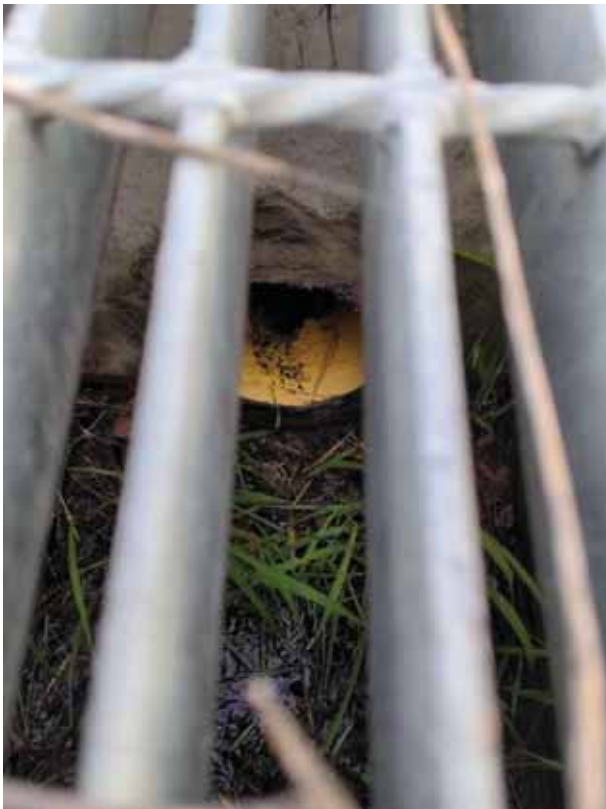
Photo Inlet

During this inspection is there water in the culvert?			No
Barrel flow	Clear	Inlet flow	
Outlet flow	Clear		cannot be determined
Outlet condition	cannot lift pit cover. pit invert is covered with dirt and grass. Possibly acting as a soakage pit?		
Inlet condition	cannot lift pit cover. Pipe condition was not assessed on the inlet side. Unable to fit in camera to check pipe condition.		
Structure condition	Appears to be in good condition		
Road surface condition	Refer to rail track condition assessment provided separately		
Batter condition	flat on either side. Made of ballast material		
What routine maintenance is required?	culvert and inlet condition will need to be checked and cleared of obstructions/dirt. clear inlet side.

Pipe condition will need to be checked.  
Vegetation, dried leaves, dirt will need to be cleared on either side.

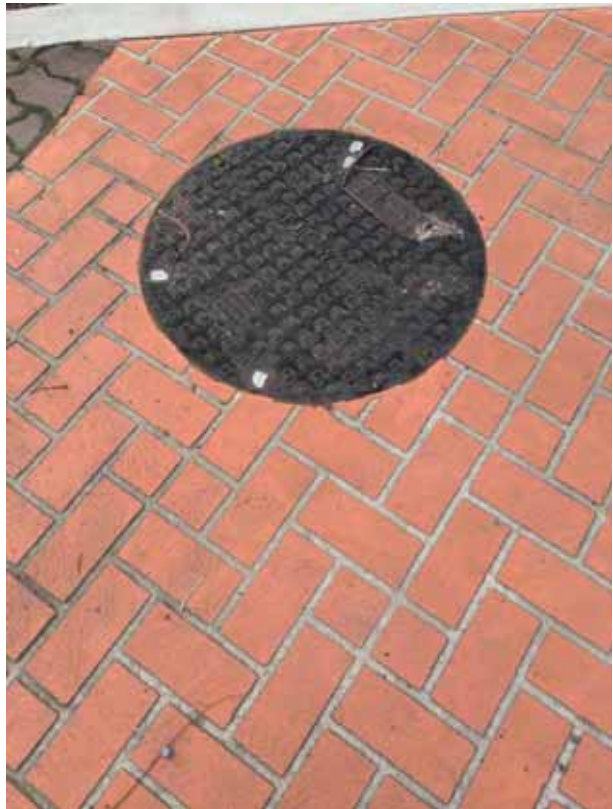
**Photo Inlet**

During this inspection is there water in the culvert?		cannot be determined
Barrel flow	cannot be determined	Inlet flow
Outlet flow	cannot be determined	
Outlet condition	manhole cover on outlet side difficult to lift.	
Inlet condition	manhole cover on inlet side difficult to lift. Pit located along median island	
Structure condition	Manhole cover at appears to be in okay condition. Culvert/pipe condition will need to be reassessed.	
Road surface condition	Refer to rail track condition assessment provided separately.	
Batter condition	Flat on either side	
What routine maintenance is required?	Pipe condition will need to be reassessed. Pit covers difficult to open

Pipe and manhole condition will need to be checked.  
Vegetation, dried leaves, dirt will need to be cleared on either side.

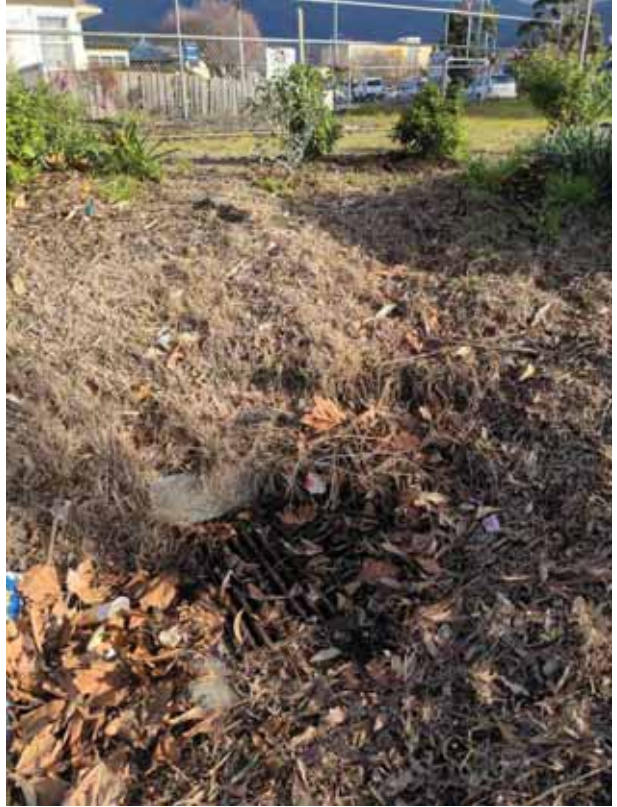
Location: Lat, Long	Type	Depth	Ped safe	Bike safe
Lat:-42.832731799999976, Long:147.28001640000002	Manhole	-	Yes	Yes
	Inlet			
Lat:-42.832702100000006, Long:147.27975060000006	Manhole	-	Yes	Yes
	Outlet			
Lat:-42.832730599999999, Long: 147.28005599999995	Manhole	-	yes	yes
Comment	pit located along footpath. cannot lift pit cover			
Lat:-42.832773599999996, Long: 147.28022150000004	inlet_sump	-	yes	yes
Comment	Grated pit covered with rubbish. pit cover difficult to open. cannot fit in camera to check pit condition. pit cover may need to be changed and cleared of debris			
Lat:-42.83281390000002, Long: 147.27981590000002	Manhole	-	yes	yes
Comment	Pit located along pedestrian refuge. Difficult to open

**Risk Photos – pit east side of Elwick Road**

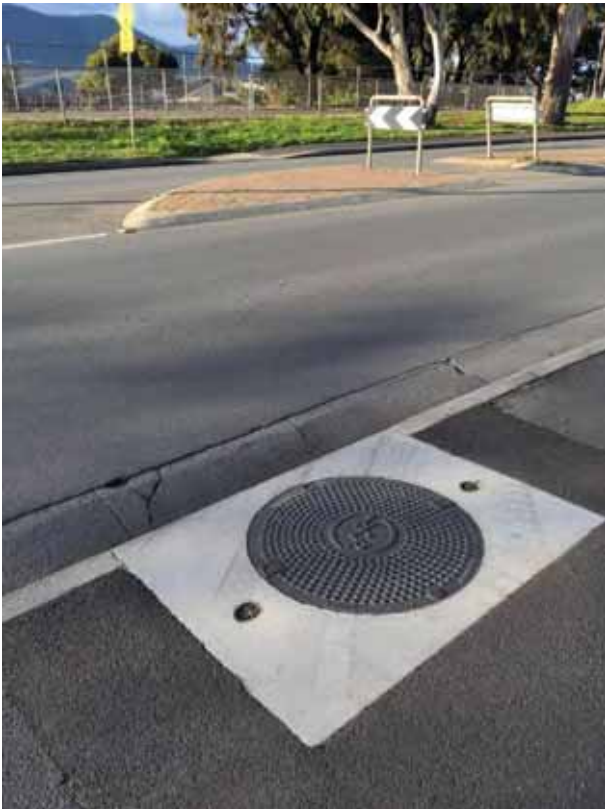
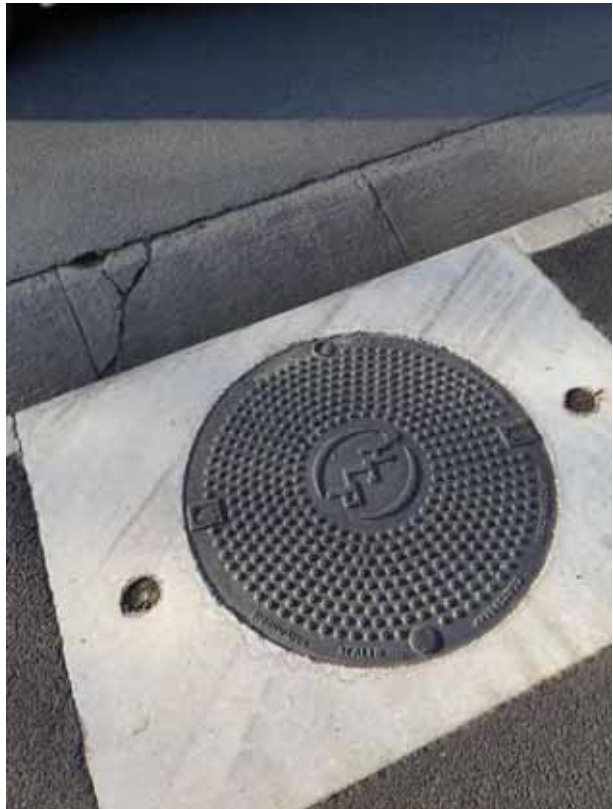
Photo Inlet

During this inspection is there water in the culvert?		Yes
Barrel flow	Clear	Inlet flow cannot be determined
Outlet flow	Clear	
Outlet condition	Vegetation/dirt/debris along the outlet Difficult to access as the area is fenced	
Inlet condition	Unable to open manhole cover	
Structure condition	Outlet side will need to be cleared of vegetation/dirt/debris. Kids were able to access the adjacent smaller pipe at the time of inspection but unable to determine where.	
Road surface condition	Refer to rail track condition assessment provided separately	
Batter condition	Flat on left side. Steep on right side. Mostly consisting of ballast material.	
What routine maintenance is required?	Pit outlet will need to be cleared of existing vegetation/dirt/debris. Pipe condition will need to be assessed

Pipe condition will need to be checked.  
Vegetation, debris, dirt will need to be cleared on either side.

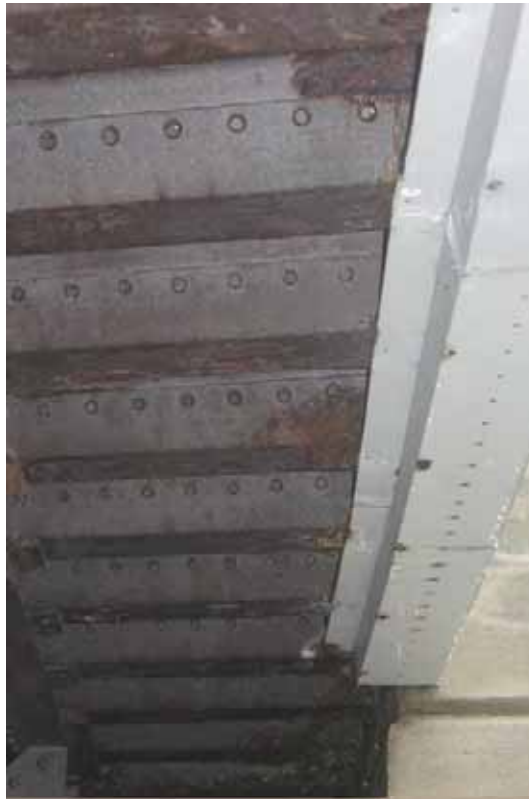
Figure 9 Corrosion extending from steel flashing at Deck 3 (typical)

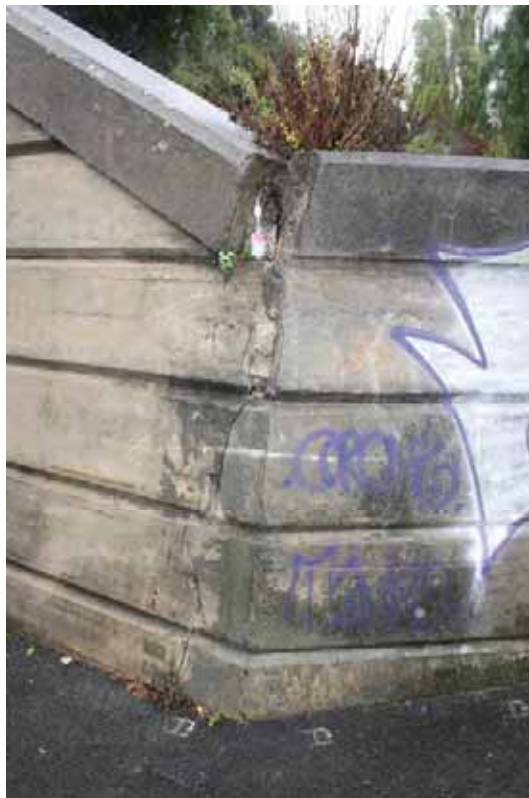
Figure 12 *Major cracking at interface between wingwall and wingwall return with spalling*

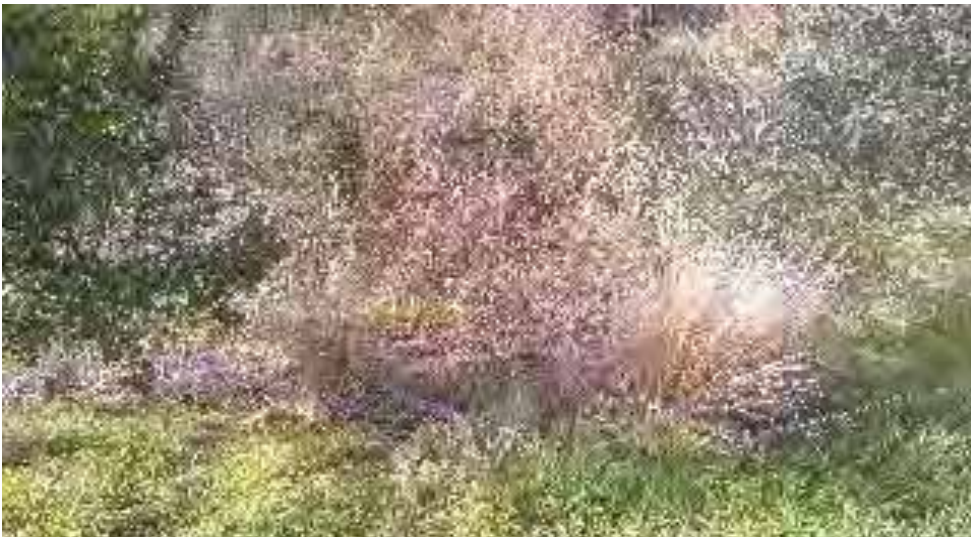
KPS 1.29 (Object ID 21)

21	POINT	1.29		Drainage feature	Culvert 726
22	POLYGON	1.31	1.34	Slope stability	Potential embankment instability on eastern side. Steep embankment, rock evident at base.
23	POINT	1.38		Drainage feature	Culvert 866
24	LINE	1.39	1.47	Widening	Narrow corridor, embankment drops off approx. 1:1 on eastern side. Significant earthworks required for widening., Possible small failures/slips, small trees planted for additional stability.
25	POINT	1.41		Drainage feature	Culvert 900

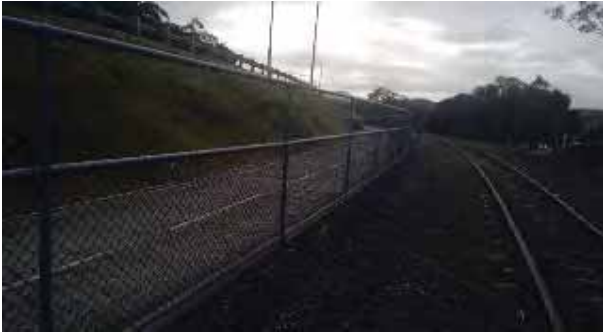
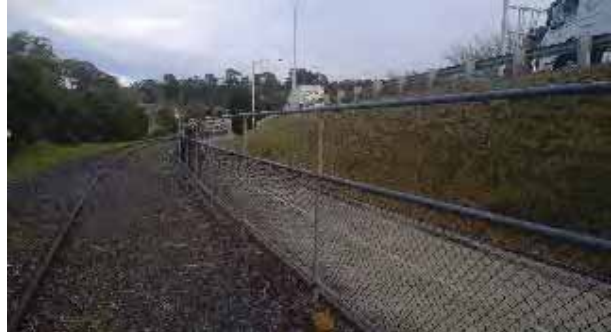
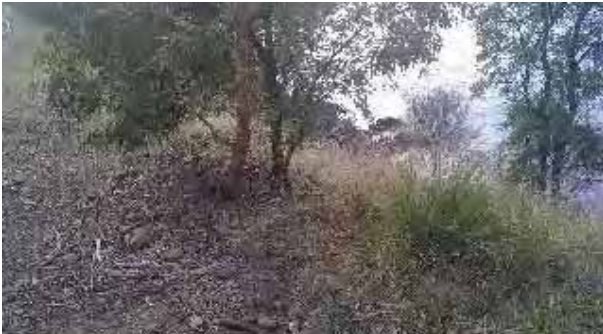
KPS 1.48 (Object ID Line 26)

OBJECT ID	TYPE	KPS (Start)	KPS (End)	Hazard Type	Hazard/Object Description & Notes
26	LINE	1.48	1.86	Widening	Steep road cutting adjacent to cycle path (road fill over dolerite). Formation drops off steep on eastern side, significant earthworks required for widening.
27	POINT	1.57		Drainage feature	Culvert 1070
28	POINT	1.57		Slope stability	Small embankment slip, scoop shape
29	LINE	1.67	1.88	Slope stability	Small retaining wall at base of road embankment, adjacent to cycle path. Approximately 0.6 metres high.
30	POINT	1.68		Drainage feature	Culvert 1138
31	POLYGON	1.70	1.77	Slope stability	Potential slope instability including rock falls. Dolerite ledge at base.
32	POINT	1.73		Drainage feature	Culvert 1163
33	POLYGON	1.80	1.88	Widening	Steep and narrow embankment, difficult for widening. Dolerite outcropping at base.
34	POINT	1.83		Drainage feature	Culvert 1186
35	POINT	1.84		Drainage feature	Culvert 1294

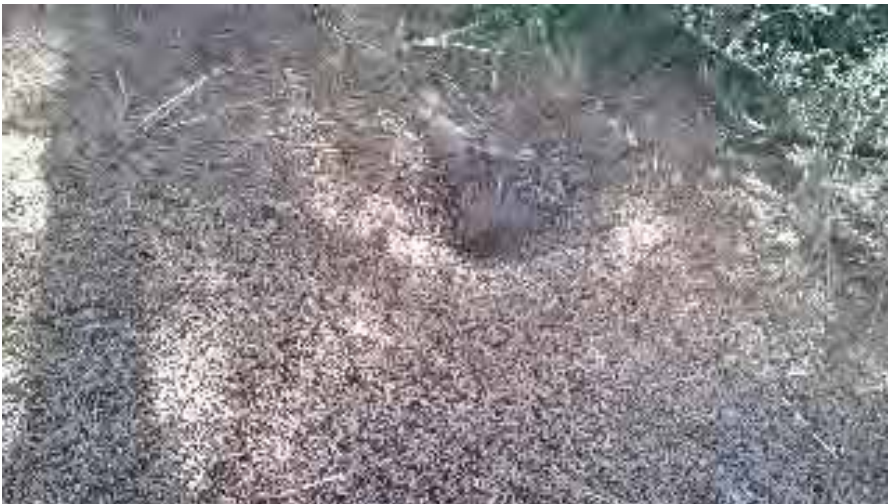
KPS 2.55 (Object ID Polygon 52)

OBJECT ID	TYPE	KPS (Start)	KPS (End)	Hazard Type	Hazard/Object Description & Notes
52	POLYGON	2.55	2.70	Slope stability	Retaining wall adjacent to cycle path. Approximately 0.7 to 0.8 metres high
53	POINT	2.68		Drainage feature	Culvert 2129
54	LINE	2.70	2.80	Widening	Narrow corridor. Embankment drops off to beach, approximately 1H:1V, well vegetated. Difficult for widening.
55	POINT	2.79		Drainage feature	Culvert 2248
56	LINE	2.82	2.85	Widening	Narrow corridor. Embankment drops off towards beach. Access track halfway down embankment on eastern side, difficult for widening.
57	POINT	2.82		Formation	Ballast thicker for approximately 10 metres on eastern side. Ballast layer up to 1.5 metres thick.
58	POINT	2.87		Formation	Thicker section of ballast and rock fill, approximately 10 metres wide and up to 1.5 metres thick.
59	POINT	2.90		Drainage feature	Culvert 2343
60	LINE	3.04	3.38	Widening	Narrow corridor. Embankment drops off to beach. Difficult for widening.

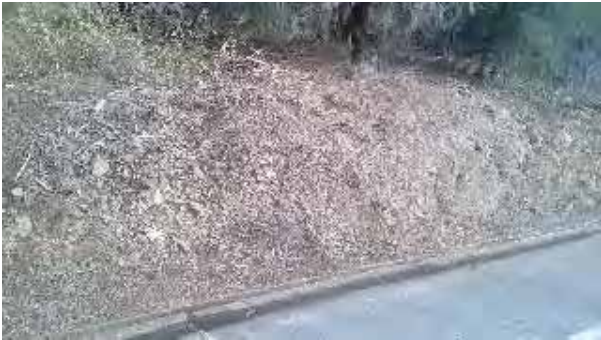
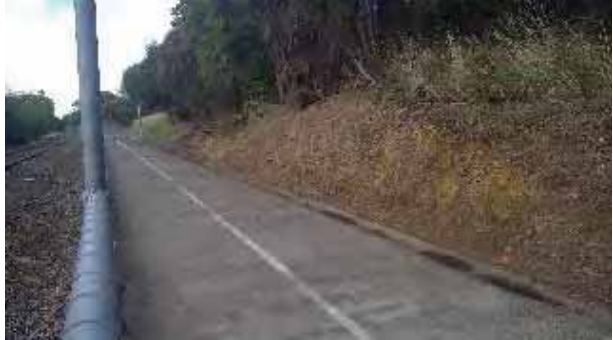
KPS 3.07(Object ID 61)

61	POINT	3.07		Drainage feature	Culvert 2515
62	LINE	3.13	3.19	Cutting	Weathered dolerite cutting adjacent to cycle track. Highly fractured, high strength. Approximately 2 metres high.
63	POINT	3.13		Drainage feature	Culvert 2583
64	POINT	3.18		Drainage feature	Culvert 2583
65	POINT	3.23		Drainage feature	Culvert 2683
66	POINT	3.44		Drainage feature	Culvert 2891
67	LINE	3.45	3.73	Cutting	Sandstone cutting adjacent to cycle path, 1H:1V. Approximately 3 to 4 metres high.
68	LINE	3.46	3.64	Widening	Narrow corridor. Embankment drops off towards beach. Access track to Cornelian Bay adjacent to embankment on eastern side, difficult for widening.
69	POINT	3.61		Drainage feature	Culvert
70	POINT	3.70		Adjacent feature	Existing rail platform, eastern side.
71	LINE	3.83	4.04	Slope stability	Retaining wall adjacent to cycle path, approximately 0.8 metres high.
72	LINE	4.06	4.42	Formation	Embankment on northern side, slope 25 degrees, up to approximately 2.5 metres high. Grassed.

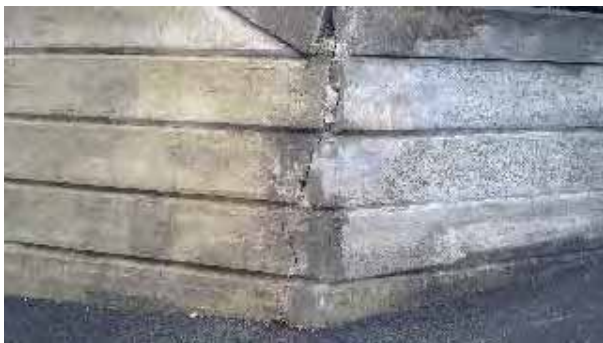
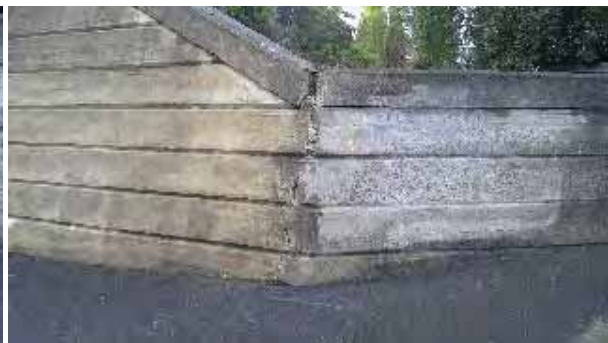
KPS 4.70 (Object ID 79)

OBJECT ID	TYPE	KPS (Start)	KPS (End)	Hazard Type	Hazard/Object Description & Notes
79	POINT	4.70		Formation	Settlement cracking in concrete slabs on southern abutment.
80	POINT	4.71		Adjacent feature	Bridge abutment, cracked concrete.
81	POINT	4.72		Formation	North abutment concrete settlement cracks and displaced slabs. Approximately 20 mm displacement.
82	LINE	4.73	4.88	Slope stability	Steep embankment, approximately 40 degrees vegetated with grasses and weeds. Hummocky slope possibly related to small instabilities within embankment.
83	LINE	4.73	4.89	Formation	Embankment, long grasses/vegetation obscure view of slope surface
84	LINE	4.75	4.80	Formation	Settlement of existing rail track, tension cracks observed. Maximum 0.3 metres vertical displacement on south side. Inward rotation of left rail (north bound).
85	POINT	4.76		Slope stability	Leaning light tower.
86	POINT	4.77		Slope stability	Displacement of concrete slabs. Vertical displacement up to 20 mm, laterally up to 40 mm.

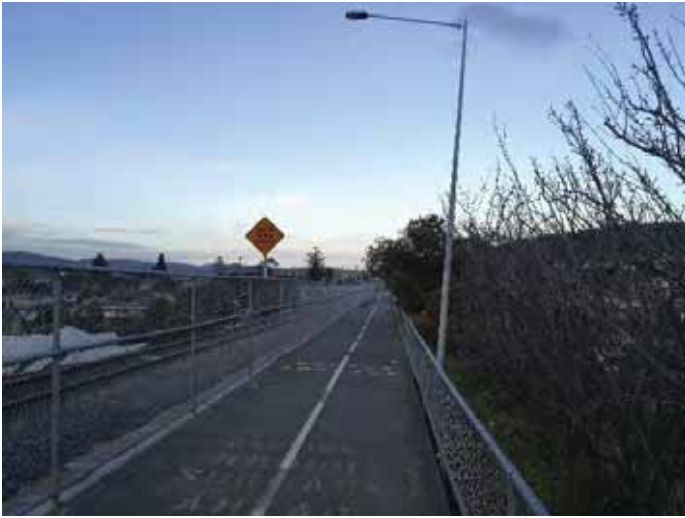
KPS 4.78 (Object ID Polygon 87)

87	POLYGON	4.78	4.81	Formation	Tension cracking in adjacent cycle path.
88	POINT	4.84		Slope stability	Leaning light tower.
89	LINE	4.91	5.28	Slope stability	Retaining wall adjacent to cycle path, steel post timber waler. No obvious overturning. Some bulging of timbers, up to 1.2 metres high, generally 0.6 to 1.0 metres. Cutting behind wall is up to 4.5-5.0 metres high on western end. Slope angle approximately 40-45 degrees.
90	POINT	4.99		Slope stability	Slope remediation adjacent to cycle path. Fence at crest leaning outward.
91	LINE	5.00	5.06	Slope stability	Overturning fence posts.
92	LINE	5.07	5.09	Adjacent feature	Undermining at toe of southern bridge abutment.
93	POINT	5.08		Widening	Bridge piers for overpass. Would obstruct widening works.
94	LINE	5.12	5.17	Slope stability	Debris at toe of small cutting, slope approximately 30 to 35 degrees. Gravel sand silt mixture.
95	LINE	5.37	5.53	Formation	Embankment, up to 2 metres high. Variable slope angle between 25 and 30 degrees.

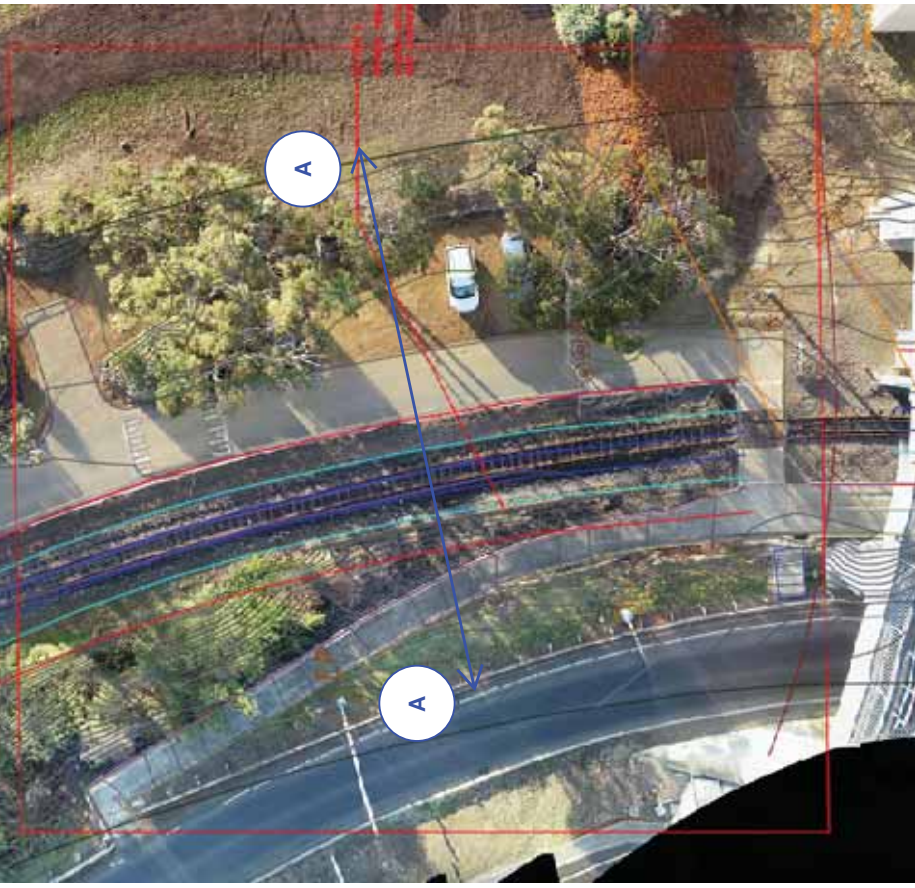
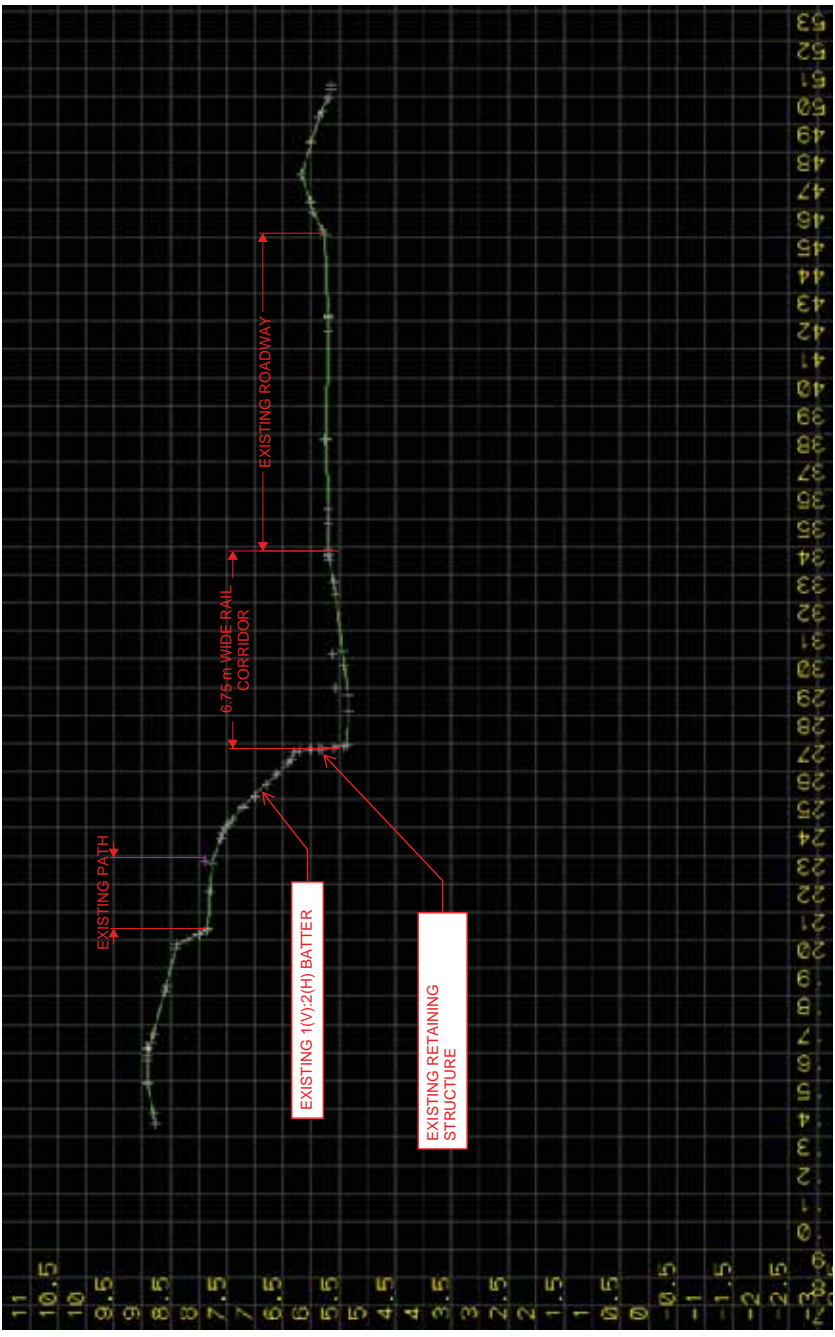
SECTION 2

EXISTING RAIL CORRIDOR CONSTRAINED BY RETAINING STRUCTURE AND EXISTING ROADWAY.

RISK: RELOCATION AND REINSTATEMENT OF RETAINING STRUCTURE OR EXISTING ROAD REQUIRED TO WIDEN RAIL CORRIDOR.

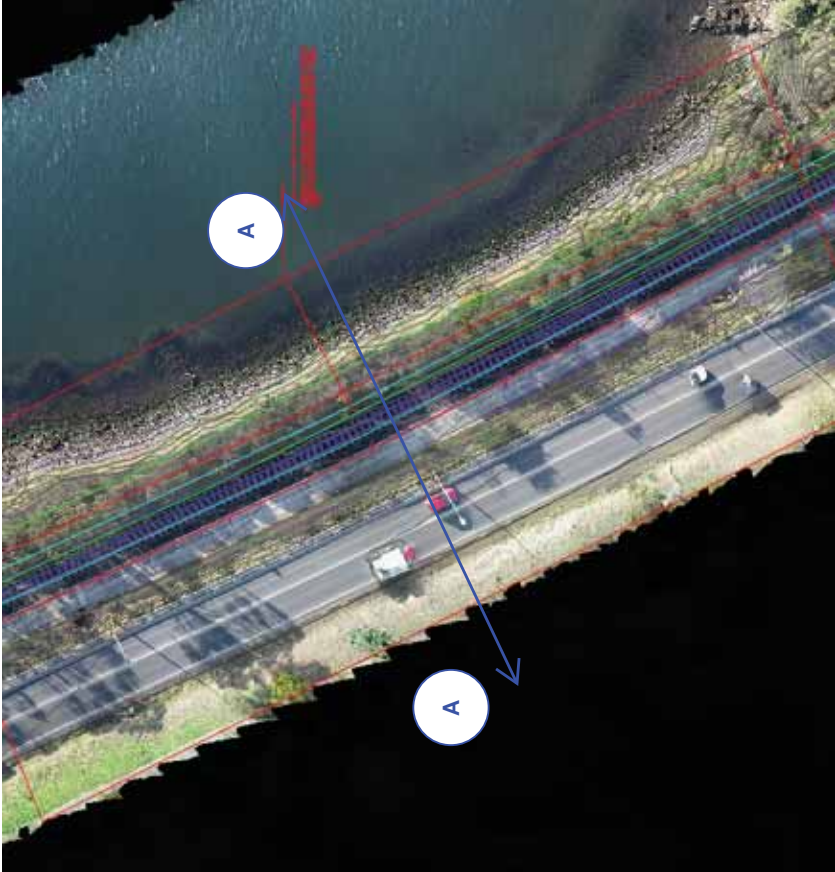
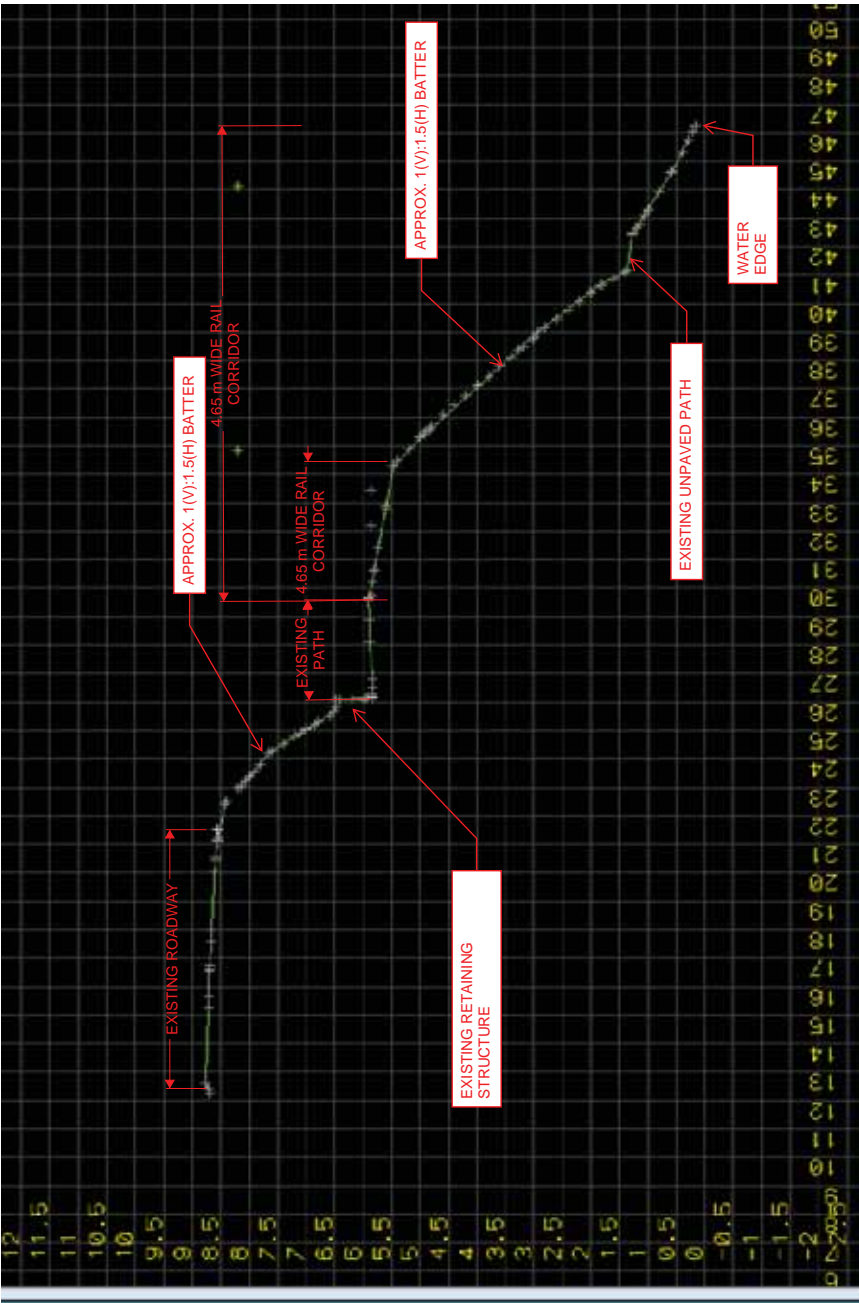
SECTION 3

EXISTING RAIL CORRIDOR CONSTRAINED BY STEEP EMBANKMENTS / ROCK FACE BATTERS.

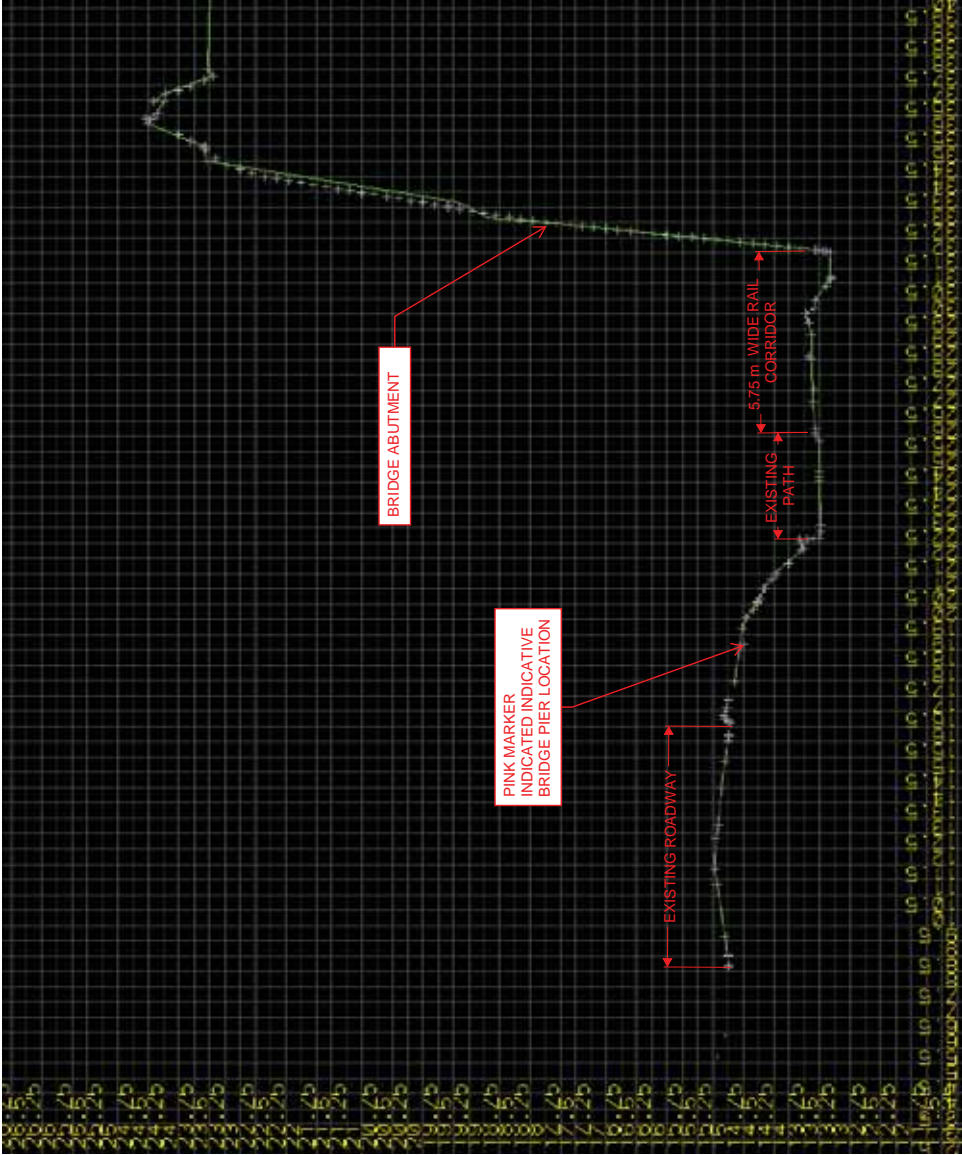
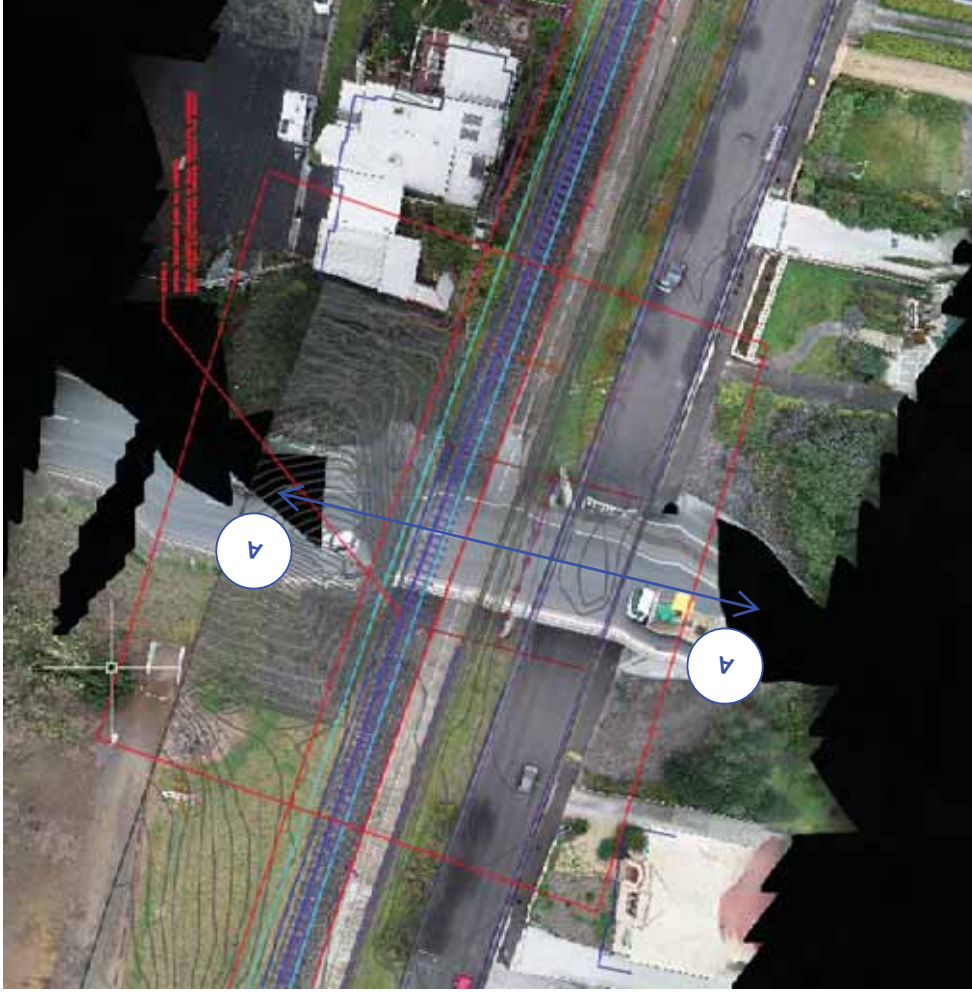
SECTION 4

EXISTING RAIL CORRIDOR CONSTRAINED BETWEEN BROOKER HWY BRIDGE SUPERSTRUCTURE (BRIDGE ABUTMENT AND PIERS) AND THE EXISTING PATH AND ROADWAY.

APPROX. EXISTING CORRIDOR WIDTH = 5.75m

RISK: CURRENTLY BRIDGE ABUTMENT FALLS WITHIN STRUCTURAL CLEARANCE ZONE AS PER YARRA TRAM STANDARD DWG T9000. POTENTIAL MODIFICATION FOR BRIDGE SUPERSTRUCTURE AND/OR PATH TO ACCOMMODATE REQUIRED RAIL CORRIDOR WIDTH AND CLEARANCE - MORE INVESTIGATION REQUIRED.

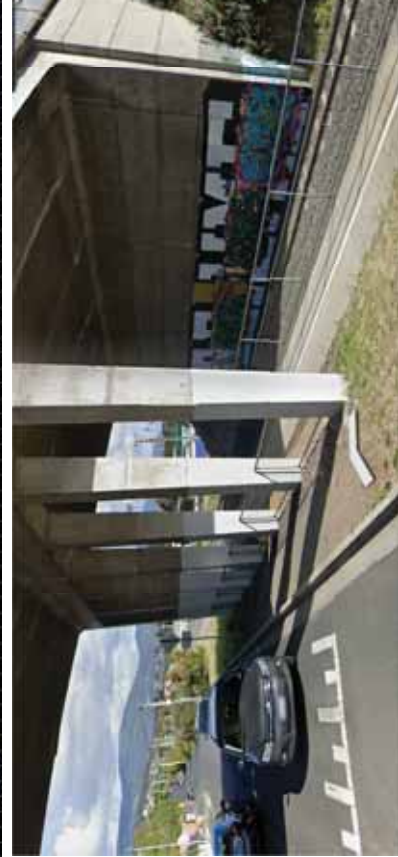
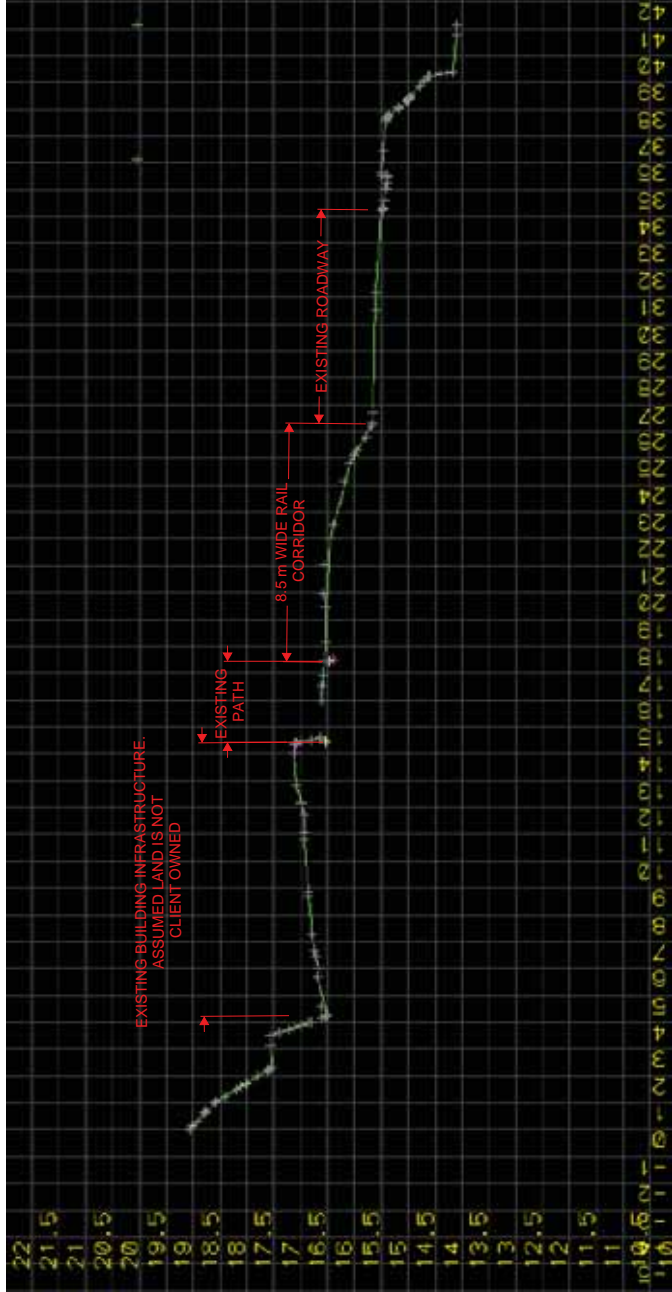
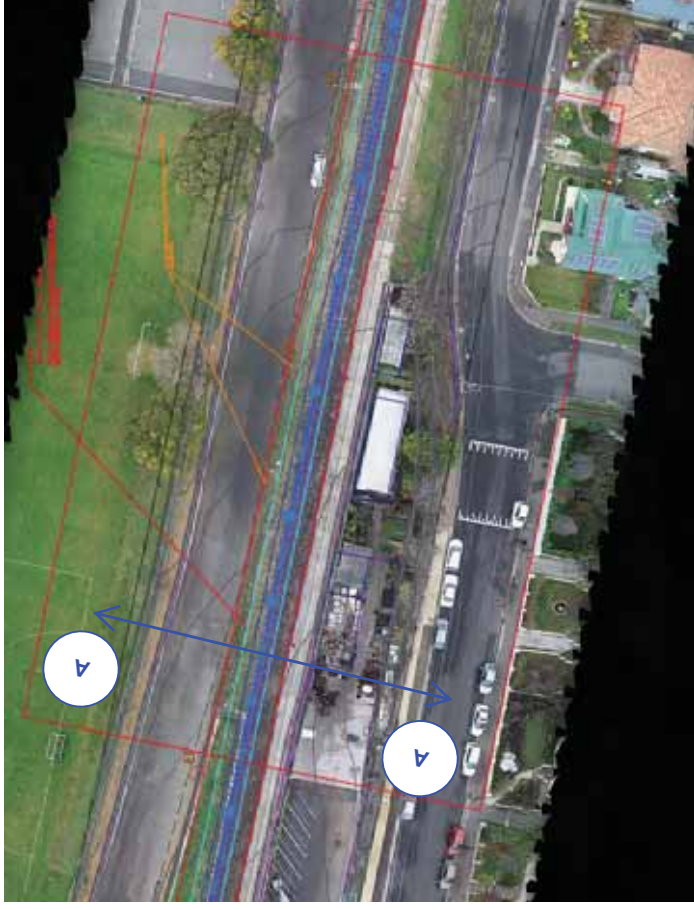
SECTION 5

PROPOSED RAIL CORRIDOR FOOTPRINT FALLS WITH THE EDGE OF THE EXISTING ADJACENT BELL STREET ROAD EDGE, CLASHING WITH MULTIPLE ROAD VERGE INFRASTRUCTURE. IT IS ASSUMED THE EXISTING CYCLE PATH BACKS ONTO EXISTING BUILDING INFRASTRUCTURE ON PRIVATE PROPERTY.

RISK: POTENTIAL LAND ACQUISITION OF THE PROPERTIES ON THE SOUTH SIDE OF THE RAIL CORRIDOR REQUIRED TO LOCALLY SHIFT THE CYCLE PATH AND RAIL CORRIDOR FOOTPRINT BEYOND BELL STREET ROAD VERGE.

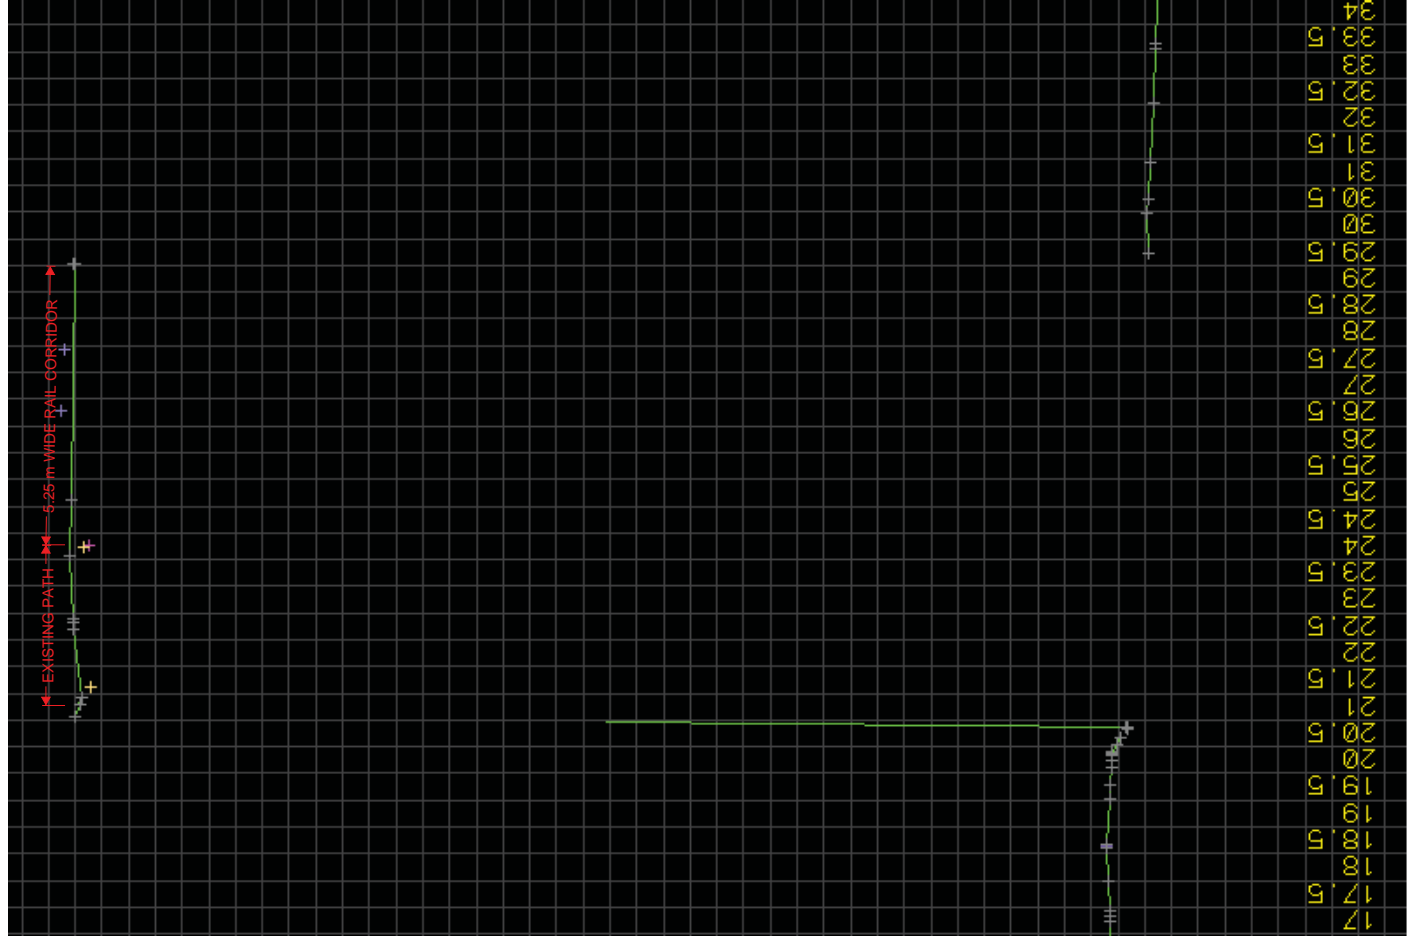
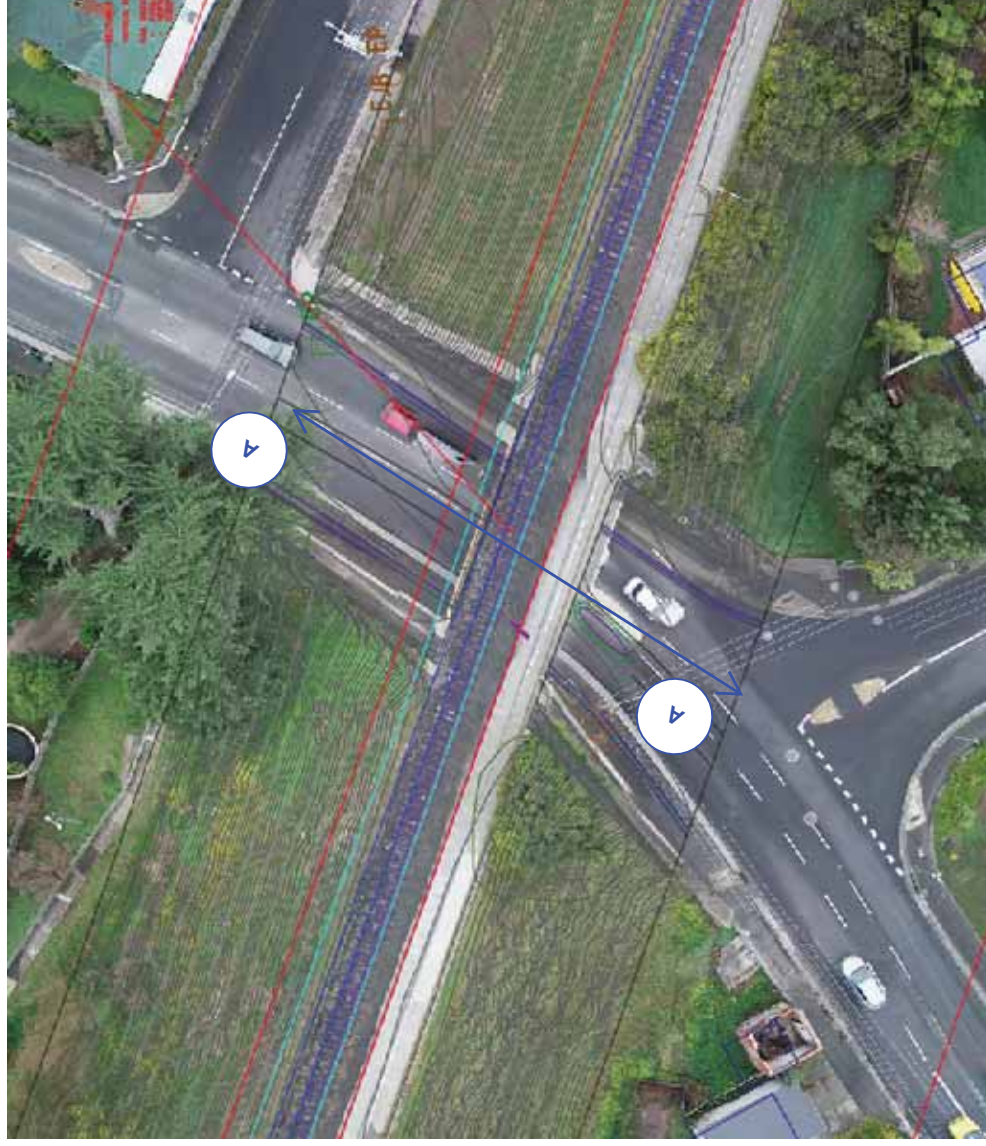
SECTION 6

EXISTING BRIDGE WIDTH IS INSUFFICIENT TO ACCOMMODATE THE REQUIRED RAIL CORRIDOR WIDTH ADOPTED IN THIS INVESTIGATION. ADDITIONALLY EXISTING 1(V):1.5(H) EMBANKMENTS WILL NEED TO BE STEEPENED ON THE APPROACH AND DEPARTURE FROM THE RAIL BRIDGE TO ACCOMMODATE THE WIDER RAIL CORRIDOR.

RISK: IN ADDITION TO THE OUTCOME OF A STRUCTURAL CAPACITY ASSESSMENT THE EXISTING RAIL BRIDGE WILL REQUIRE UPGRADING AND WIDENING TO ACCOMMODATE THE MINIMUM GEOMETRIC AND CLEARANCE REQUIREMENTS.

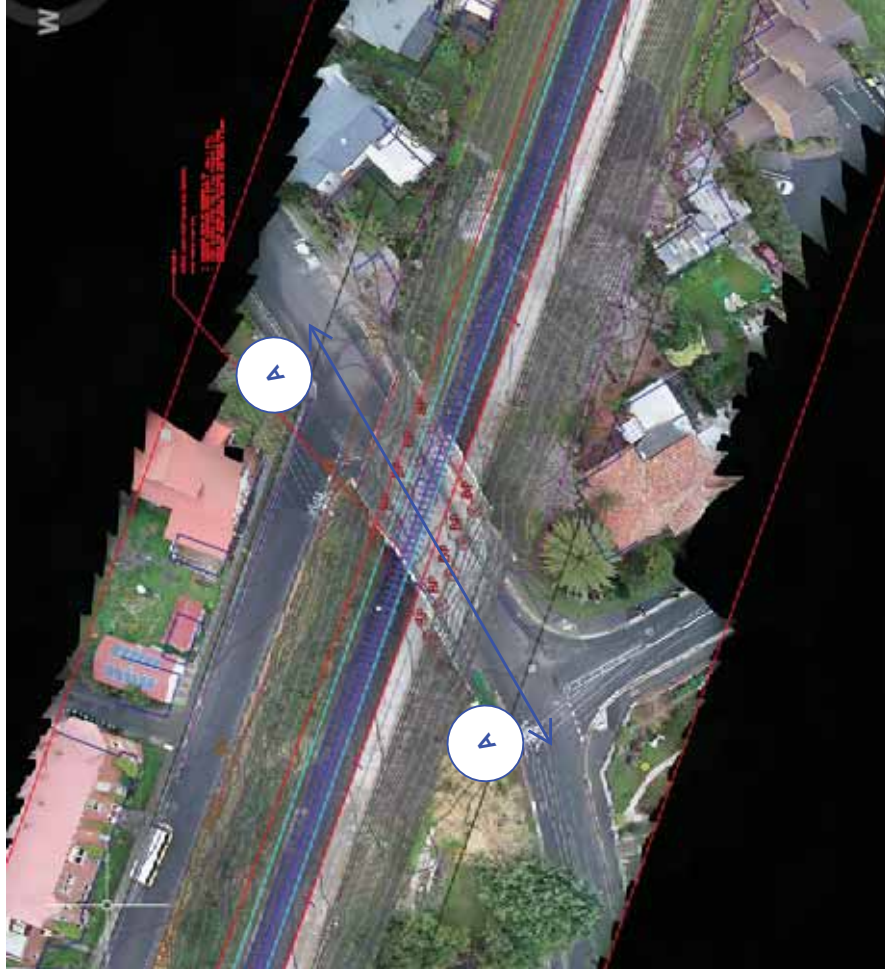
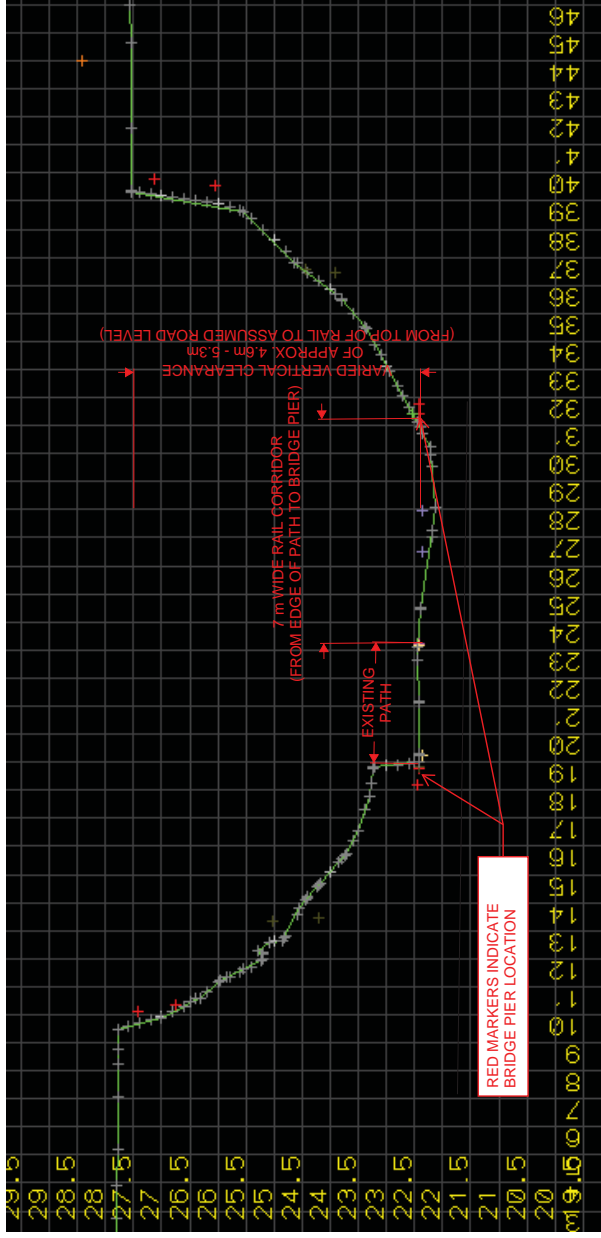
SECTION 7

EXISTING RAIL CORRIDOR RUNS FLUSH BETWEEN THE EXISTING CYCLE PATH AND TOWER ROAD BRIDGE PIERS. POTENTIAL FOR BRIDGE PIERS TO FALL WITHIN THE RAIL STRUCTURAL CLEARANCE ZONE (SUBJECT TO FURTHER DESIGN OF RAIL ALIGNMENT)

RISK: THE RAIL ALIGNMENT WILL NEED TO BE LOWERED TO ACHIEVE THE MINIMUM VERTICAL CLEARANCE REQUIRED FROM TOP OF RAIL TO BRIDGE SOFFIT. THIS WILL INCREASE THE OVERALL EARTHWORKS FOOTPRINT IMPACTING EXISTING BRIDGE PIERS / SUPERSTRUCTURE AND CYCLE PATH.
