**General Arrangement Plan Drawings –  
Culvert Location**

Size <b>A3</b>	Row <b>A</b>	
Client <b>DEPARTMENT OF STATE GROWTH</b>		Drawing Title <b>GENERAL ARRANGEMENT PLAN</b>	
Project <b>NSTC CONDITION ASSESSMENT</b>		Status <b>S2</b>	
Project No. <b>12548571</b>		Drawing No. <b>12548571-SK003</b>

Department of State Growth  
Northern Suburbs Transit Corridor -  
Condition Assessment

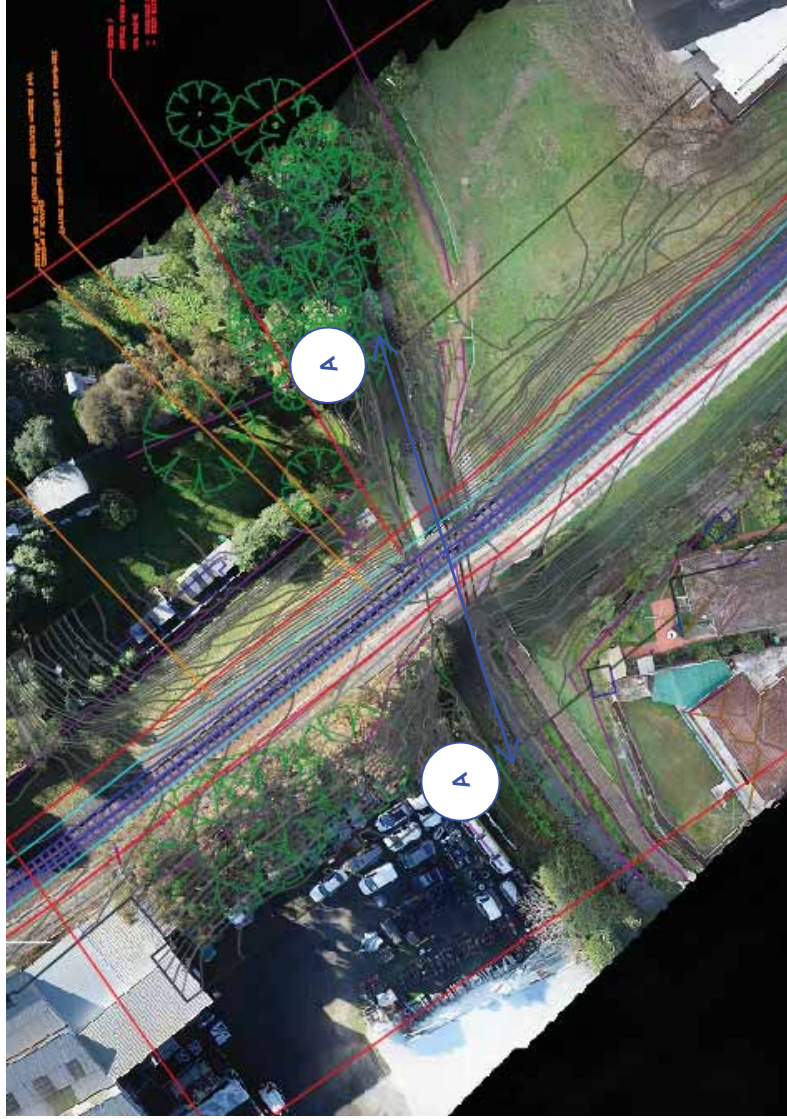
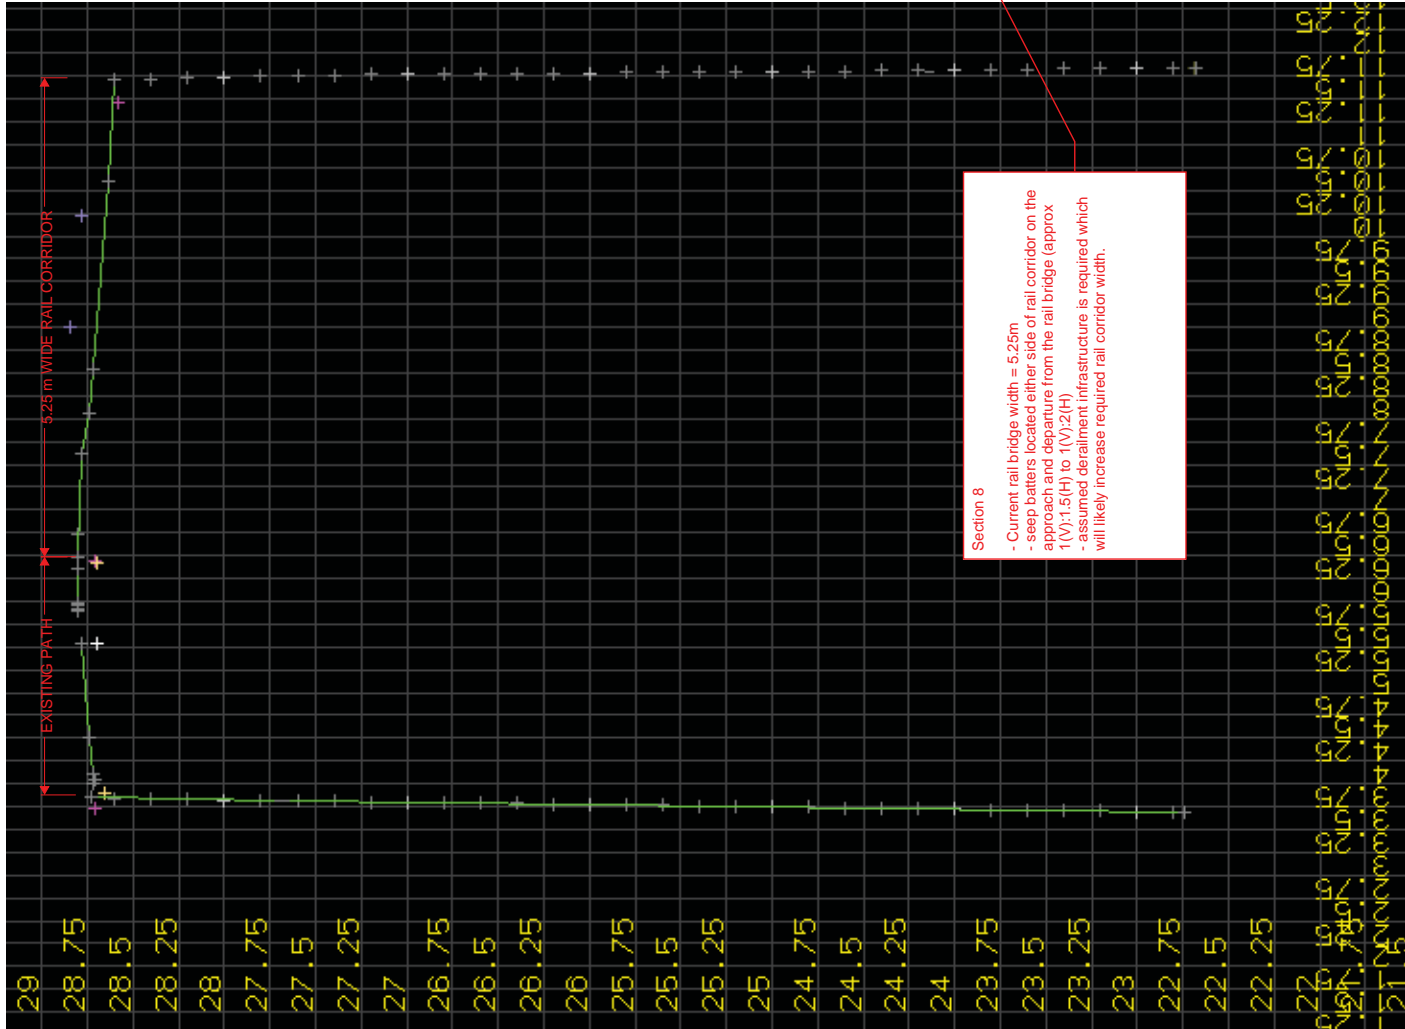
SECTION 8

EXISTING BRIDGE WIDTH IS INSUFFICIENT TO ACCOMMODATE THE REQUIRED RAIL CORRIDOR WIDTH ADOPTED IN THIS INVESTIGATION. ADDITIONALLY EXISTING 1(V):1.5(H) EMBANKMENTS WILL NEED TO BE STEEPENED ON THE APPROACH AND DEPARTURE FROM THE RAIL BRIDGE TO ACCOMMODATE THE WIDER RAIL CORRIDOR.
